SAFETY ALERT

Lightning strikes stationary truck

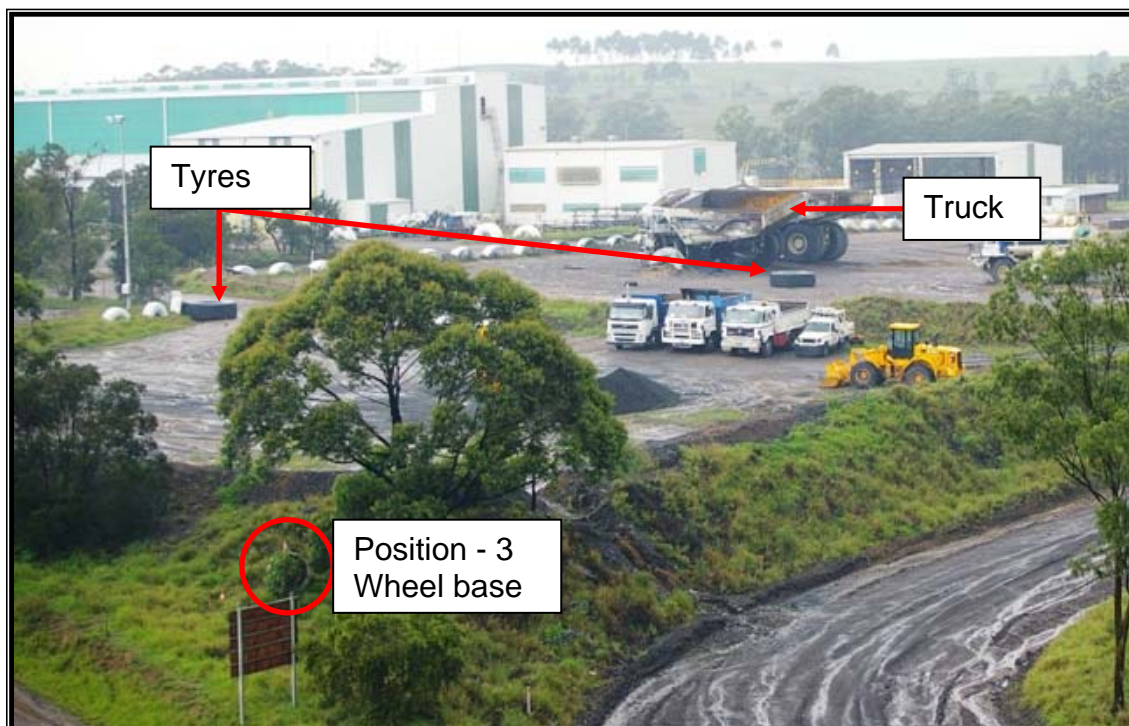
Figure 1: Parking area

The air blast and shock wave caused damage to the operator's cabin, other equipment and buildings up to 230 metres from the truck.

The operator's cabin windscreen of a water truck parked 20 metres from the RDT was blown out.

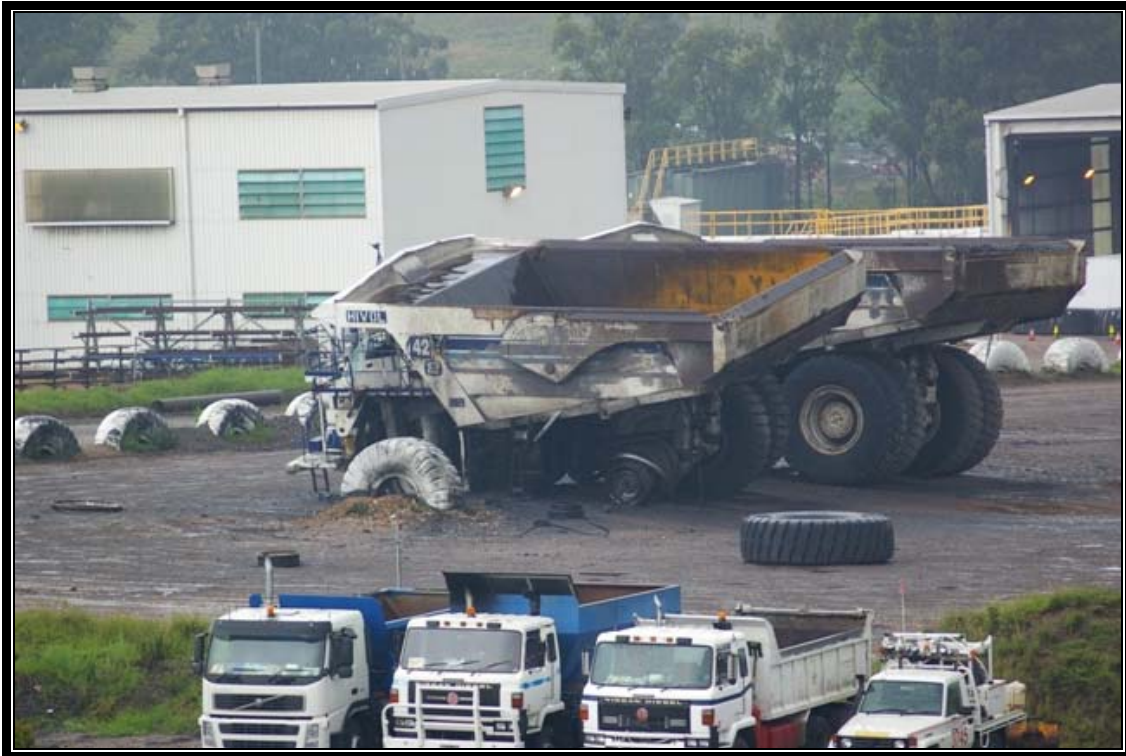
Figure 2: Close-up of the truck

1. The truck operator's rear cabin window was blown into the cabin and all other windows were blown outwards from the cabin. The driver's door was blown open.

2. The final drive was extensively damaged. The rear outer position 3 wheel base exploded off the final drive breaking 57 one-inch grade 10.9 bolts in tension with a calculated force of approximately 270 kNewtons. The final drive outer planetary carrier and axle were blown off the truck.

7. The front position 1 wheel strut mounting was distorted, and the front wheel hub was bent.
8. Fuel tank mountings were significantly damaged.
9. The three wheel bases were damaged and scrapped.

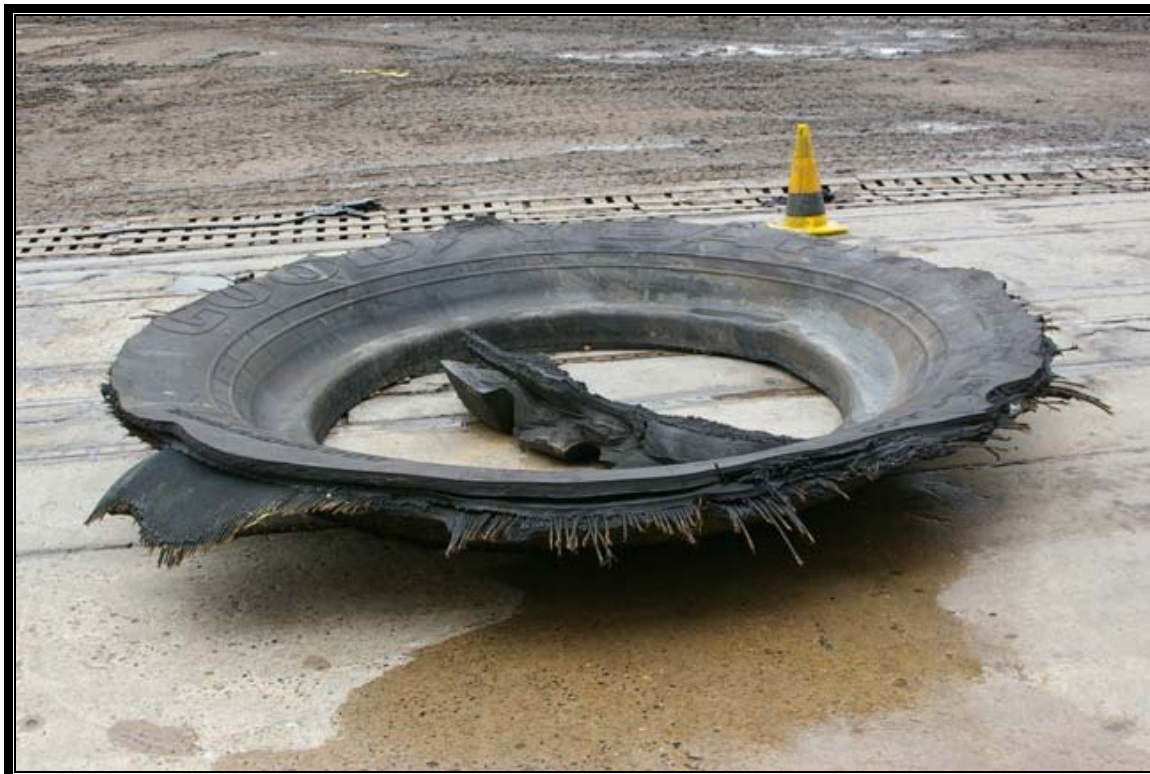
Figure 3: Tyre side wall from position number 1

3. Position 1 tyre (new tyre) had one complete side wall blown out.
4. Position 3 tyre had the side wall blown out for three-quarters of the circumference.

Position 1 tyre (driver's side front) showed evidence of earthing through this tyre, and it's believed the lightning earthed through No 1 and No 3 position tyres.

All tyres have been sent to the manufacturer for further inspection.
