Quarterly safety report

January to March 2024

About this report

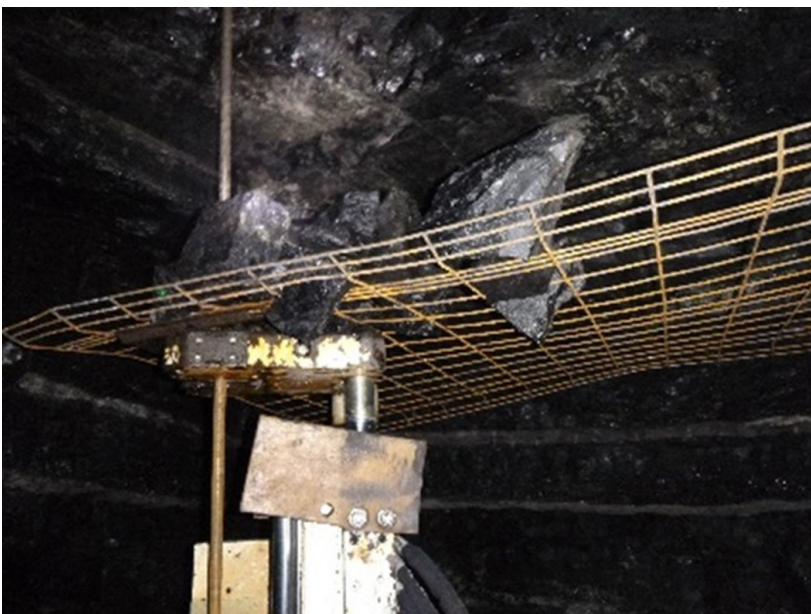
Picture 1.
Coal sitting on roof support.

Dangerous incident | IncNot0046138 – Underground coal mine roof coal dislodgement

Summary: An operator on a bolting platform was hit on the left shoulder when a drill steel dislodged a piece of roof coal that was about 2 m x 1 m x 0.6 m. The coal made contact with the temporary roof support, slid down the mesh and hit the centre console bolting rig controls before a second piece of coal that was 250 mm x 400 mm x 100 mm hit the operator - standing about a metre from where the coal was dislodged.

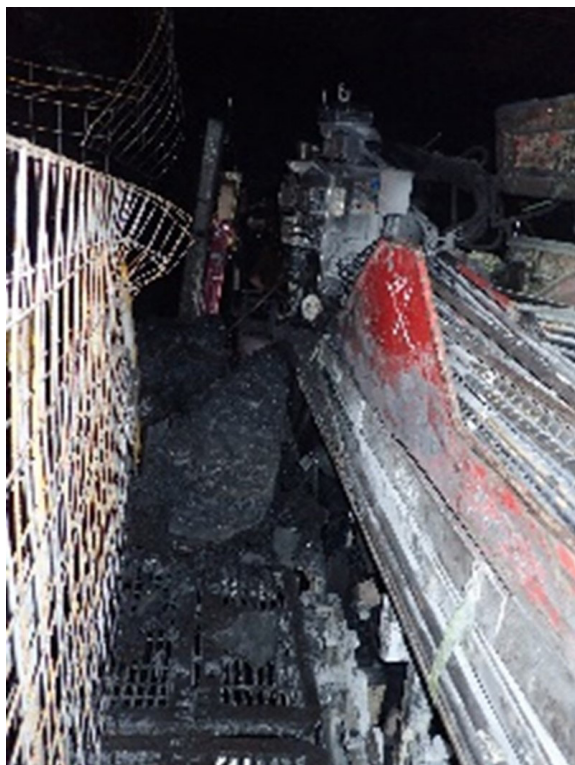
Picture 2.
Unbolted piece of strata.

Summary: An operator lost consciousness when hit by a large piece of strata that fell from the rib. The miner was pulling back because the vent trunk had fallen out. While pulling back, an unbolted piece of strata fell from the rib and hit the operator. The piece of strata was estimated to exceed 200 kg.

Comments to industry: Underground mines should review the adequacy of their strata monitoring arrangements and associated trigger action response plans (TARPs) to ensure that workers are not exposed to unacceptable risks associated with strata failure. Mine operators should consider developing procedures to install rib support bolts, so workers are not exposed to unsupported rib conditions during the work cycle at development faces.

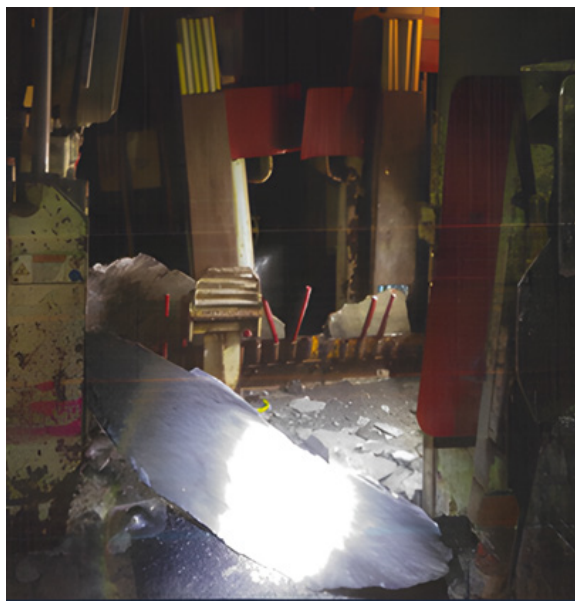
Picture 3.
Large piece of stone fallen from roof.

Summary: A large piece of stone broke from a roof, fell over the mesh landing on the temporary roof support (TRS) and hit a worker. The miner had been grading up in stone for a belt chamber and cutting a full face of stone 3500 mm high in a seam split area. The piece of stone was reported as being 1000 mm x 700 mm x 200 mm thick.

Comments to industry: Additional hazards must be considered when strata conditions change during the production cycle. In such situations, strata support designs should be reassessed to ensure they are adequate.

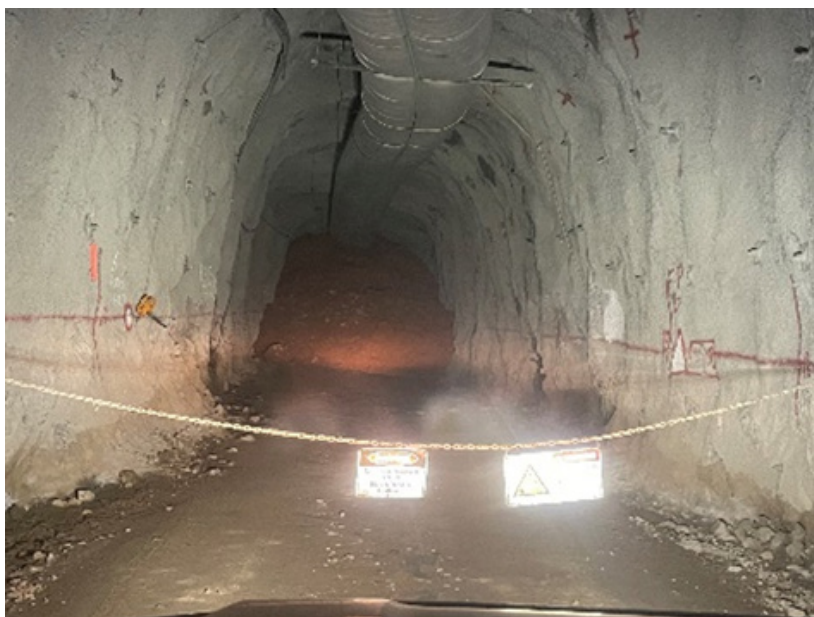
Picture 4.
Liquified clay following the blast.

Summary: After firing a draw point to shake the ore down, approximately 70 linear metres of clay type material flowed down the drive. The shockwave of the percussion blast appears to have caused the clay material in the old block cave to liquefy and push down the drive. There was nobody in the mine when the blast took place.

Comments to industry: Mine operators must assess the risk of inrush and inundation. When the risk exists, a principal hazard management plan must be in place. When developing the control measures to manage the risks of inundation or inrush of any substance, mine operators must consider:

- the failure or blocking of the flow channels
- the potential for the accumulation of water, gas or other substances, or materials that could liquefy or flow into other workings or locations.

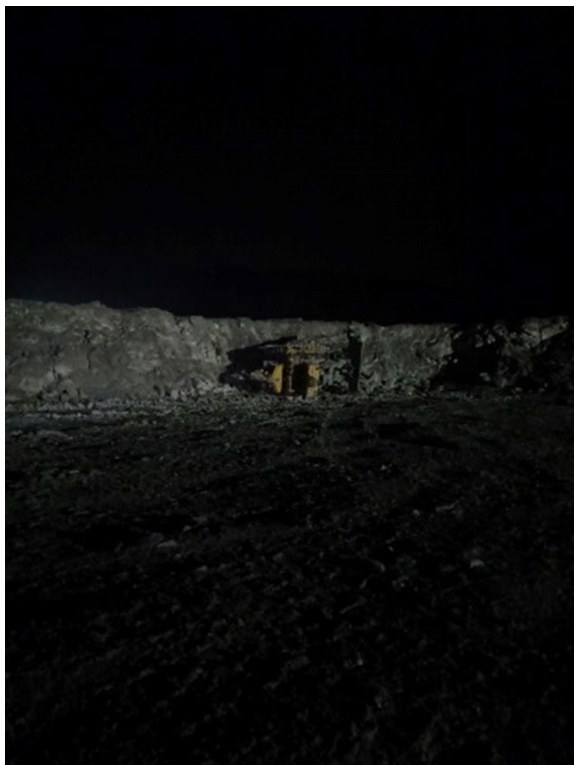
Picture 5.
Dozer after fall from bench.

Summary: While capping a shot, a dozer operator reversed over the edge of a bench and came to rest on a ripper box. The dozer pivoted onto its right-hand side. The dozer operator was a trainee under instruction at the time of the incident. The operator was wearing a seatbelt and was not injured.

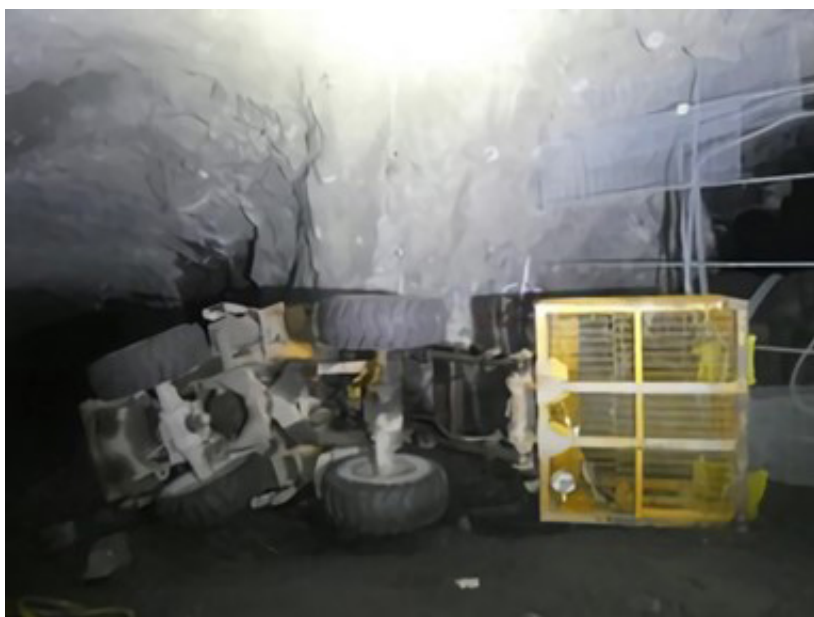
Picture 6.
Trucks after collision.

Summary: An integrated tool carrier overturned while 2 workers were in the basket installing mesh. The workers in the basket instructed the IT operator to turn the IT so that it was square to the wall. When turning to the left on a cross-cut on the ramp (1 in 7) the operator felt the right-hand rear of the machine lift and the IT slowly overturned. Both workers in the basket were wearing harnesses and were uninjured.

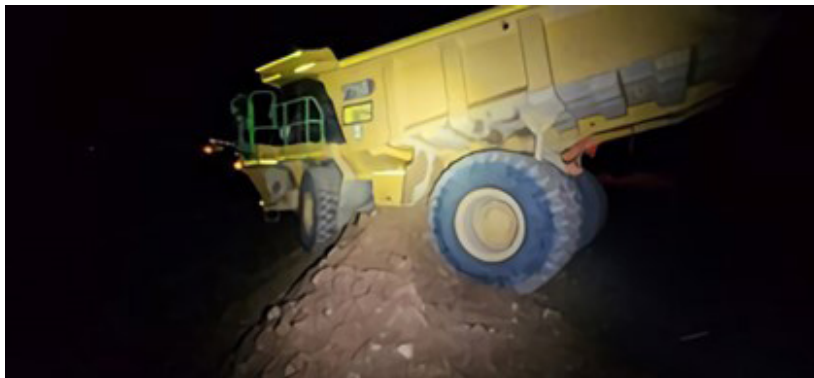
Picture 7.
Haul truck on bund.

Summary: An operator lost control of a haul truck when leaning down to pick up a water bottle. The 2 front wheels ended up over a bund where there was a 1.5 m drop into bush land.

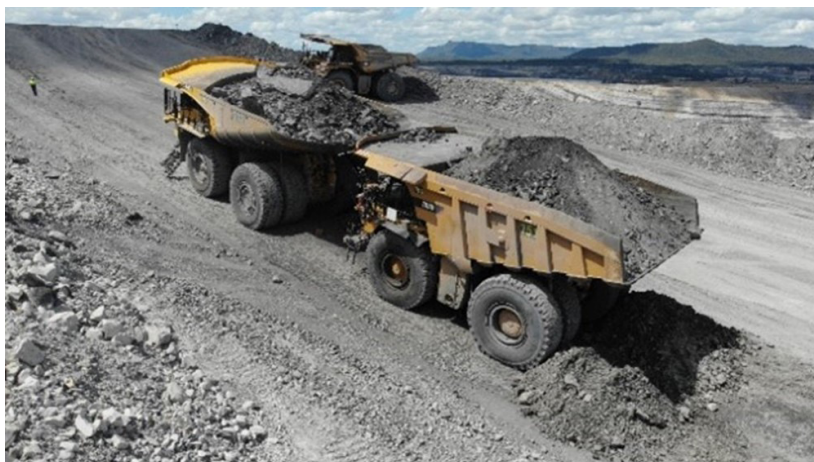
Picture 8.
Trucks after collision.

Summary: Two loaded trucks collided while driving up a ramp. The truck in front stopped and the truck behind ran into the back of it. The tray of the front truck went over the cab of the rear truck as per design and there were no injuries.

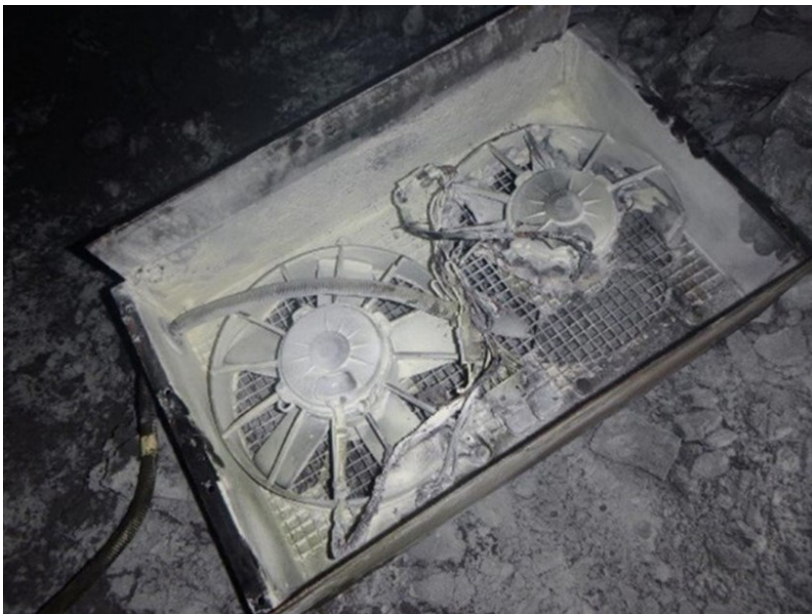
Picture 9.
Condenser unit after fire.

Dangerous incident | IncNot0046232 – Air conditioner condenser unit fire

Summary: An air-conditioner condenser unit at the rear of an operator’s cabin on a long-hole drill rig caught fire while it was underground. A fitter was inspecting a fault on the unit and observed fire and smoke. The fire was extinguished immediately by the fitter and the driller.

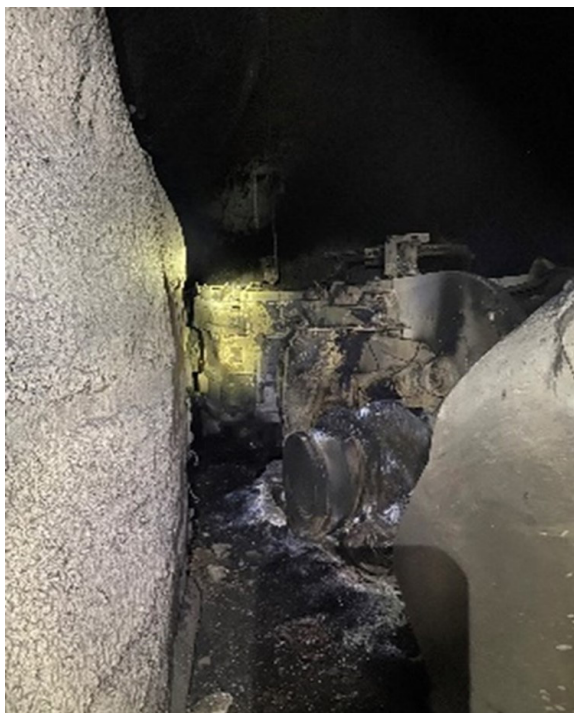
Picture 10.
Fire damage to automated loader.

Summary: A remote-control automated loader caught fire underground. The mine's fire suppression system initiated but did not fully extinguish the fire. The loader continued to burn, and the mine's emergency response was activated. All people were accounted for in refuge chambers and the loader was allowed to burn until the fire went out.

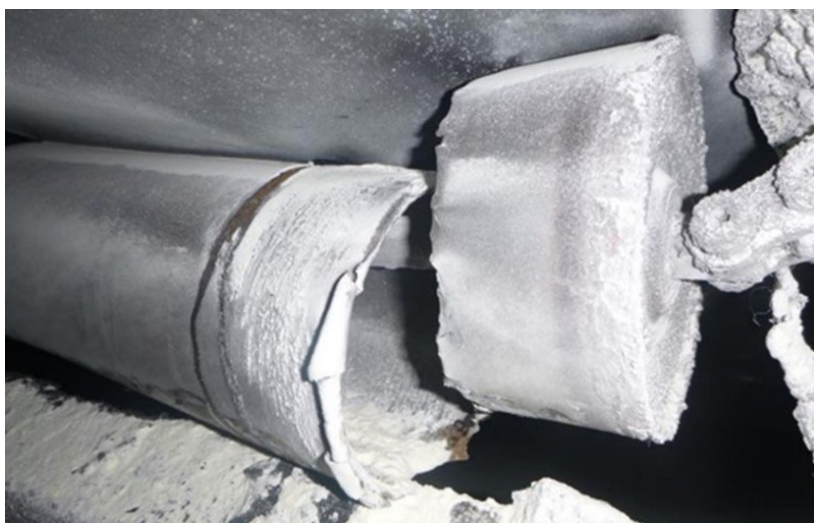
Picture 11.
Fire damage.

Summary: While standing on a longwall maingate, a deputy noticed a burning smell and identified 4 ppm carbon monoxide on a Drager X-am gas detector. The deputy travelled outbye to investigate and found a small ball of material about 20 cm diameter burning on top of the return belt. This was then extinguished with a fire extinguisher. The cause of the fire was a troughing idler failure.

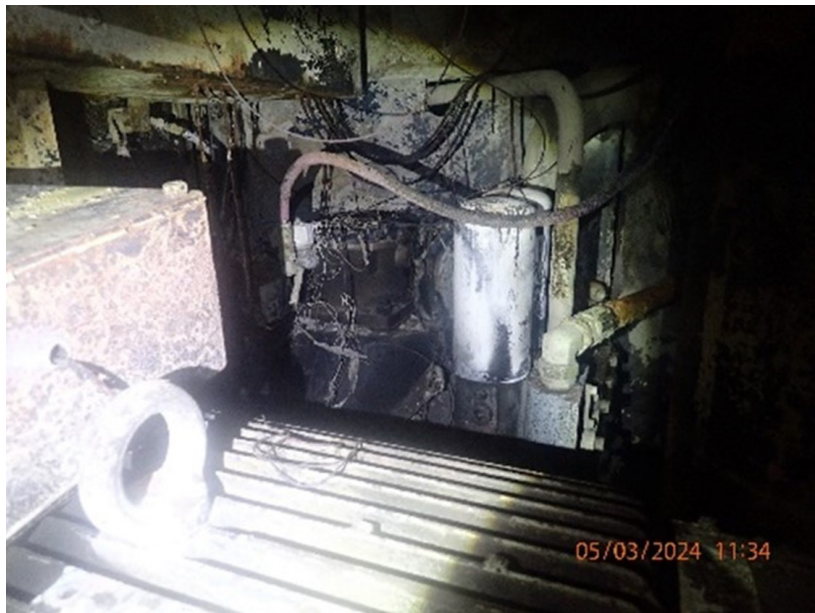
Picture 12.
Damaged compressor after fire.

Summary: Underground workers had to retreat to refuge chambers following a fire on a compressor. An emergency response team was sent to one person who was in a refuge chamber close to the fire location. Nobody was injured.

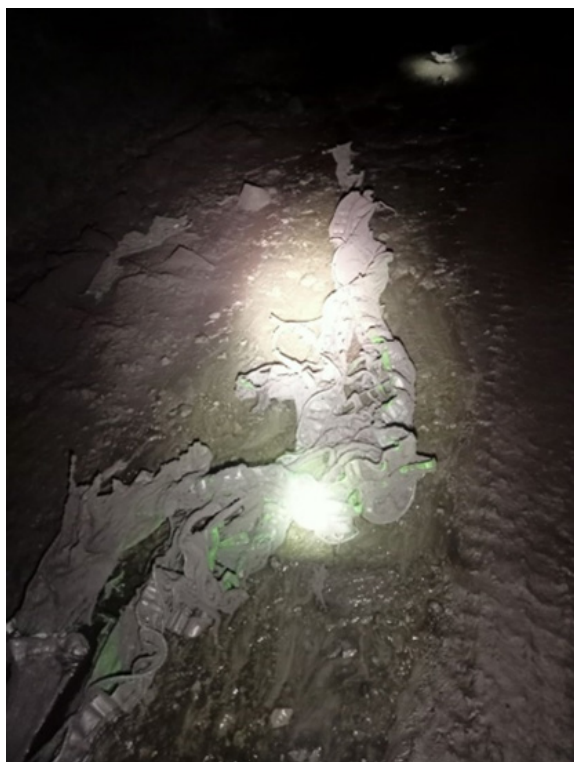
Picture 13.
Damaged ventilation bag.

Summary: A sulphide dust explosion occurred underground after a heading was fired. Approximately 70 metres of ventilation bag was either blown down or melted.

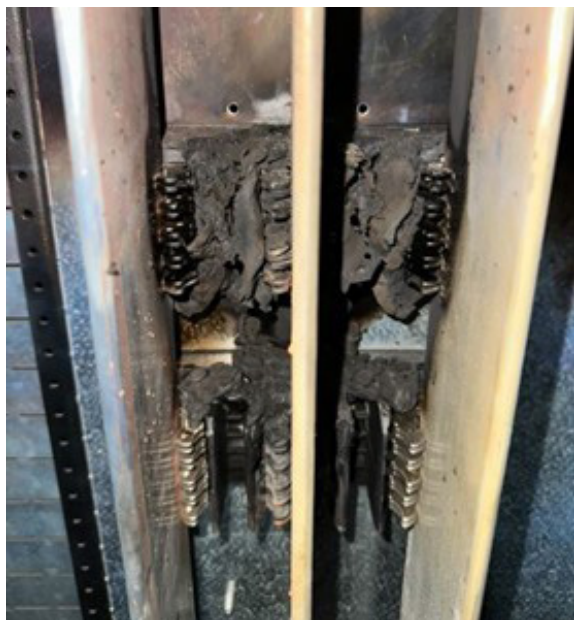
Picture 13.
Melted busbar plug.

Summary: A switchroom starter for an underground conveyor tripped and couldn't be reset. An electrician could smell something burning and opened the cubicle doors. The cubicle emitted smoke, but no flames were seen. A further investigation revealed that the busbar plug had melted.

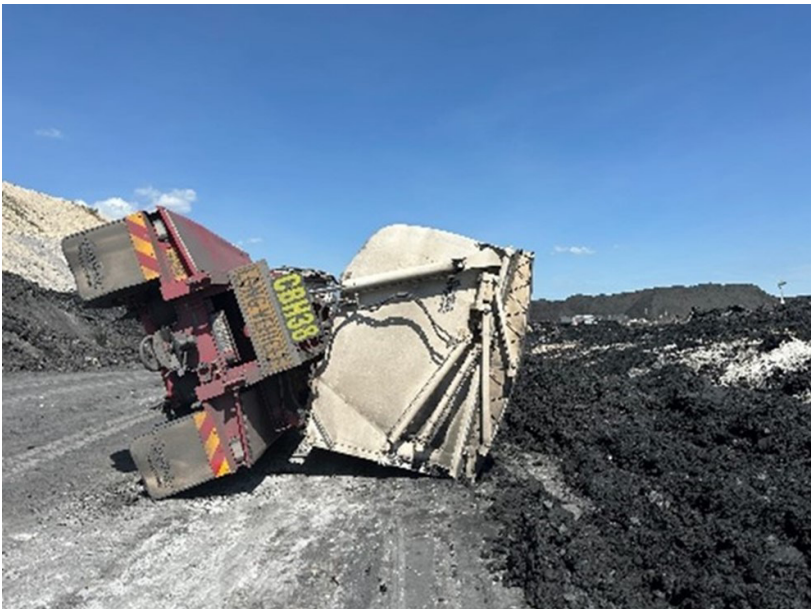
Picture 15.
Rolled rear trailer.

Dangerous incident | IncNot0046231 – Rear trailer rolled while unloading rejects on ROM pad

Summary: The rear trailer of a road registered B-double side-tipper truck rolled over while unloading rejects on the ROM pad. The load was a mixture of belt press filter and coarse rejects with about 21 tonne in trailer.

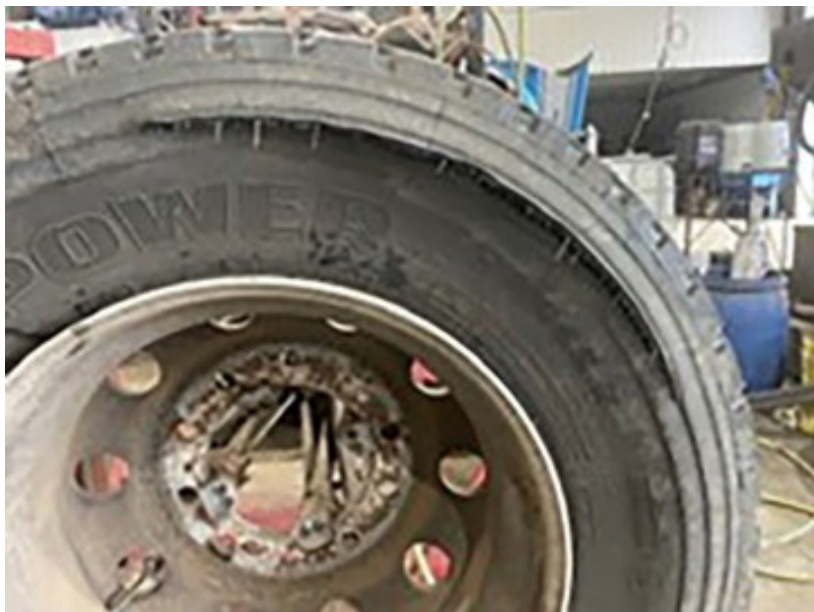
Pictures 16.
Exploded tyre.

Summary: While inspecting and reinflating a truck tyre that had been run flat, the tyre exploded while a worker was standing in front of it. The worker was knocked over by the force. He was transported to hospital. A second worker suffered a cut over their left eye.

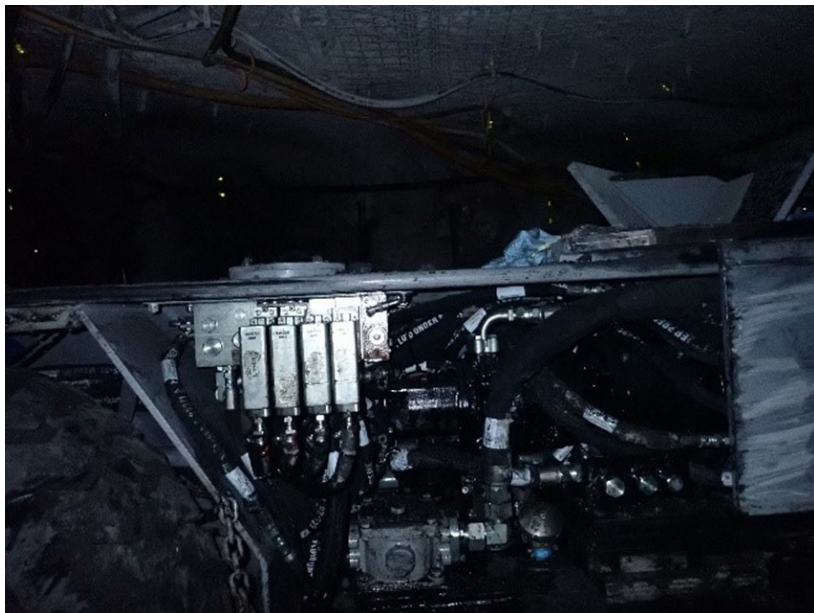
Picture 17.
Valve bank.

Summary: A shuttle car had a leaking valve bank during night shift that was repaired. On the day shift, it was found to be leaking again during the prestart. A fitter isolated the shuttle car and was sprayed with hydraulic oil in the face and chest while removing the brake pressure solenoid. The fitter had oil in his left eye despite wearing safety glasses. The accumulator circuit pressure was not dissipated.

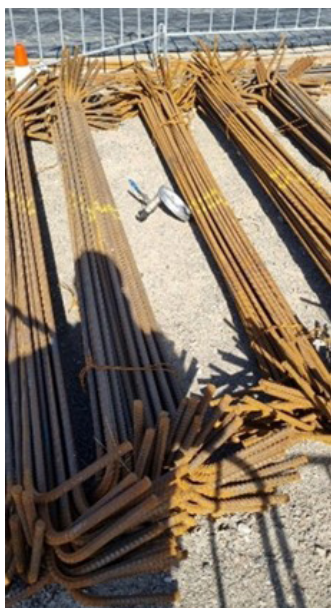
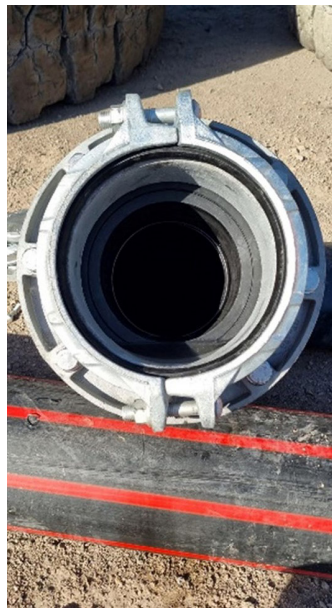
Picture 18.
Landing place of ejected end valve.

Summary: While pressure testing poly pipe during commissioning, the end cap ejected 50 metres, landing 2 metres from a worker. The failure occurred 20 minutes into a 25-minute test. No one was injured.

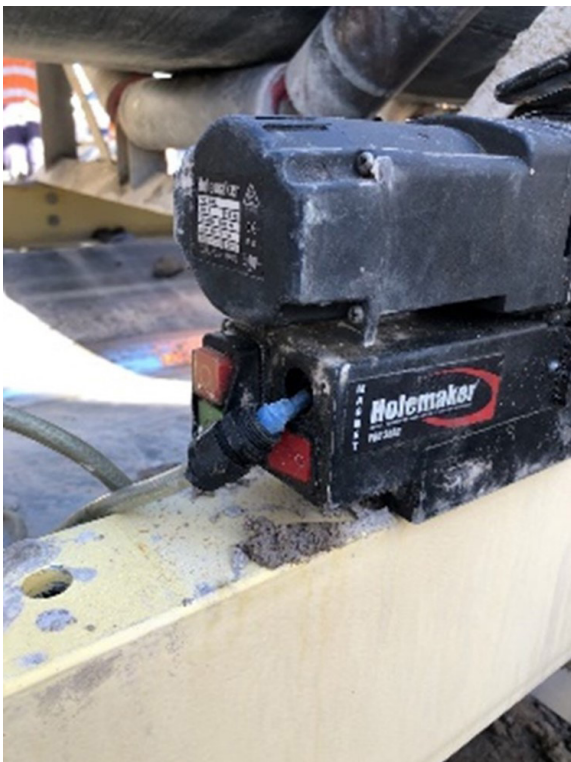
Picture 20.
Electric rotor broach

Dangerous incident | IncNot0046027 — Electric shock using electric rotor broach

Summary: A worker suffered an electric shock while installing a new skirting system to a conveyor using an electric rotor broach to drill holes. A gland on the portable drill was pulled out and allowed ingress of moisture to internal electrical components.
