Weekly incident summary

Week ending 14 June 2024

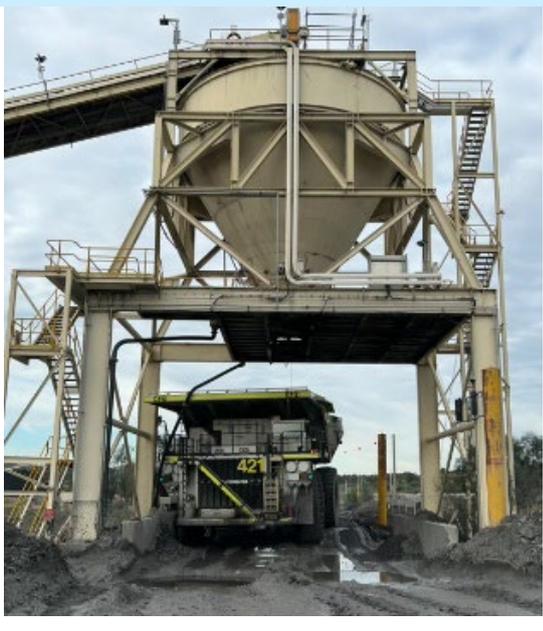
Incident type	Summary	Comments to industry
Dangerous incident	A haul truck collided with the support structure of a reject bin.	When rain causes dangerous road surface conditions, roads should be closed until they are made safe for travel.
IncNot0047058 Open cut coal mine	The truck was travelling under the bin at low speed when it slid to the right and pushed over the protective bollard in front of the bin beam. The eyebrow on the tray made contact with the bin beam.	Workers should immediately notify supervisors if they consider a work area is dangerous or not compliant with site standards. Principal hazard management plans for roads or other vehicle operating areas should consider factors that may affect an operator's ability to control a vehicle.

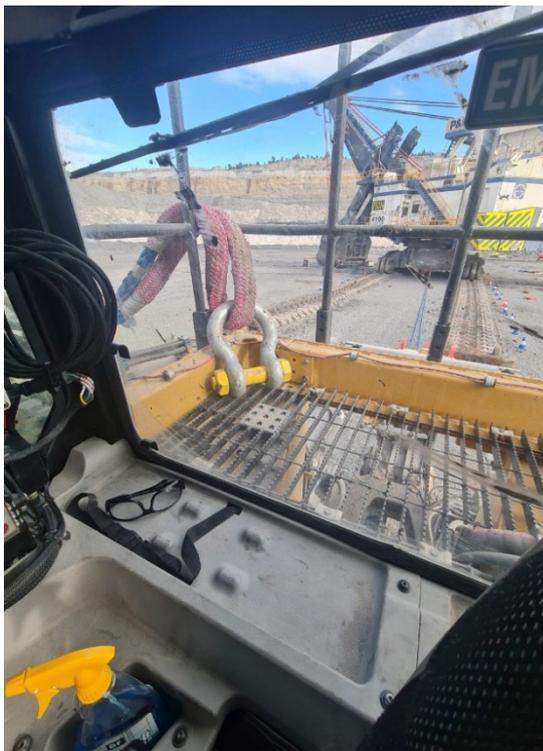
<p data-bbox="105 860 248 927">Dangerous incident</p> <p data-bbox="105 949 312 983">IncNot0047067</p> <p data-bbox="105 1005 288 1072">Open cut coal mine</p>	<p data-bbox="376 860 919 1117">While attempting to tow a face shovel back onto its tracks using 2 dozers, one of the synthetic slings snapped and recoiled towards the dozers. The shackle hit the shovel track and ricocheted onto a dozer handrail coming to rest on the deck at the back left-hand corner.</p>

<p data-bbox="983 860 1471 1084">When towing plant, special attention should be given to the attachment of slings and shackles to minimise the likelihood of generating a hard projectile in the event of a sling failure.</p> <p data-bbox="983 1106 1471 1173">Avoid loading soft slings against hard edges on attachment points.</p>

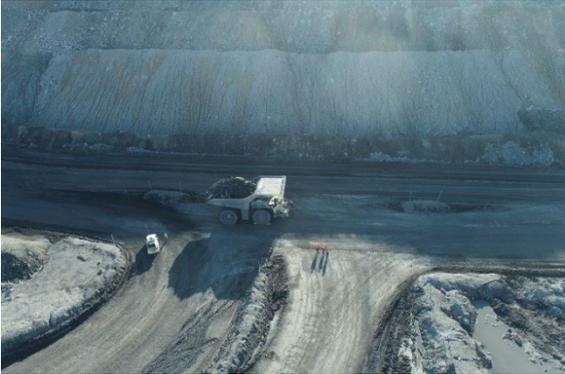
<p>When approaching a T-intersection, a haul truck crossed onto the right-hand lane to pass a grader.</p> <p>At the same time, a light vehicle approached the intersection up a ramp to turn left. The haul truck proceeded through the intersection on the wrong side of the road as the vehicle attempted to turn left.</p> <p>Before turning left, the vehicle driver looked to the right for oncoming traffic. The driver began the left hand turn but had to quickly apply the brakes to avoid a collision with the oncoming haul truck.</p>

<p>Mine operators must ensure all roadway intersections are designed, constructed, and maintained to safely manage interactions between mobile plant and light vehicles.</p> <p>Intersections should be positioned at 90 degrees to haul roads to allow clear visibility for vehicles when travelling through them.</p>
