Weekly incident summary

Week ending 31 May 2024

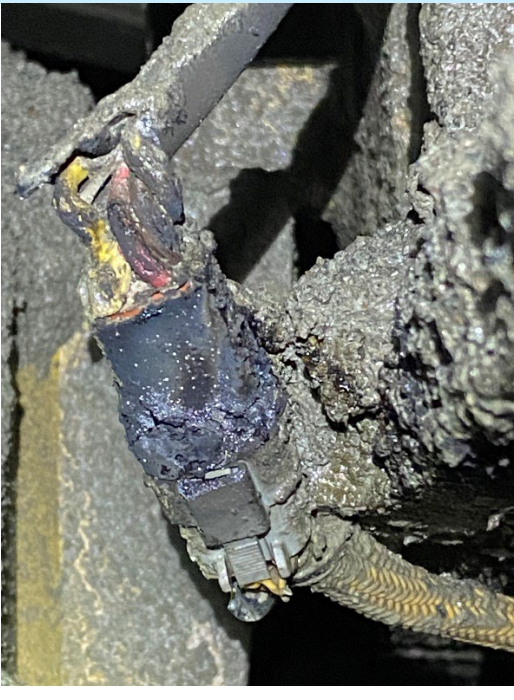
<p>A worker was refilling a water cart at the refill point on the main decline when they saw the glow of a flame. The worker removed the wheel chock and drove forward under the flowing water to extinguish the flame.</p> <p>Preliminary investigation shows that water ingress corroded an electrical connector. The connector combusted due to excessive heat generated due to the poor connection.</p>	<p>Mine operators should ensure that risk control measures to prevent the occurrence of fires on mobile plant are implemented and remain effective. Inspection regimes and housekeeping standards should be routinely examined to ensure minimum standards are met or exceeded. Mine operators should ensure stringent monitoring and quality control of maintenance and repair activities.</p>

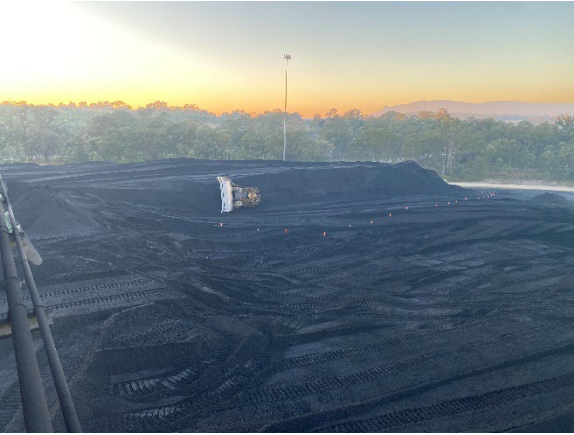
<p data-bbox="124 927 266 994">Dangerous incident</p> <p data-bbox="124 1016 325 1048">IncNot0047000</p> <p data-bbox="124 1070 301 1102">Open cut coal</p> <p data-bbox="124 1124 322 1218">Roads or other vehicle operating areas</p>

<p data-bbox="392 927 963 1218">A dozer was reclaiming for a train on the thermal product feeders. The operator came close to the edge of an adjacent stockpile boundary which was cut to the floor, leaving a vertical bench to the stockpile where the dozer was working. The vertical bench was about as high as a dozer-blade. The dozer slid off the bench onto its side.</p> <p data-bbox="392 1240 938 1384">The workers failed to complete a job hazard analysis (JHA) for working on abnormal stockpile conditions as identified in the site's procedure.</p>

<p data-bbox="999 927 1477 1218">Site procedures are developed to help protect workers from injury or illness. Where a procedure exists for a particular task, workers should follow the procedure. Any deviation from a procedure should first be discussed with a supervisor and appropriate risk control measures put in place.</p> <p data-bbox="999 1240 1458 1348">Refer to safety bulletin SB19-01 Rise in dozer incidents putting operators at risk.</p>
