# Safety Alert

## Vehicle interaction in an underground mine

A collision occurred between a light vehicle carrying 3 passengers and an integrated tool carrier (ITC).

## Safety Alert SA24-02

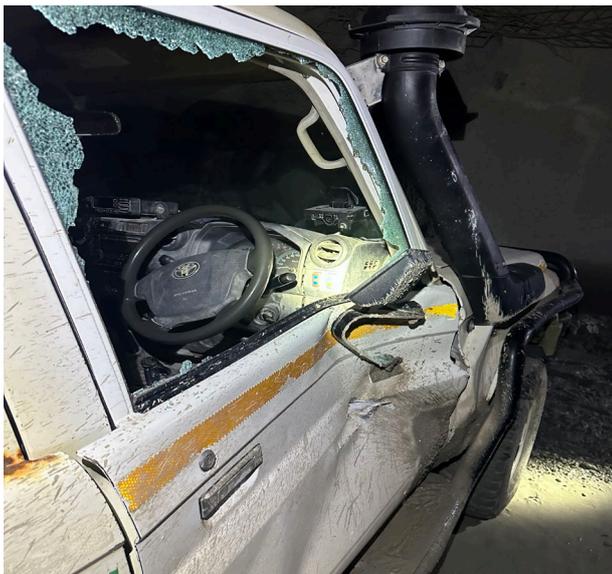
Figure 1: Damage to the light vehicle

The ITC hit the rear counterweight and the driver's door of the light vehicle, shattering the driver's side window before the ITC operator became aware of the situation, stopped and moved forward.

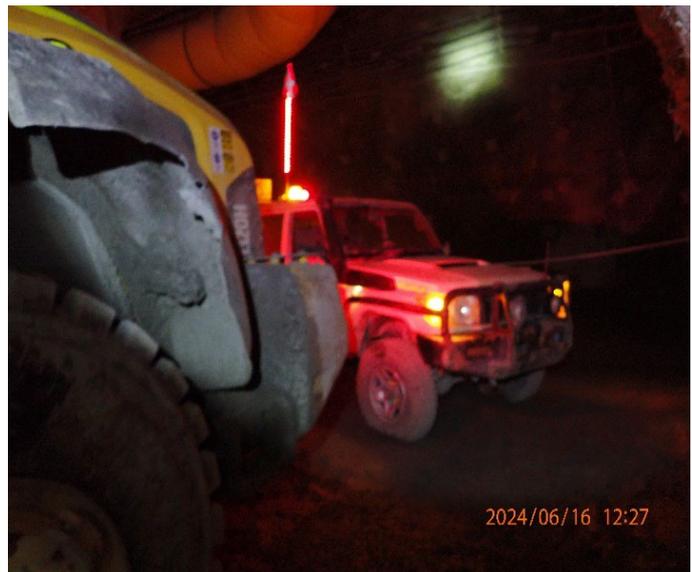
Figure 2: The position of the equipment after the incident

A light vehicle was following the ITCs and pulled into the level access area about one metre behind the second ITC.

After hearing the truck operator call on the radio that it had passed that level, the second ITC operator looked over their right shoulder and reversed out of the level back onto the decline. Due to the proximity of the light vehicle, the ITC operator was not aware of it.

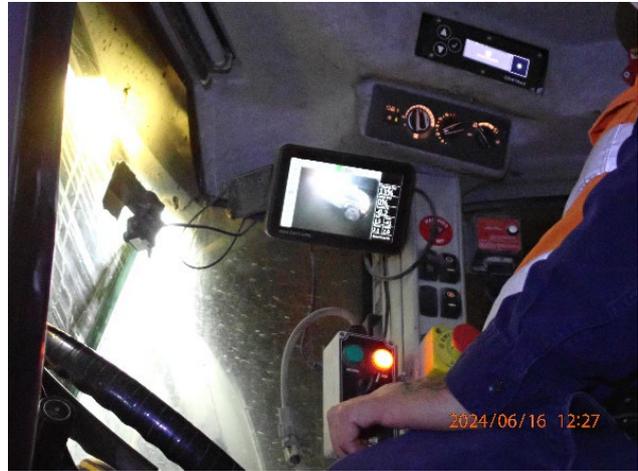
Figure 4: The view of the reversing camera

- Failure of positive two-way communication.
- Non-compliance with traffic management procedures.
- The failure to use a reversing camera on the ITC.

- Dangerous incidents must be investigated, and high order controls must be implemented when practical in a timely manner, with the aim to prevent a recurrence.
- Regularly review vehicle video to monitor workers' behaviour.
- Regularly assess and correct worker behaviour with respect to compliance with rules and procedure.
- Review procedures, rules, and systems to ensure they detail the behaviours required by workers to work safely.
- Assess the experience, demographic and habits of workers to develop competencies to ensure workers are competent to use all technology available and ensure they safely operate mobile plant and equipment.
- Mine operators should conduct human and organisational factor investigations/assessments of contractors to help determine and manage the culture of the organisation.
