Weekly incident summary

Week ending 12 July 2024

Weekly incident summary week ending 12 July 2024

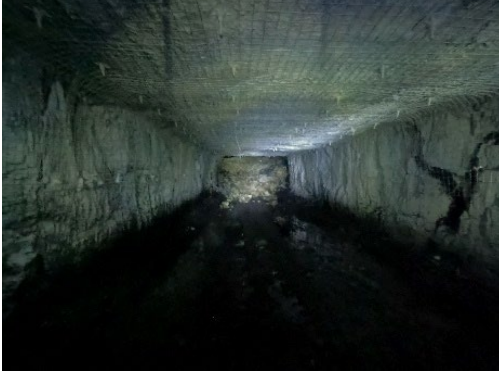
<p>A fall of ground occurred affecting an entire intersection at a heading where mining had been occurring inbye of the area during night shift. The crew had withdrawn equipment for planned maintenance on day shift before the fall occurred.</p> <p>The area design was a run out on the left-hand side of the bord and pillar panel with herringbone and floor stripping. There was an unbolted section and a bolted section through the run out. At 11am, it was observed there was a roof and skin failure in the open lift (unbolted area). At 3pm, it was reported that the fall of ground had progressed through the entire intersection (bolted and unbolted).</p>	<p>This incident is under investigation and further information may be published later.</p> <p>Mine operators are reminded of the need for workers who are required to install and maintain tell-tale strata monitoring devices to be trained on the correct installation and defect management requirements for the lifecycle of the devices.</p>

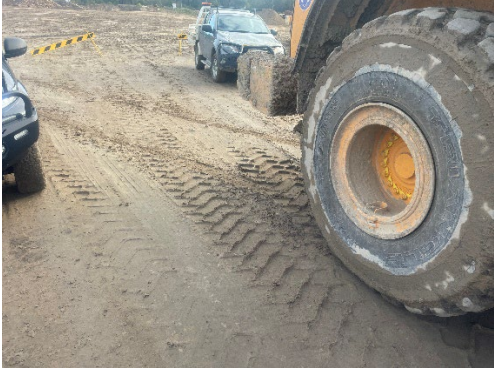
<p data-bbox="419 589 935 1128">A loader reversed into one of 2 light vehicles that had stopped about 10 metres behind it. The first vehicle failed to make positive communications with the loader because of a flat radio battery. When the loader began to reverse, the first vehicle moved out of the way and the loader continued until it hit the second vehicle. The second vehicle operator assumed the first vehicle operator made positive communications but didn't hear anything. He had his flashing light on and sounded the horn to stop the loader.</p>

<p data-bbox="943 589 1481 712">When stopping light vehicles, workers must not place themselves at risk of interactions with heavy vehicles.</p> <p data-bbox="943 723 1481 987">Following a recent awareness campaign on vehicle interactions the Regulator published a video that can be used for training purposes and toolbox talks. Mine operators are encouraged to use this resource. You can watch the video on YouTube.</p> <p data-bbox="943 999 1481 1783">To achieve positive communication, a clear direct message must be given. Additionally, the person receiving the message must actively reply with a clear understanding of the message. Supervisors should be continually monitoring positive communications compliance during every radio call on their shift. Work Health and Safety Regulation 2017 clauses 35 & 36 requires higher order risk controls be implemented and administrative controls such as positive communication, only be used when no higher order controls can be implemented. Controls such as equipment segregation and proximity awareness systems should be implemented before positive communication only systems are considered.</p>

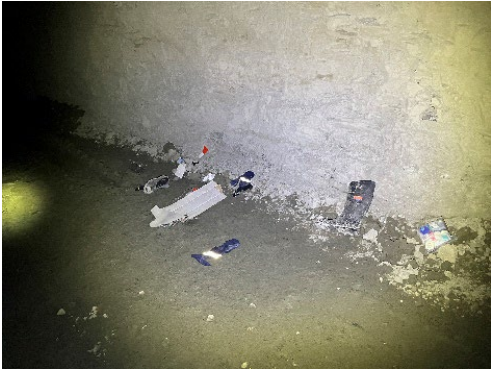
<p data-bbox="113 1812 411 1897">Serious injury IncNot0047226</p> <p data-bbox="113 1908 411 1991">Underground metalliferous mine</p>	<p data-bbox="419 1812 935 1991">A worker on foot in a decline was hit by a loader that travelled into the area. The worker suffered serious leg and foot injuries.</p>	<p data-bbox="943 1812 1481 1935">This incident is under investigation and further information may be published later.</p>

Incident type	Summary	Comments to industry
	<p>A light vehicle stopped in front of vent doors towards the bottom of a decline. The passenger got out and went to the rear of the light vehicle to get equipment. The vehicle driver advised that a loader was coming down the decline and proceeded to go through the vent doors. The loader operator was unaware of the worker on foot and discovered the incident only after parking up.</p>
