Weekly incident summary

Week ending 5 July 2024

Weekly incident summary week ending 05 July 2024

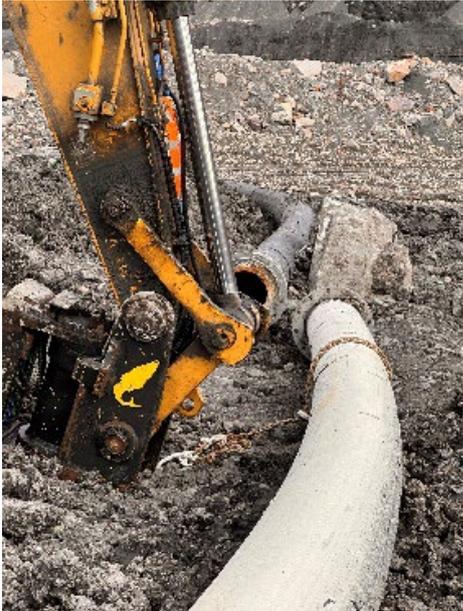
Incident type	Summary	Comments to industry
	<p>One of those poly pipes was resting on the ground, being supported by a large rock. The other pipe was secured via a single wrap chain attached to an excavator hitch. There was a slight overlap and misalignment of the 2 pipe flanges. As the 2 poly pipe flanges were being joined, it appears the poly pipe attached to the excavator hitch moved (slipped) within its restraining chain allowing the poly pipe to hit the left leg of the worker. The internal stored energy within the poly pipe released when the chain slipped along the pipe.</p>

<p>and assessed as being competent in that SWP. The SWP should:</p> <ul style="list-style-type: none"> • be developed from a risk assessment that sets out and assesses all foreseeable risks to workers during in-pit pulling and/or joining activities. This should include risks associated with mobile plant, potential stored energy within the poly pipe and possible in-pit environmental conditions. • set out fit-for-purpose equipment to be used and how it is to be used. • provide a fit-for-purpose means to secure the poly pipe to the pulling equipment. • provide safe standing zones for workers so they are, so far as is reasonably practicable outside possible recoil zones. • provide processes to pull in-pit poly pipes together • provide processes to join 2 poly pipe flanges together. <p>Refer to Safety bulletin: <u>SB09-03 Broken pull chain results in fatality</u></p>
