# Investigation information release

## Dangerous incident at Clarence Colliery – roof fall

**Location:** Clarence Colliery, Bells Line of Road, Clarence NSW 2790

## Investigation information release IIR24-05

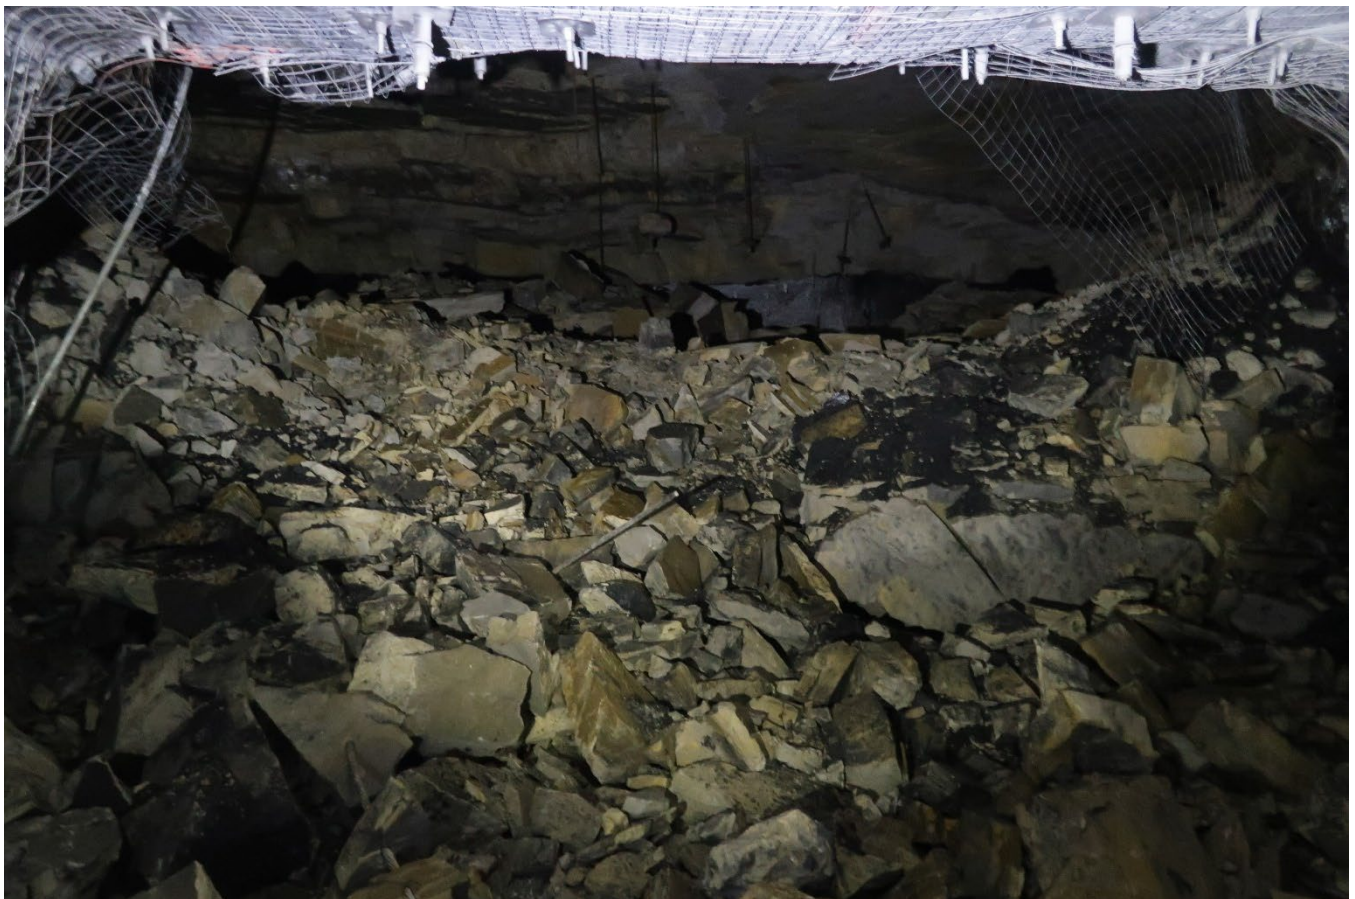
About 11 am on July 9, 2024, a roof and skin failure occurred in the 'Z' heading outbye of the intersection at 13 cut-through. The roof in this area was supported about 6 metres from the centreline of 13 cut-through in accordance with the Red TARP requirements, which left the remainder of the Z heading roadway unsupported. There were no workers present at the time. As a safety measure the area, including the intersection, was barricaded off to prevent access.

About 3pm, there was a roof collapse throughout the entire intersection at 'Z' heading 13 cut-through. Both bolted and non-bolted sections of the roof fell. Given the area had already been barricaded off, no workers were present when this occurred.

Figure 1: Intersection at 'Z' heading 13 cut-through inbye

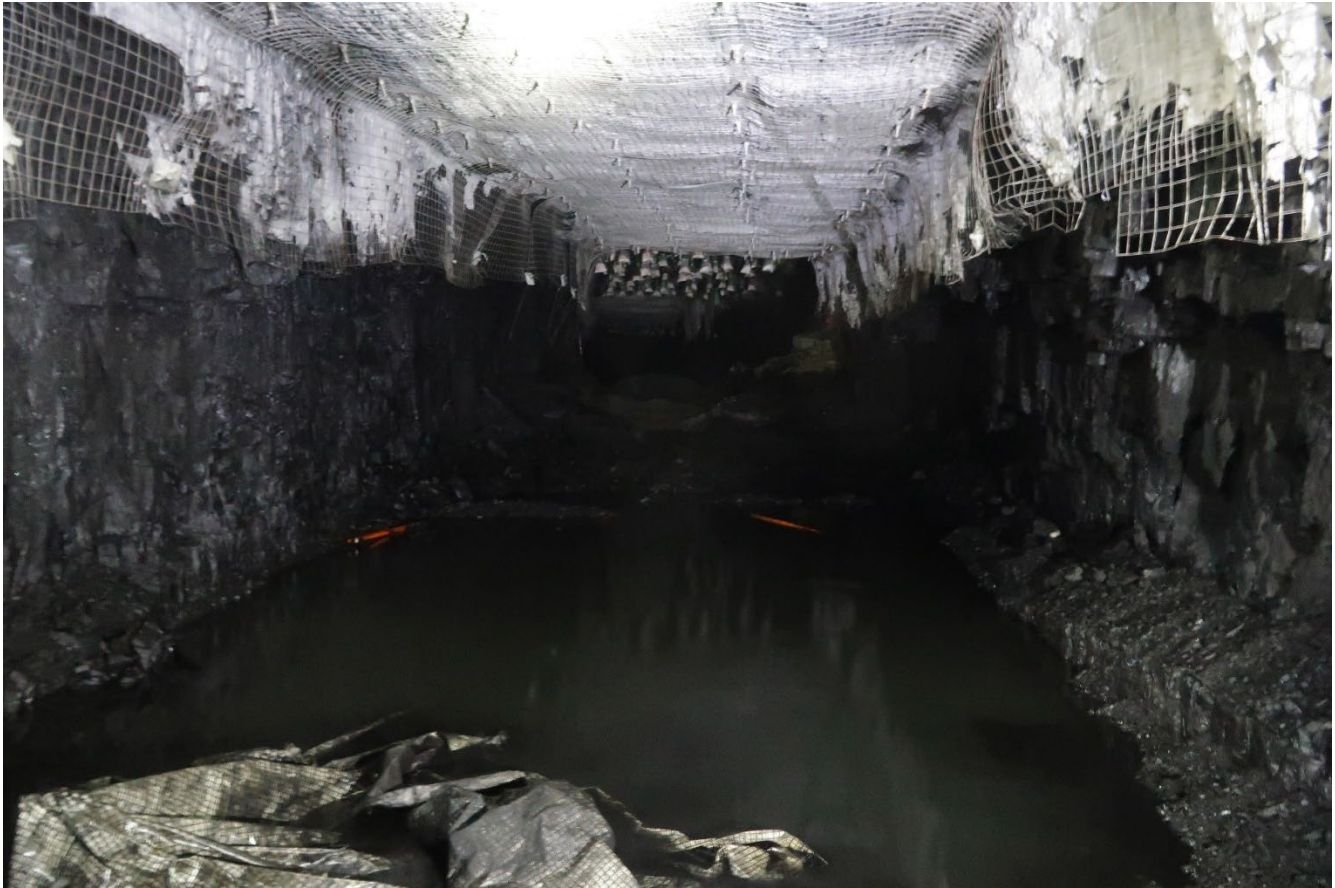
Figure 2: 12 cut-through inbye to intersection at 'Z' heading with floor stripped (for context of final roadway dimensions)
