# Investigation information release

## Serious injury arising from vehicle/pedestrian interaction in an underground metalliferous mine

**Location:** Ridgeway Gold Mine, Orange District, NSW

## Investigation information release IIR24-06

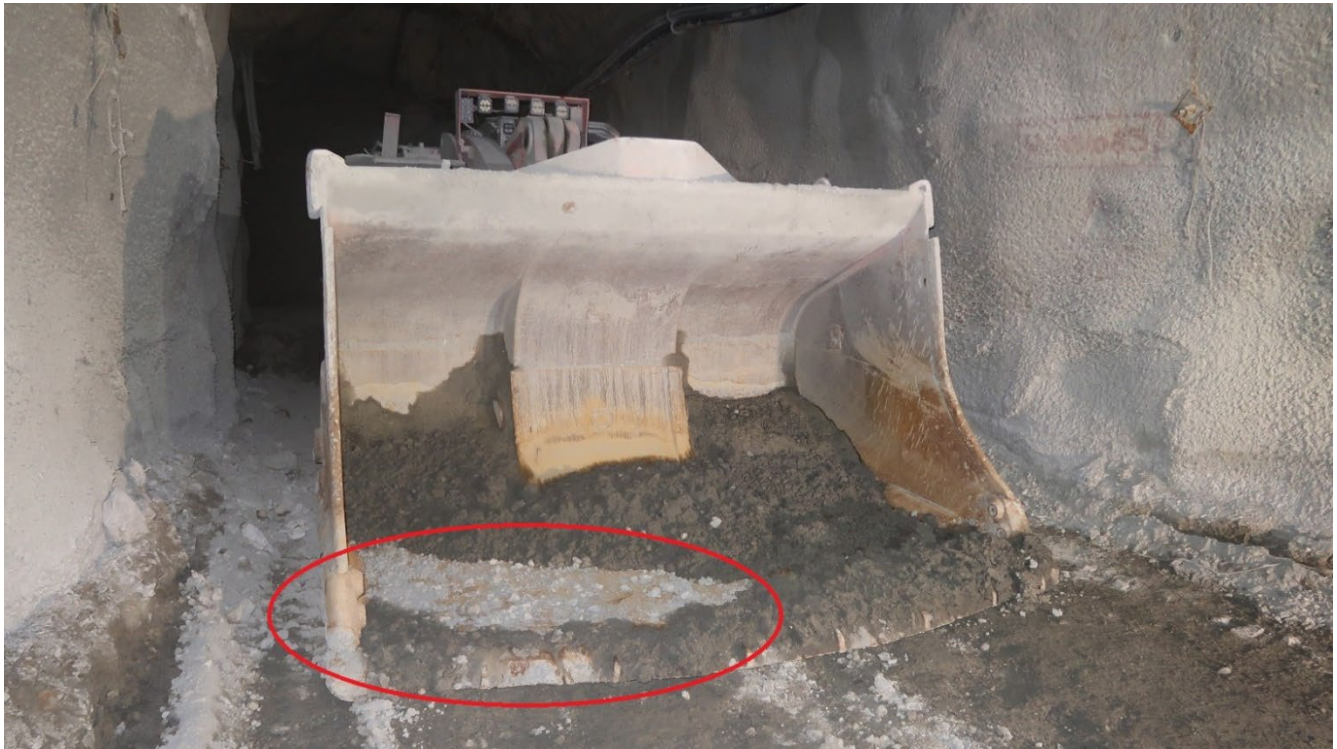
Meanwhile, the loader operator drove the loader down the decline towards the sump with the intention of parking the machine nearby before commencing bogging. The loader proceeded around a bend in the decline and down the slope where it hit the pedestrian from behind with the bottom lip of the loader's bucket coming into contact with his lower leg. The loader operator stopped when he noticed a cap lamp beam and exited the operator's cabin to investigate its source, then discovering the injured worker lying on the ground.

Figure 1: The loader involved in the incident with the likely point of impact circled in red

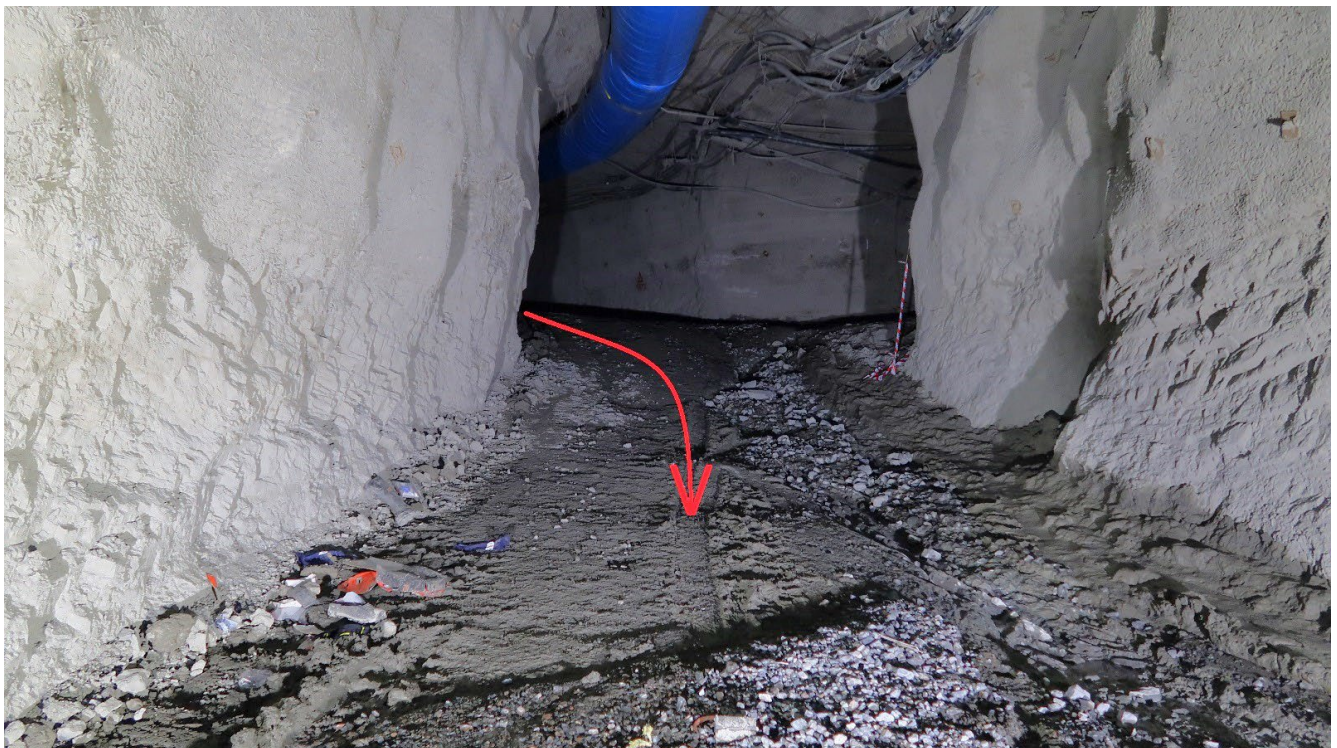
Figure 2: View of the point of collision facing up the decline with a red arrow indicating the loader's path of travel

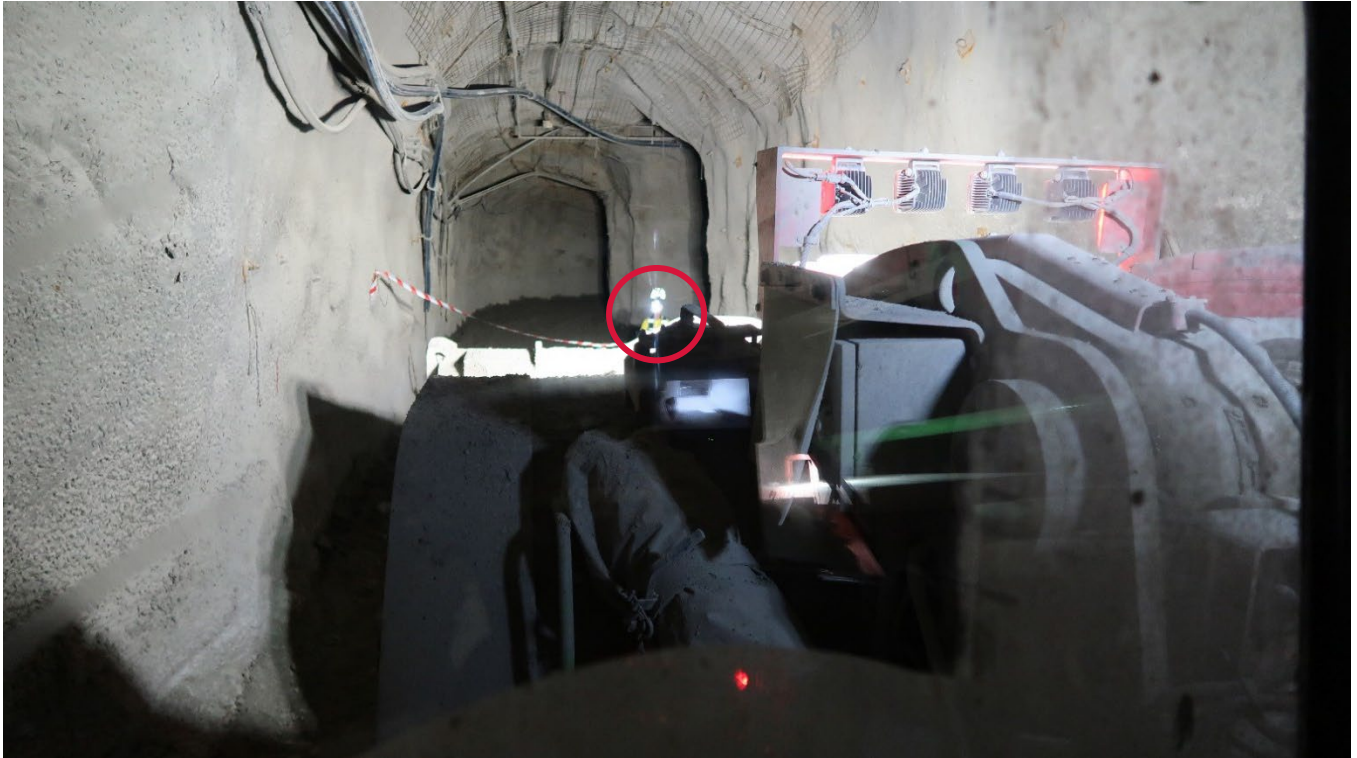
Figure 3: View from the operator's cabin of a worker (circled in red) standing 10 metres in front of the loader bucket during incident recreation. The worker was not visible to the operator at closer distances

- implement a safe system of work to prevent vehicle/pedestrian interaction

- ensure positive two-way communications are used consistently in relation to vehicle and worker movements
- ensure underground traffic management procedures include controls for vehicle movement in all areas of the mine.
