Quarterly safety report

April to June 2024

Title: Quarterly safety report – April to June 2024

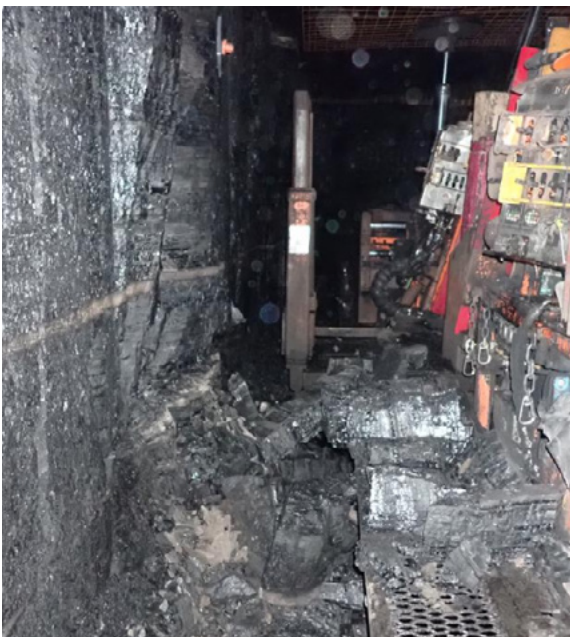
Picture 1.
Coal sitting on roof support.

Dangerous incident | IncNot0046675 – Rib failure between installed support

Summary: Following completion of rib support, a wedge of rib failed from between installed support. The wedge toppled onto the platform of a continuous miner in the vicinity of the rib bolting control box. The rib support was installed in accordance with the approved support plan. Noticeable jointing was evident on inspection after the incident.

Comments to industry: Underground mine operators should review the adequacy of their strata monitoring arrangements and associated trigger action response plans (TARPs) to ensure that workers are not exposed to unacceptable risks associated with strata failure.

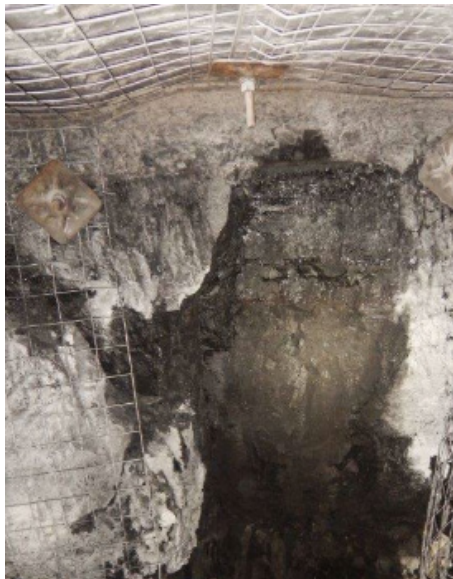
Picture 2.
Damaged mesh after rib failure.

Summary: A breakaway was being cut in an intersection with a continuous miner. The miner commenced cutting the breakaway and in doing so, a rib mesh sheet was caught on the miner apron. The mesh was damaged in between the rib bolts. The miner was flitted outbye to continue cutting the turn and a vent tube was required to be recovered. As the vent tube was being recovered, the rib slumped between the 2 sets of rib bolts and damaged the mesh, hitting a worker on the left foot and lacerating his toes.

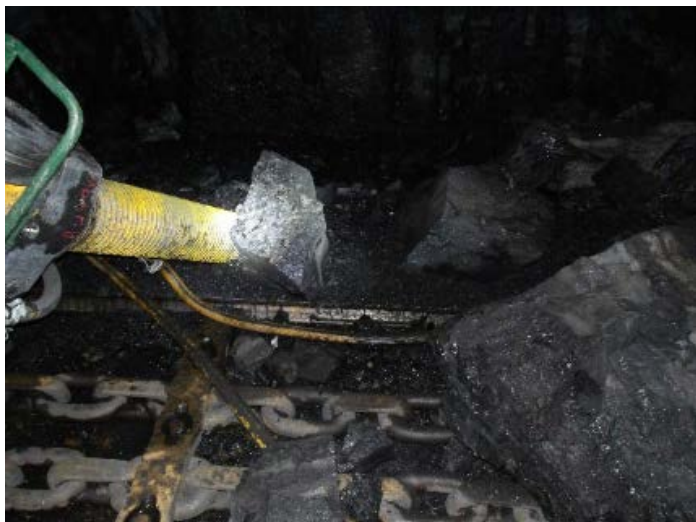
Picture 3.
Spalled coal slab.

Summary: While in the bolting cycle at a longwall shield, a slab of coal fell from the face and toppled into the work area and onto the armoured face conveyor (AFC). The coal slab landed about one metre from the hand bolter. An operator was 2 metres from the coal slab's final position, standing under an adjacent shield. The dimensions of the coal slab were 1 m x 0.7 m x 0.4 m. The top of the spalled coal released from a height of about 2 metres.

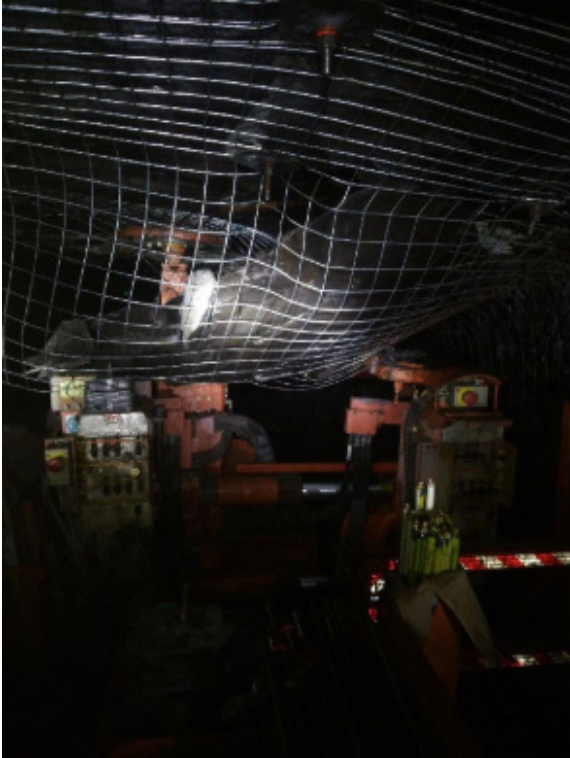
Picture 4.
Material on mesh and timber jacks.

Summary: A multi-bolter was being used to install rib mesh on the face following a plunge cut. Two workers held a sheet of mesh for the temporary roof support to take to the roof. The workers stood back and shortly thereafter a piece of stone (1.8 m x 1.2 m x 150 mm) fell from the roof, slid on the mesh and landed on the timber jacks. There was one worker in the vicinity.

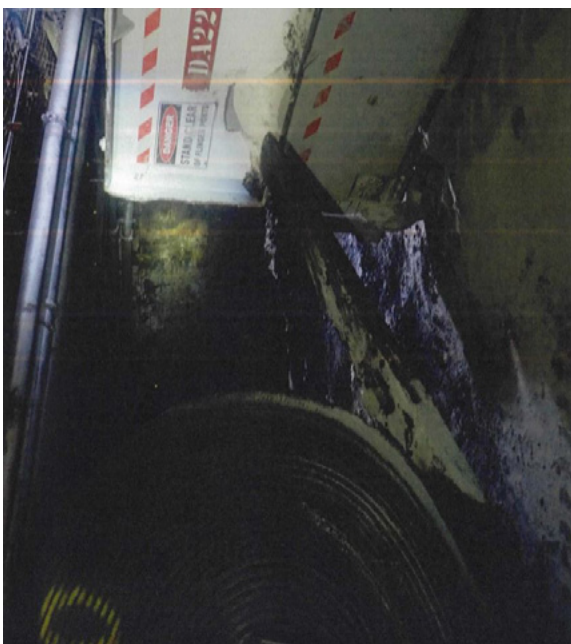
Picture 5:
Vehicle collision aftermath.

Dangerous incident | IncNot0046643 – LHDs collide at underground intersection

Summary: Two load haul dumps (LHDs) collided at an underground intersection. Both LHDs had slowed before entering the intersection and both sounded their horns. One LHD had a roll of conveyor belt on its forks and was travelling outbye when it collided with the other LHD, which had a flinger stone duster on its forks. The forks on the first LHD collided with the duster.

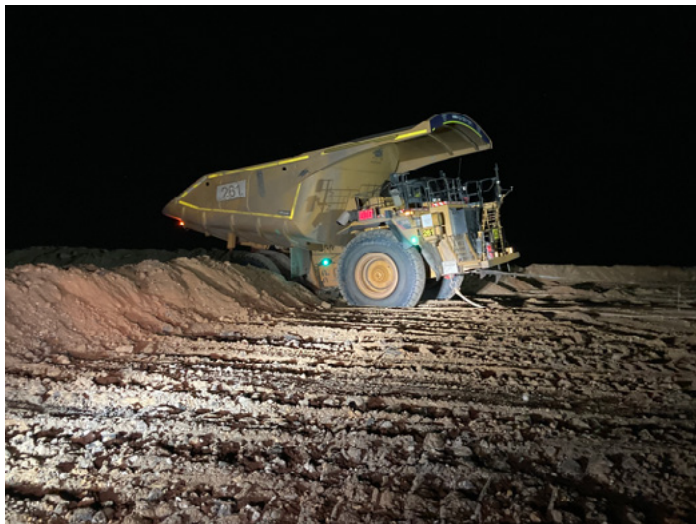
Picture 6.
Dump truck straddles windrow.

Summary: While reversing to the tip face to dump a load, the operator failed to stop on time and the position 5 and 6 tyres breached the windrow. The operator remained in the cab while the truck was pulled forward off the windrow.

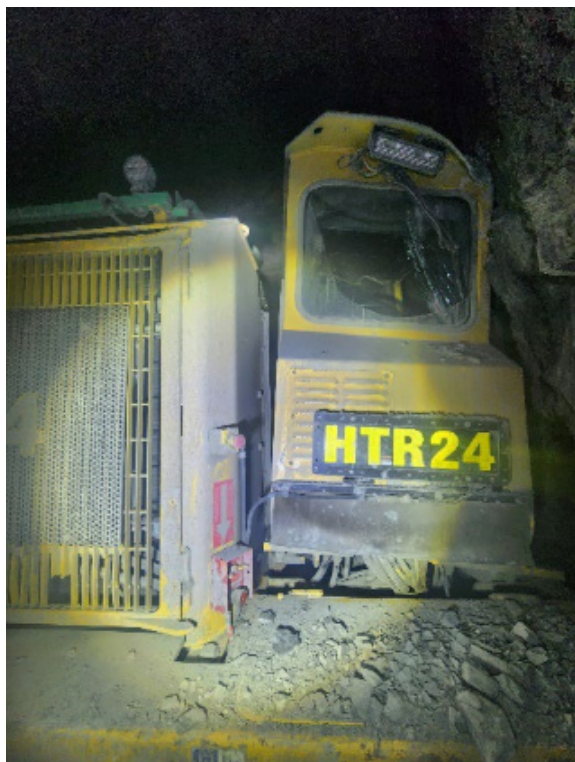
Picture 7.
Haul truck at wall.

Summary: A haul truck collided head-on with the wall of a decline when the steering function failed because of fluid loss from a damaged hydraulic hose. The operator was uninjured.

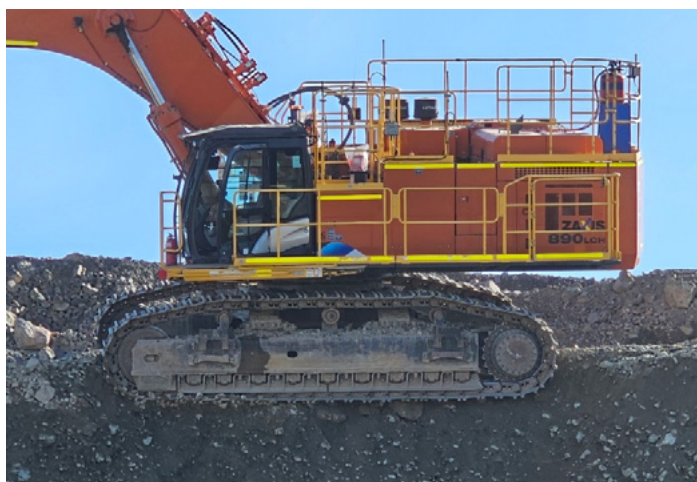
Picture 8:
Excavator tilted on failed embankment.

Summary: A 90 tonne excavator was tracking parallel to a bench. While in transit, the embankment under the left track of the excavator gave way. The operator observed material moving in the rear vision mirror, exited the vehicle and reported the incident to the area supervisor.

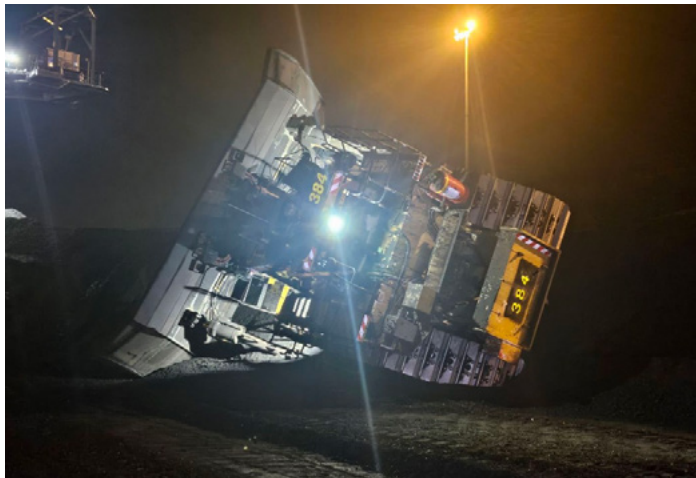
Picture 9:
Dozer on its side.

Summary: A dozer was reclaiming for a train on the thermal product feeders. The operator came close to the edge of an adjacent stockpile boundary which was cut to the floor, leaving a vertical bench to the stockpile where the dozer was working. The vertical bench was about as high as a dozer-blade. The dozer slid off the bench onto its side. The workers failed to complete a job hazard analysis (JHA) for working on abnormal stockpile conditions as identified in the site's procedure.

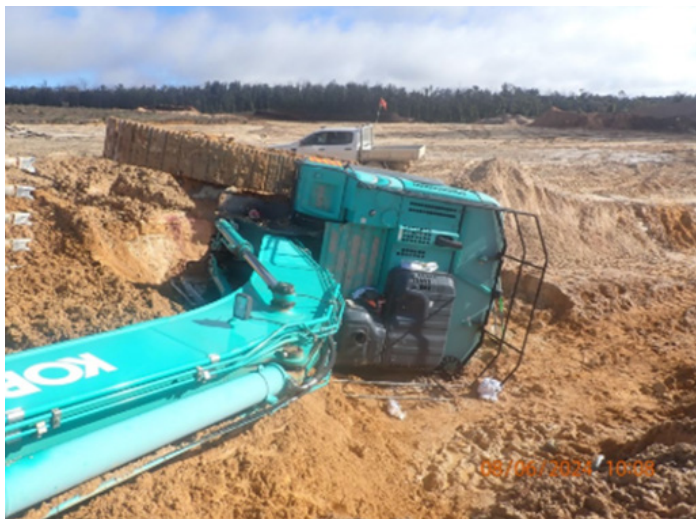
Picture 10:
Excavator on its side.

Summary: An excavator operator began work at 6:15 am, clearing clay from a bench he had formed the previous evening. The intent was to begin loading a waiting truck once they had removed the clay from the area. The operator did not conduct a pre-shift inspection of the area and the area did not have supplementary lighting. While tramping backwards, the operator lost situational awareness of the trench and backed into it, rolling on its cab side. The quarry's emergency plan was activated, and emergency services successfully freed the operator from the cab. The operator suffered minor injuries.

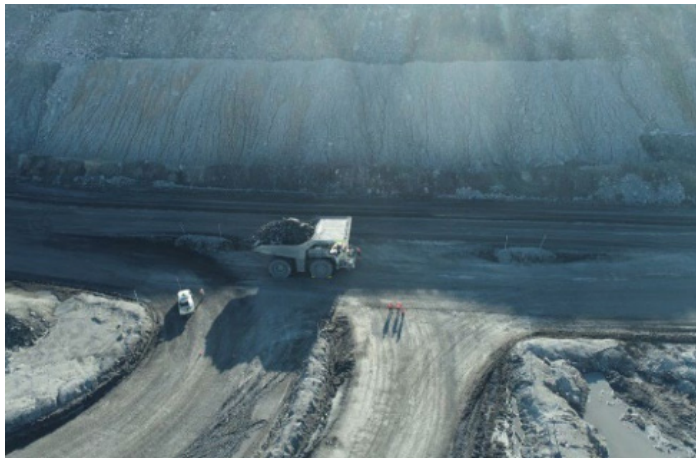
Picture 11:
Vehicles at intersection.

Summary: When approaching a T-intersection, a haul truck crossed onto the right-hand lane to pass a grader. At the same time, a light vehicle approached the intersection up a ramp to turn left. The haul truck proceeded through the intersection on the wrong side of the road as the vehicle attempted to turn left. Before turning left, the vehicle driver looked to the right for oncoming traffic. The driver began the left hand turn but had to quickly apply the brakes to avoid a collision with the oncoming haul truck.

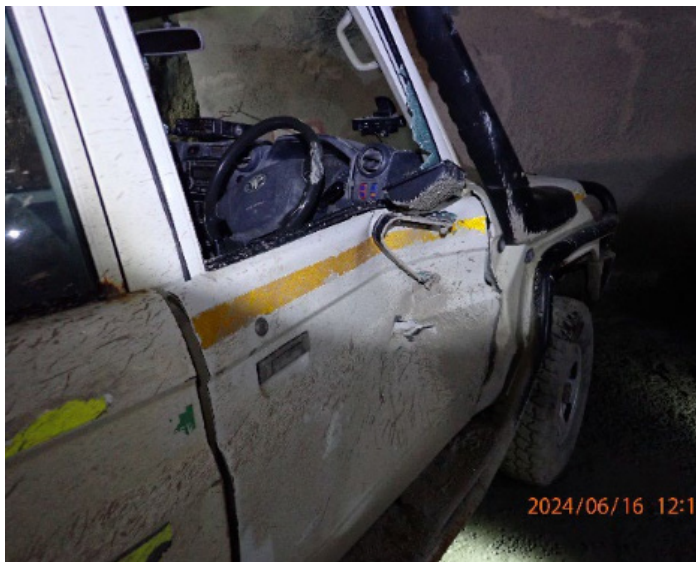
Picture 12:
Light vehicle damage after incident.

Summary: Two integrated tool carriers (ITCs) followed by a light vehicle, were tramming down a decline and pulled into a level access to give way to a truck travelling uphill. When the truck cleared the access, the second ITC began reversing out of the access and the rear counterweight collided with the driver's door on the occupied light vehicle. The vehicle operator parked in a hazardous location behind the ITC and failed to make positive communications with ITC operator. The ITC operator did not use the reversing camera and failed to sound the horn before reversing.

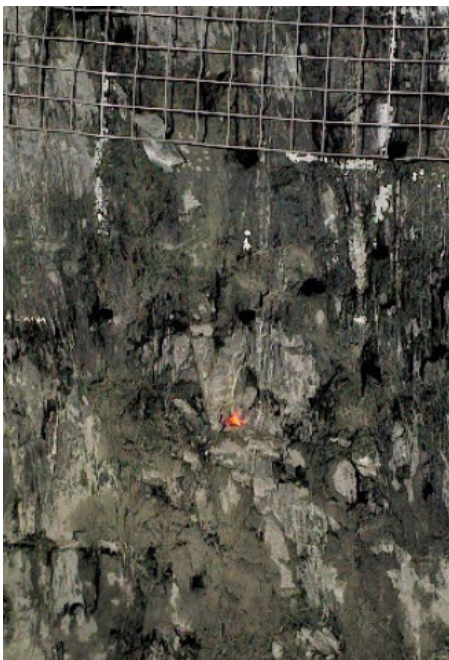
Picture 13.
Flame in drill hole.

Dangerous incident | IncNot0046811 – Flames from face drill hole

Summary: A Jumbo operator was drilling a face top down and required a clean-up by a loader to drill out the lifter holes. The loader operator cleaned up the area and scratched the bottom of the face to remove any loose rock left before departing the job. When the operator scraped the face, they heard a noise and looked back and noticed flame coming from a drill hole at the face.

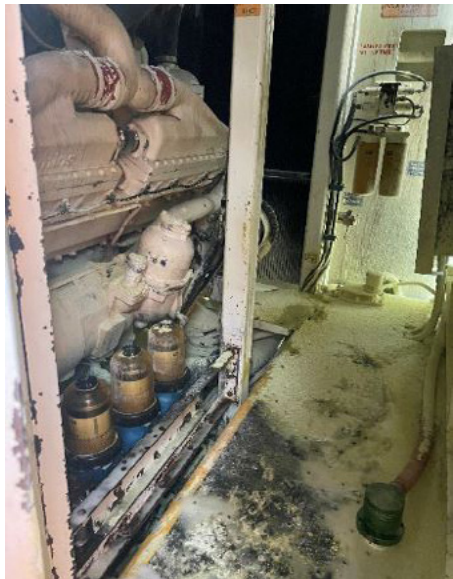
Picture 14.
Engine compartment after fire.

Summary: An excavator operator noticed excess oil on top of the stairs and the engine compartment of the excavator. Fitters attended to degrease the oil spill, which occurred from a failed hose. The fitters put degreaser on the roof of the engine compartment to clean up the excess oil. When they went into the engine room, they saw degreaser dripping through the roof. The degreaser fell onto a hot exhaust manifold and started a fire. The fitters exited the engine room, passed the fire and activated the fire suppression system.

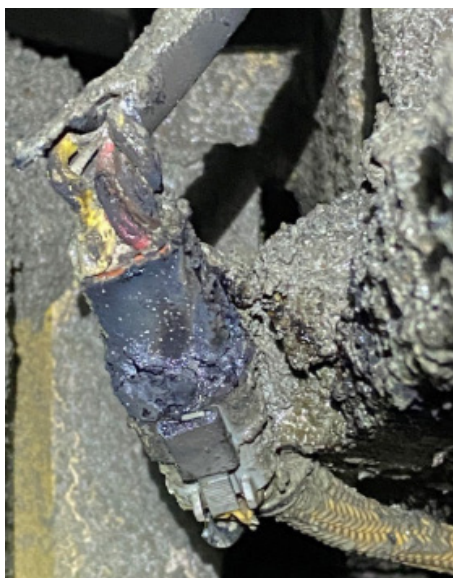
Picture 15.
Electrical connector after fire.

Summary: A worker was refilling a water cart at the refill point on the main decline when they saw the glow of a flame. The worker removed the wheel chock and drove forward under the flowing water to extinguish the flame. Preliminary investigation shows that water ingress corroded an electrical connector. The connector combusted due to excessive heat generated due to the poor connection.

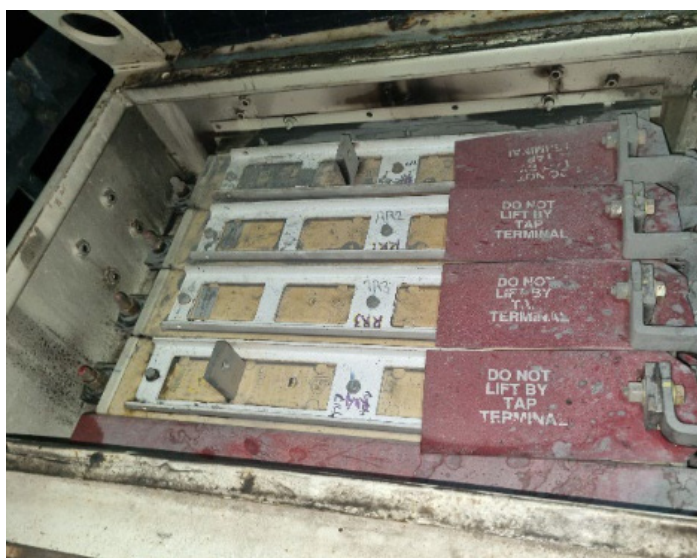
Picture 17:
Misaligned grids.

Summary: An operator noticed sparks coming from the grid box of an oncoming truck and notified the driver who immediately called an emergency and hit the E-stop in the truck, then safely positioned positions one tyre against the windrow to make the truck fundamentally stable. The operator safely exited the truck via normal egress. A workshop maintenance worker opened the grid box cabinet and found there was no flame. A water cart sprayed the grid box for about 5 minutes to cool it down. A preliminary investigation shows the grids were aligned in incorrect positions
