Safety Bulletin

Date: July 2024

Wheel assemblies detaching from mobile plant

Safety Bulletin SB24-05

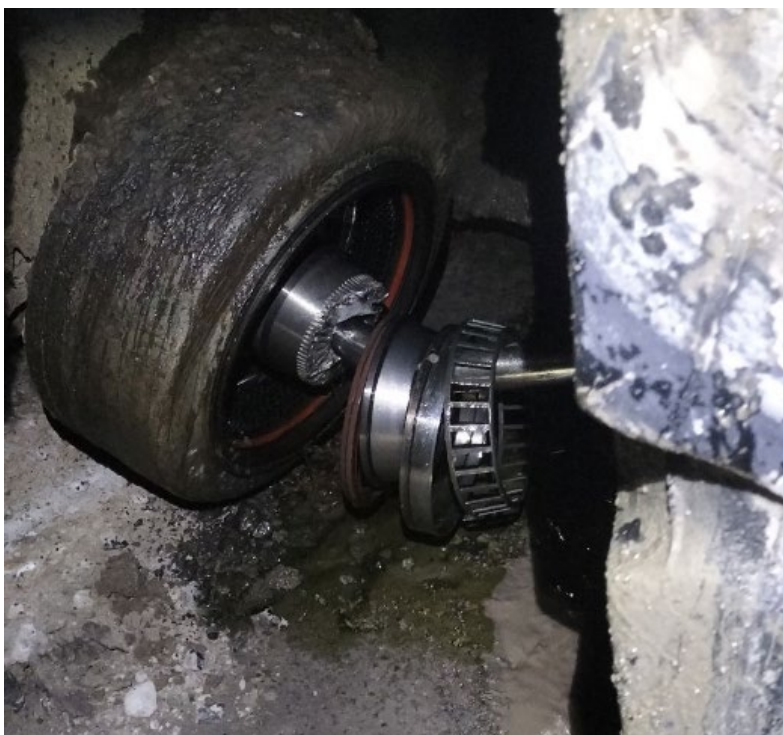
Figure 1: Failed position 1 wheel assembly on a haul truck, resulting in a loss of steering

A loaded haul truck was ascending the decline when the position 1 wheel assembly detached, resulting in a loss of steering. The wheel assembly became jammed between the machine and the wall. The truck driver was uninjured and shut down the truck. All workers safely evacuated the underground mine.

The remaining truck fleet was inspected by maintenance personnel before returning the fleet to operation. An investigation was carried out by the mine and the truck OEM and determined the root cause to be failure of the wheel end assembly.

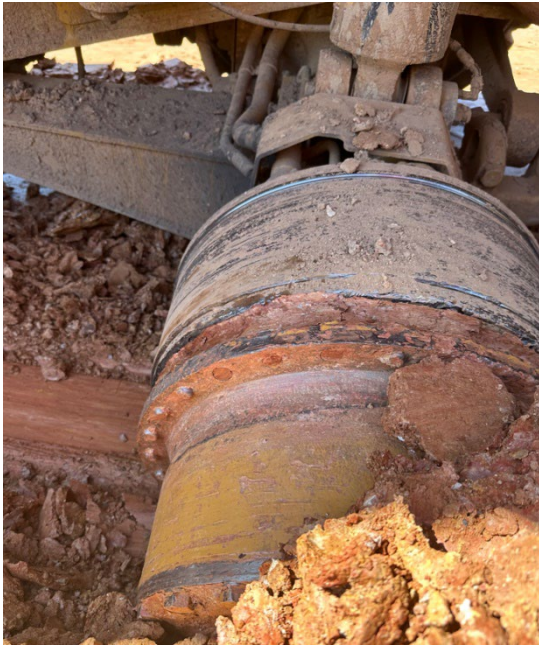
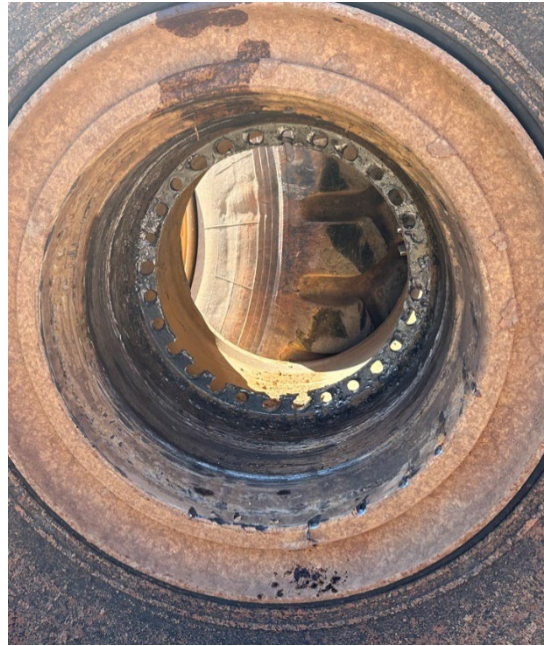
A worker was driving an articulated dump truck at low speed on flat ground when the position 2 tyre and rim disengaged from the wheel hub. This caused the front right underside of the truck to make contact with the ground. The wheel assembly remained beside the truck, and the driver was not injured.

Figures 2 and 3: Articulated truck with a disengaged wheel assembly, broken wheel studs and elongated holes

An initial investigation suggested the wheel nuts became loose, allowing the rim to move relative to the hub. This resulted in elongated holes in the rim and broken wheel studs. Prestart inspections did not identify the issue. All similar equipment on site was parked up until they were inspected by maintenance personnel.

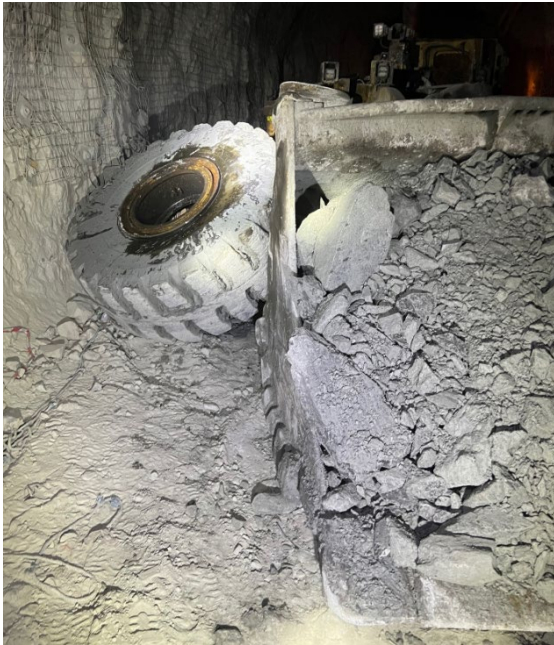
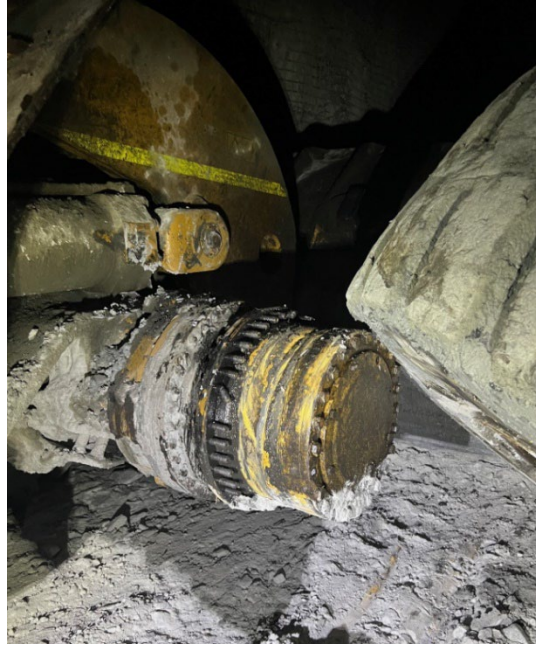
Figure 4 and 5: Loader wheel against wall, and intact wheel studs on hub

There was a lack of machine history due to the LHD being second-hand plant. Prestart inspections indicated the wheel/rim condition was inspected, and loss of wheel integrity was not identified by operators in previous prestart inspections. The wheel nut torque was checked on all other loaders.

Preliminary findings showed all but 2 wheel studs were undamaged, which would suggest the wheel nuts had worked loose. The preliminary cause for the loss of wheel nuts was determined to be incorrect torque setting on workshop rattle guns.

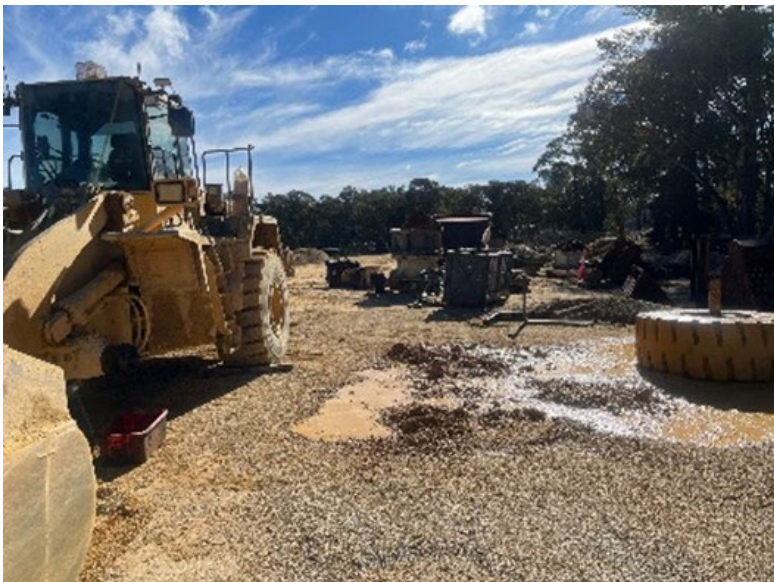
A front-end loader was loading a hopper bin with surge material when the front left wheel assembly detached from the front differential. The wheel rolled about 110 metres down a roadway and came to rest adjacent to a stockpile near the crushing plant. Visual inspections at the time of the incident suggested the differential had failed.

Figure 6: Loader with recovered wheel assembly

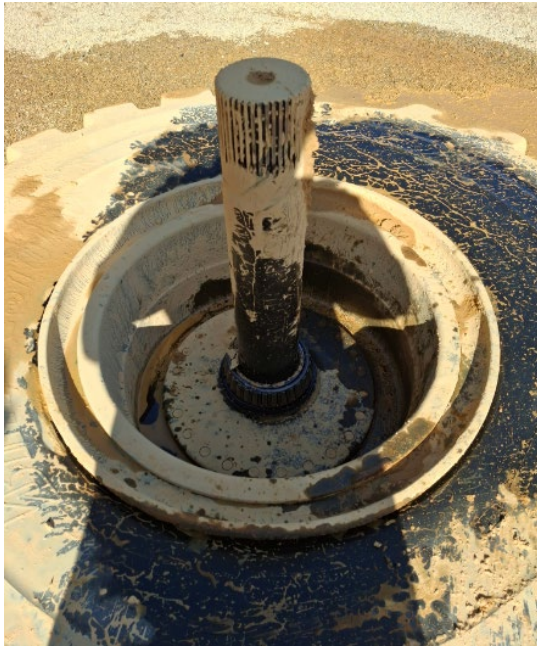
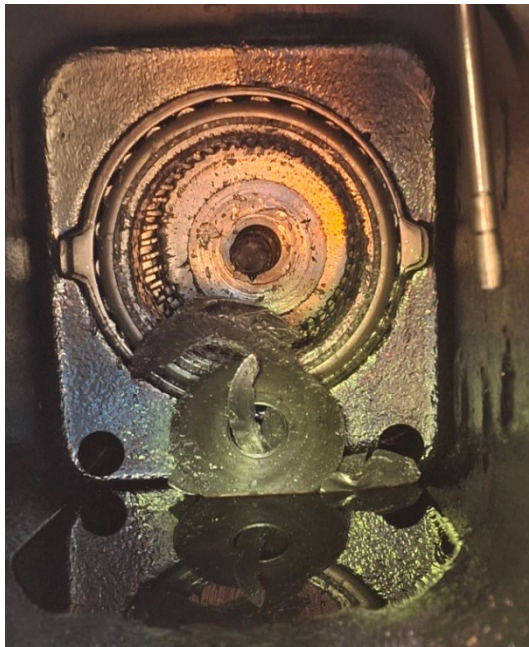
Figures 7 and 8: Loader drive shaft splines, and differential drive shaft retaining bolt and shims

The mine supplied a non-original equipment manufacturer (OEM) differential to the loader, which was installed 3 months before the incident. The remanufactured differential was sourced from a local third-party supplier from an overseas refurbisher and appears to have no quality assurance paperwork to identify the drive shaft retaining bolts were correctly shimmed and torqued.

Both the supplier of the differential and the OEM were made aware of the incident. The OEM considered the bolt retaining the axle in the axle tube was either not torqued up or worked loose.

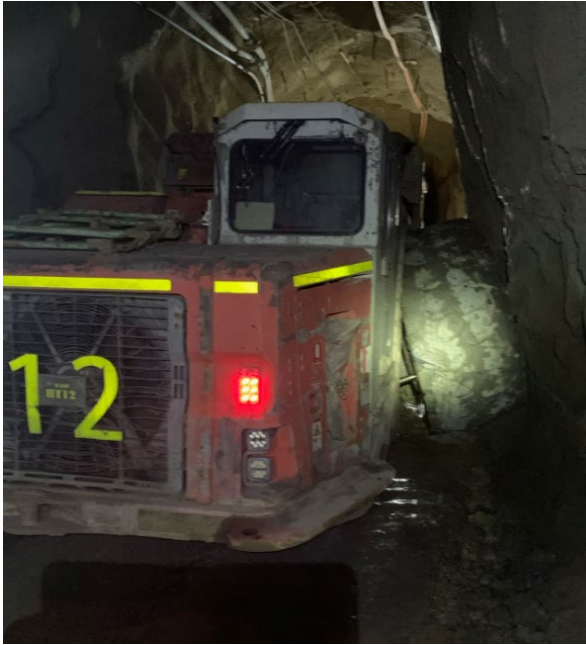
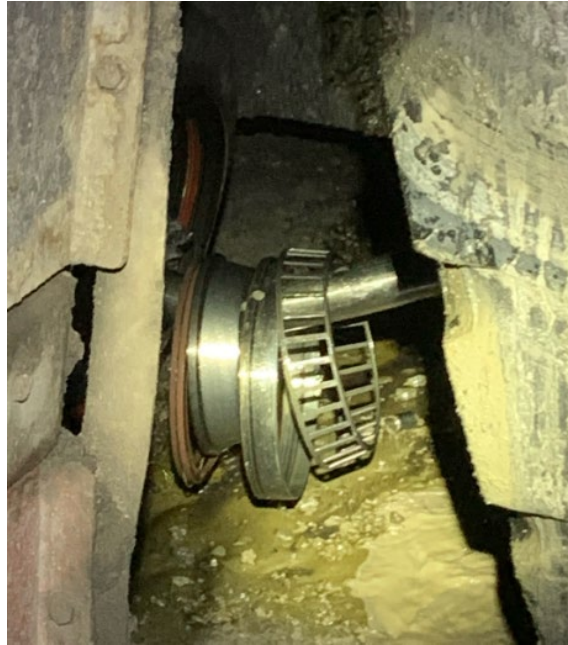
Figures 9 and 10: Haul truck in decline with detached wheel assembly against wall, and showing failed hub and bearings
