Investigation information release

Unplanned explosion during mining operations

Incident date: 20 August 2024

Location: Mt Arthur South (Thiess Pty Ltd) coal mine, Muswellbrook, NSW.

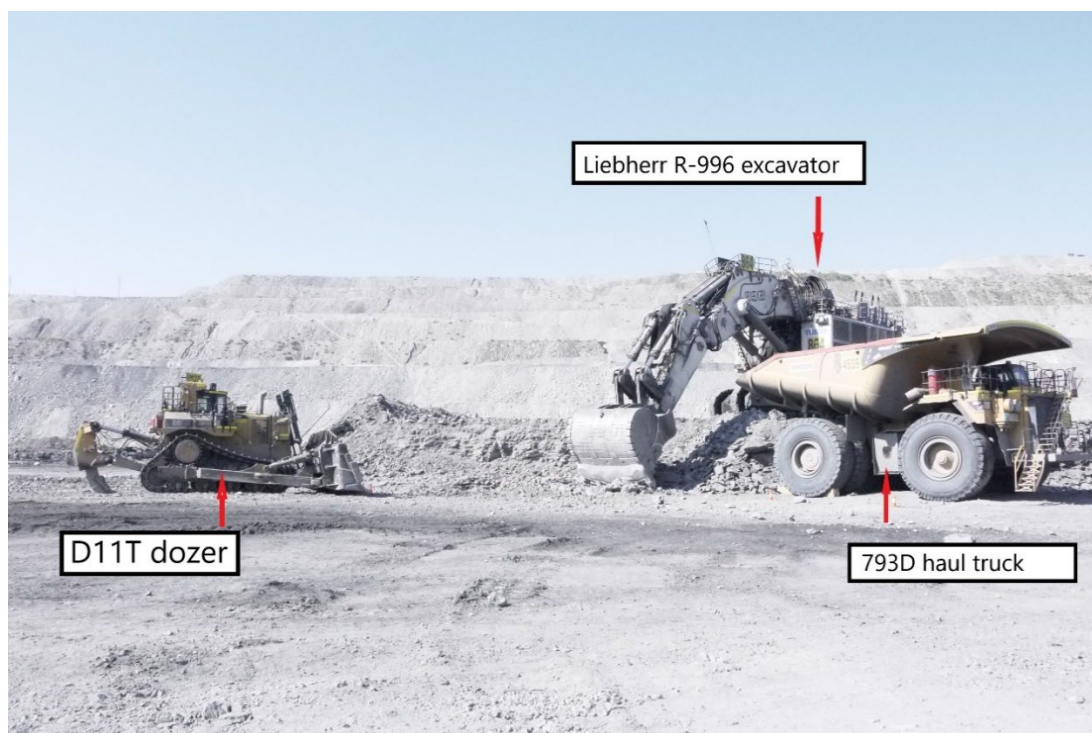
A worker was operating a Caterpillar D11T dozer in the Roxburgh Pit at the mine about 7.30 am on Tuesday 20 August 2024. The dozer was operating on a bench directly in front of and below a Liebherr R-996 excavator. The excavator was loading a 793D haul truck. The bench being excavated had been fired, in accordance with a planned shot on 20 May 2024.

Figure 1: The dozer, excavator and haul truck after incident

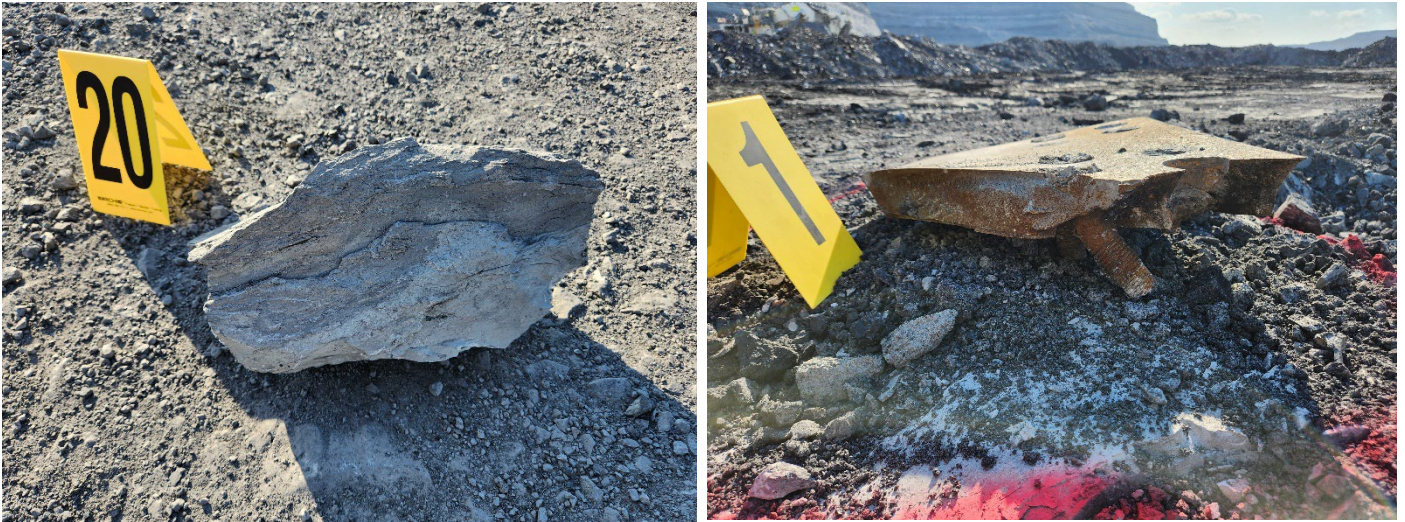
While the dozer operator was pushing blast waste material on the lower bench, an unplanned initiation of explosives occurred. The explosion caused multiple pieces of fly rock and parts from the dozer blade to be projected about 100 m from the incident site. The location of the explosion left a crater measuring 1.8 m deep, and about 3.5 m in width.

Figure 2: Some of the fly rock (left) and part of the dozer blade (right)

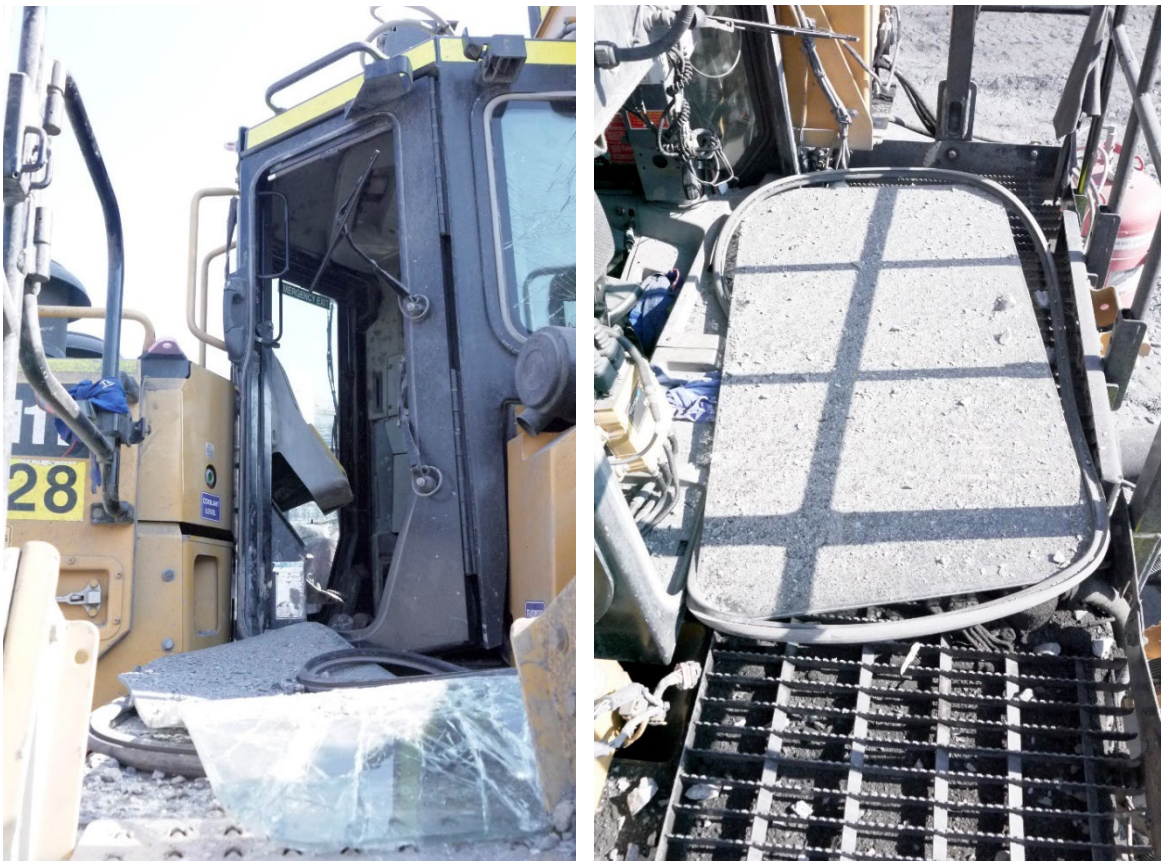
The operator was not physically injured, but the dozer was significantly damaged as a result of the explosion, including a section of blade (Figure 2 above) and glass blown out of the cabin entry door and rear window. The front window of the excavator was also shattered.

Figure 3: Damage to the dozer door (left) and rear window (right)

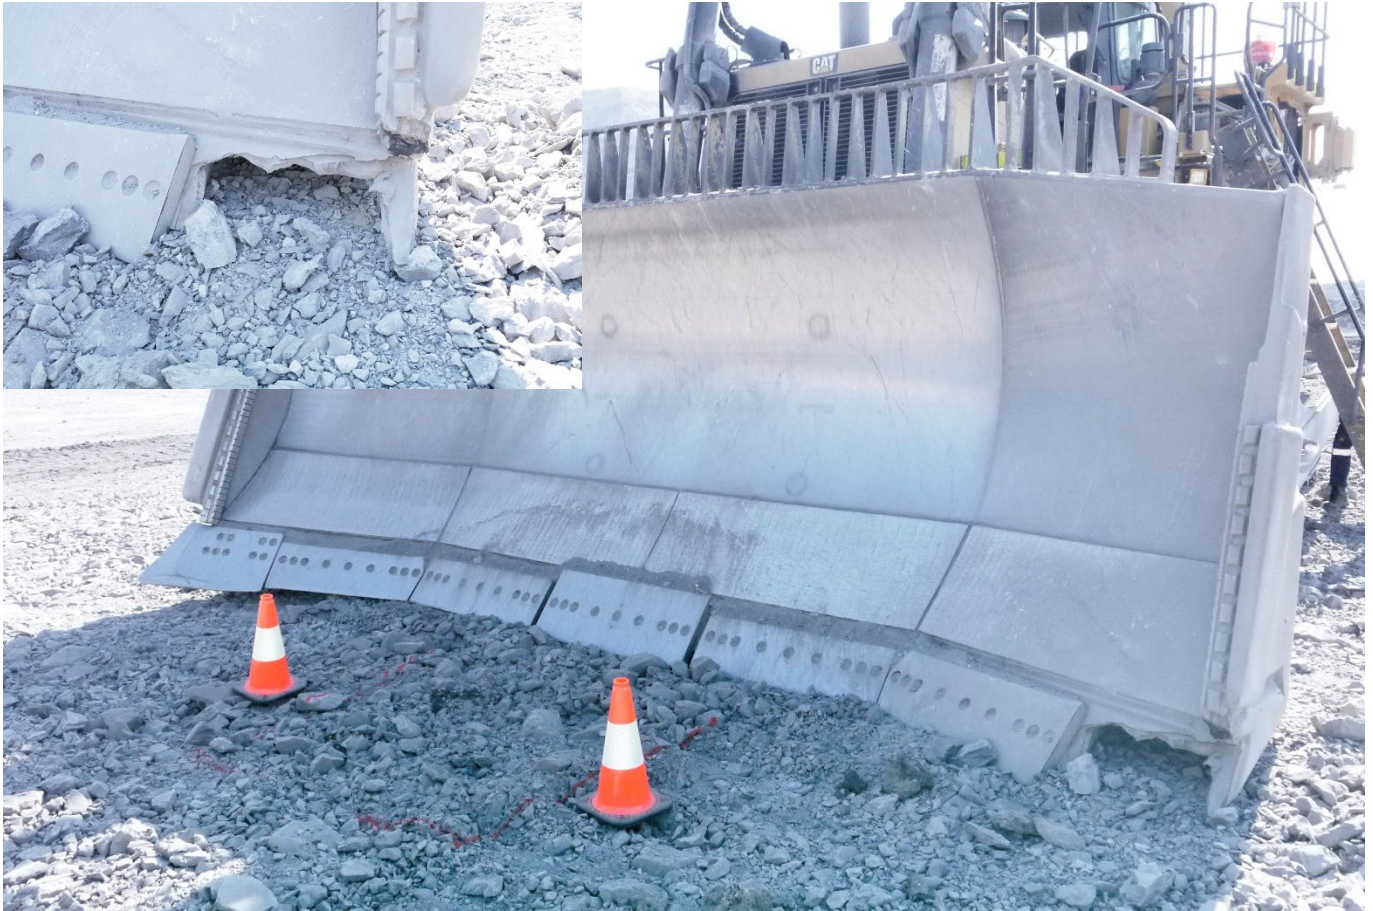
Figure 4: The blade of the dozer, showing damage to one side
