Safety Bulletin

Date: September 2024

Incidents and injuries associated with working on pressurised systems

Safety Bulletin SB24-06

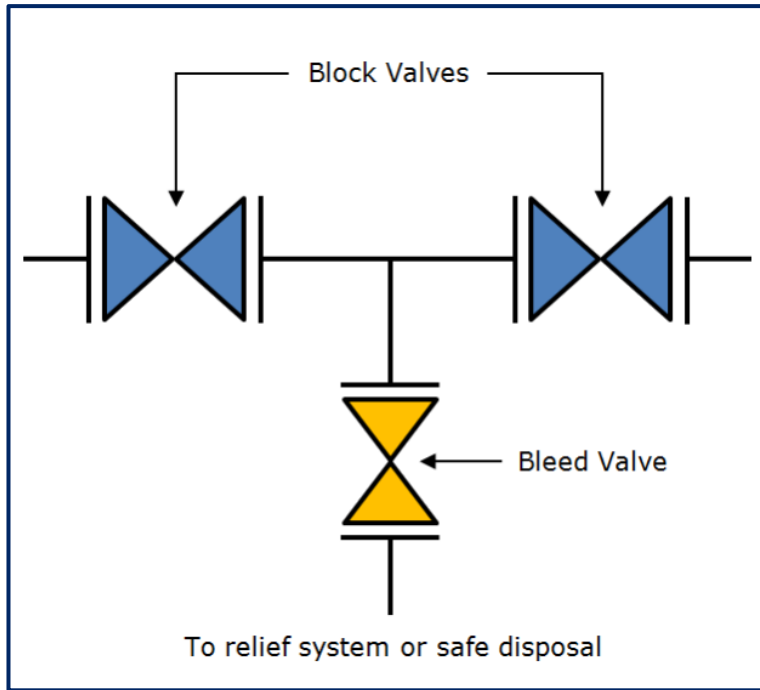
Figure 1: Double block and bleed (2 separate isolation valves and 1 drain valve)

The procedures should include a step that requires workers to **test and confirm** that the pressurised systems they are about to work on have been deenergised. For pressurised systems, the use of a double block and bleed isolation is considered good practice.

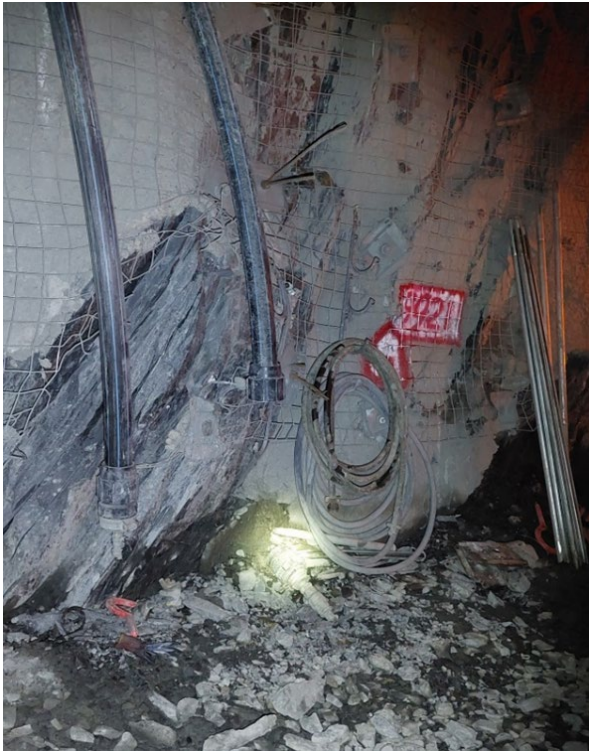
About 4pm, a service crew was sent to 8395 level to unblock an air header which was reported on the previous shift and they isolated the services. They accessed an airline dropper and opened it. Nothing came from the dropper, so the crew assumed that the service was successfully bled (deenergised). They began to take the air header off using C spanners.

Once the header was loose enough to start removing by hand, the poly pipe header whipped and struck one of the operators. The operator suffered a deep laceration to the cheek and reported shoulder pain.

Figure 2: The header and C spanner

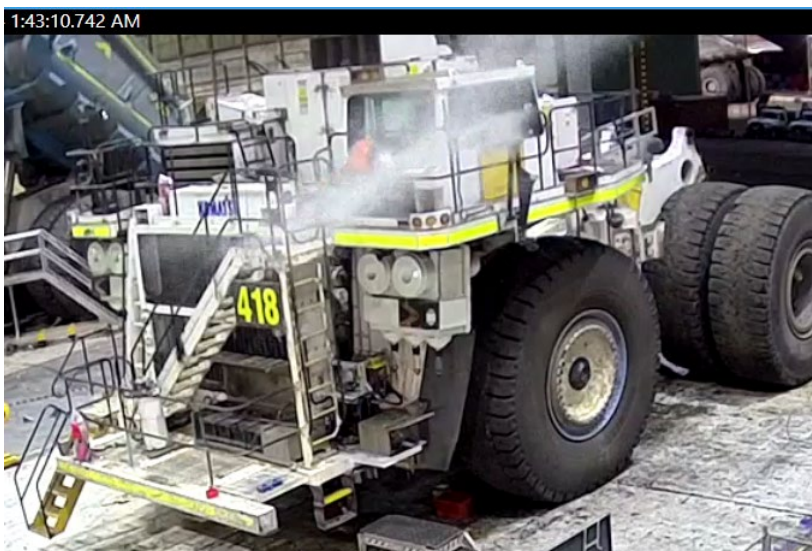
A work party was bleeding the brakes on a Komatsu 830E haul truck while under live testing. When they tried to bleed position 1 tyre it was identified there was no pressure. They conducted troubleshooting and determined the problem was an incorrectly routed hose to the treadle valve in the cabinet at front of the operator's cab.

One of the workers disconnected the hose without having isolated the truck and bleeding down the brake accumulators. Upon disconnecting the hose pressurised fluid sprayed over the worker's head and shoulders, soaking him. The pressure source is believed to come from the 220 Bar (3,200 PSI) brake accumulator.

Figure 3: Release of uncontrolled energy - brake system hose whipping about releasing oil
