Investigation information release

Fatality - worker falls into mine shaft

Location: Austar Coal Mine number 2 shaft

Investigation information release IIR24-09

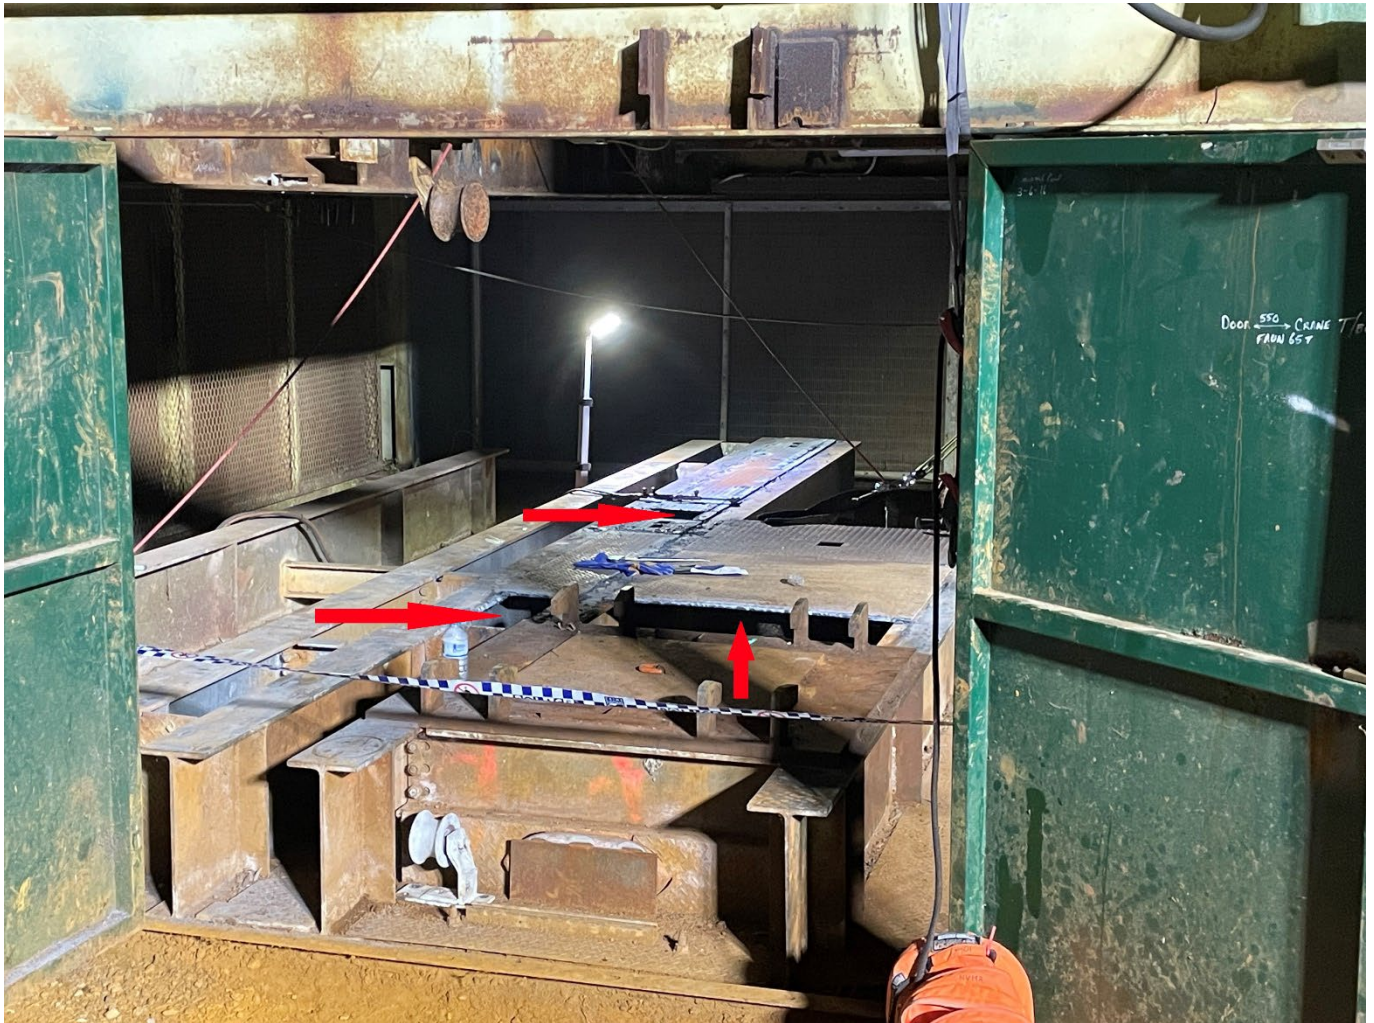
Contractors were preparing to attach steel plates to beams fixed to a shaft cover about 12.30 pm on 17 September 2024. Several sections had been cut out of existing steel plates that were fixed to several beams on the shaft cover. The largest of these cuts was about one to 2 metres long and 0.5 metres wide. A contract worker fell through the area that had been cut and into the shaft.

Initial inquiries indicated that fall prevention and/or fall arrest equipment was not used at the time of the incident.

Figure 2: Incident scene with red arrows showing areas where the shaft was exposed when the incident occurred

- provide adequate protection against the risk of a fall occurring and ensure that a safe system of work is implemented and maintained
- ensure that adequate information, training, instruction and supervision is provided to workers exposed to potential falls from working at height, including:
 - the proper use, wearing, storage and maintenance of personal protective equipment (PPE)
 - the hazards and risks associated with work performed at heights
 - specific guidance of how to follow health and safety procedures associated with this work, including the contents of any safe work method statements (SWMS), and
 - the reasons fall protection measures have been put in place and how they are required to be appropriately implemented for each stage of the work.
