# Safety Alert

Date: October 2024

## Haul truck rear strut injures worker

## Safety Alert SA24-04

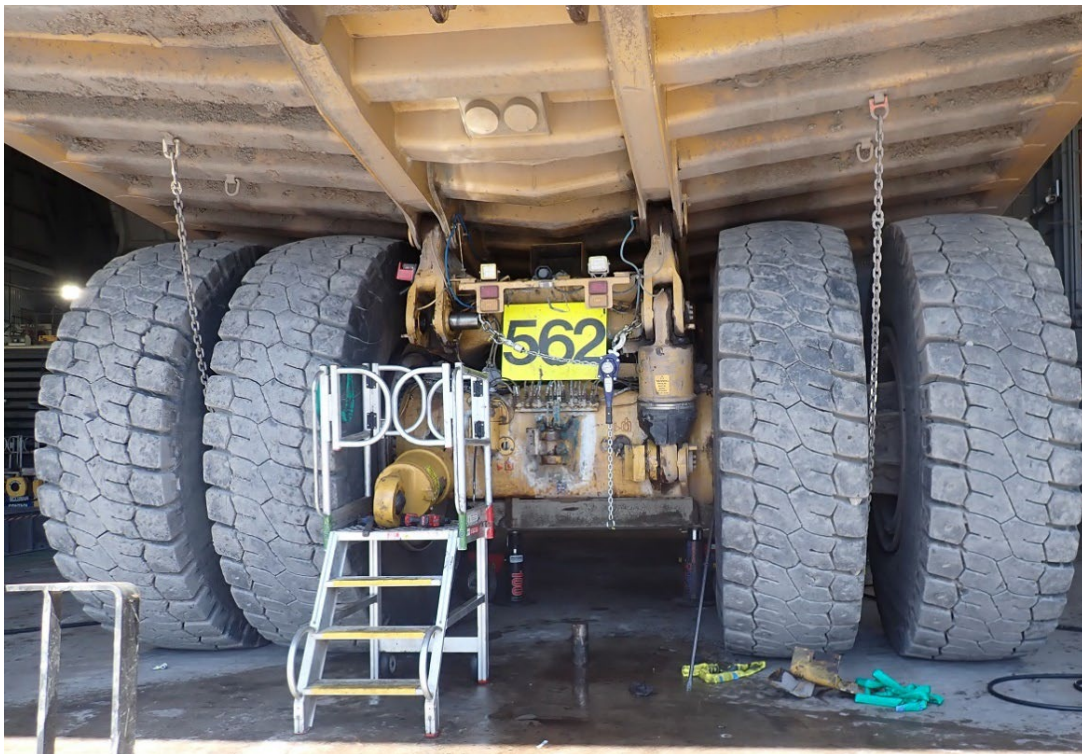
Figure 1: A suspension strut pivoted about a lower pin and landed on an access platform after hitting a worker

On 23 September 2024, workers at an open-cut coal mine were replacing a rear suspension strut on a haul truck. The strut was secured by a lower pin, and pivoted back onto a worker in the access platform resulting in a serious laceration to his upper leg.

- Identify potential falling, pivoting, swinging and sliding load hazards when removing and replacing linkages, cylinders, suspension and driveline components.
- Fit-for-purpose tooling, lifting jigs, or restraint devices should be labelled appropriately.
- Workers must be trained in using lifting jigs or task-specific tooling, and hold appropriate high risk work licences for activities to be undertaken.
- Ensure procedures are available for routine tasks that clearly identify specific task methodology and controls, such as independent means of restraint for components being removed and replaced, if task-specific lifting jigs are not available.
- Use stop/hold points in procedures to ensure hazard controls have been appropriately implemented and checked by workers or supervisors, preferably independent of the task where possible.

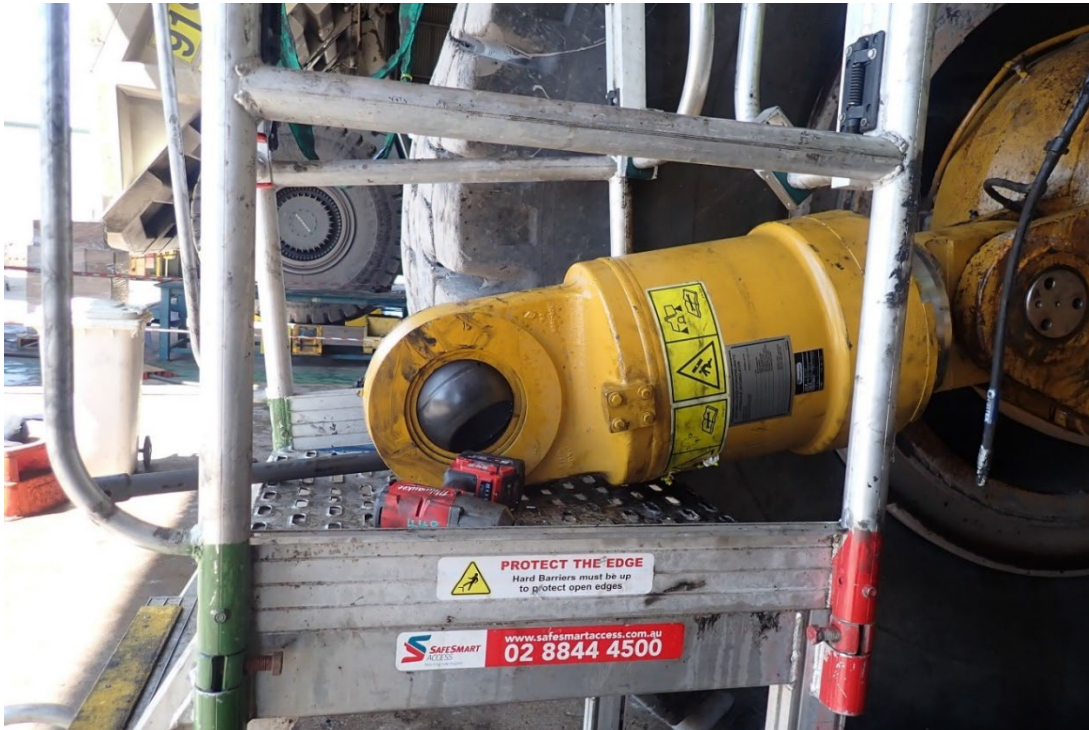
Workers were initially supporting the strut with a sling attached to a forklift jib while the lower pin was installed, and then the cylinder was lifted to allow the top pin to be inserted. When the partially inserted top pin fouled on the outer chassis, workers removed the sling and forklift, and brought a work platform behind the strut to allow access to manipulate the outer chassis bush and pin. Workers tried to partially withdraw the pin using a lever hoist to return the outer bush to the correct position, and realign the cylinder by jacking the truck chassis. The upper pin then slid far enough out as to no longer capture the strut cylinder allowing it to pivot and hit the worker.

Figure 2: The strut where it came to rest after hitting the worker

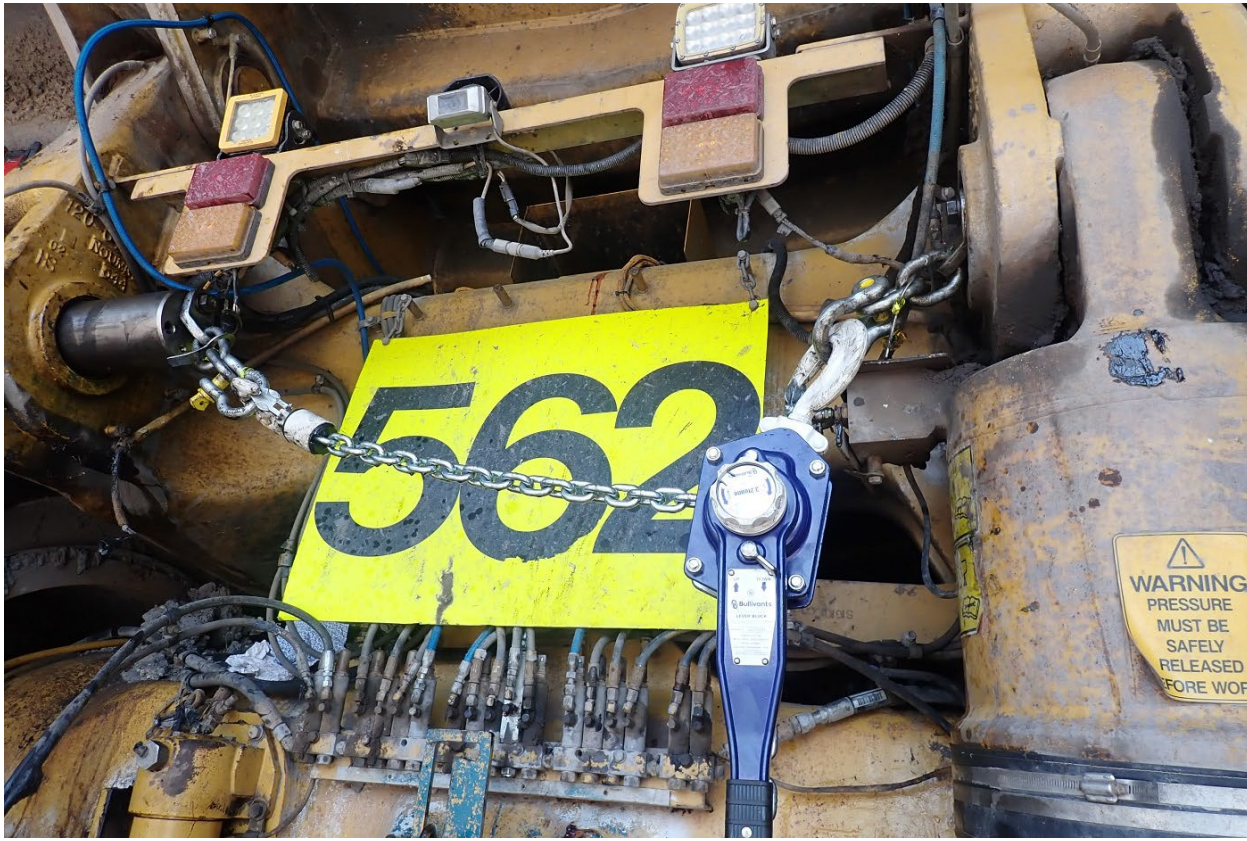
- workers were using a job hazard analysis in combination with an original equipment manufacturer (OEM) procedure for the task. Although the OEM procedure nominated component weights, it did not detail specific means for lifting and controlling component loads during removal and replacement
- the task was being conducted with the dump body on the truck so that the overhead workshop crane could not be used for the task
- the forklift lifting jib initially used to lift the strut with a sling to install the lower pin was not successful to install the upper pin, and was removed after the outer body clevis bush was fouled
- the site had a rear strut cylinder lifting jig that was compatible with the strut cylinder, however, not all workers were familiar with it, or were sure about compatibility with different class haul trucks, and its use for this task was not documented in a procedure

Figure 3: Lever block used to draw back the top pin
