Weekly incident summary

Week ending 18 October 2024

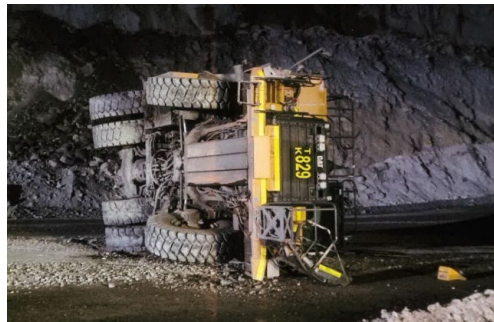
Incident type	Summary	Comments to industry
Dangerous incident IncNot0047820 Open cut coal mine Roads or other vehicle operating areas	<p>A service cart overturned when completing a U-turn. The cart transitioned from a wet to a dry line and overturned onto its left side. There were no injuries to the operator.</p> <p>Speed has been established as a major contributing factor.</p>	<p>Service cart operators need to take extra care when turning their vehicles as the movement of fluid in tanks mounted on mobile plant can significantly influence the centre of gravity and overall stability of the vehicle.</p> <p>Extra caution is needed when changing from a wet to a dry line and vice versa.</p> <p>U-turns should be executed at a low speed.</p>

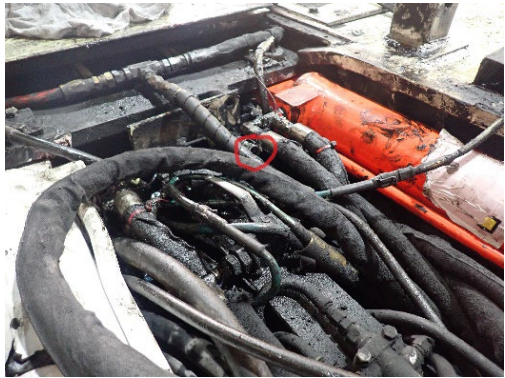
Incident type	Summary	Comments to industry
<p>Dangerous incident IncNot0047836 Underground coal mine</p>	<p>A fitter disconnected a hydraulic hose while replacing the transmission spool valve on a load haul dump machine (LHD). The valve was replaced but the hydraulic hose was not reconnected.</p> <p>The electrician confirmed with the fitter that he was finished and that was okay to start the machine. The electrician turned the machine on and pulled the parking brake off. There was a release of fluid that narrowly missed the electrician. The pressure in the circuit was up to 2500 psi 17.2 mpa.</p>

<p>A safety bulletin in relation to the prevalence of incidents involving the release of stored energy from pressurised systems was published recently.</p> <p>Refer to: <u>SB24-06 Incidents involving pressurised systems increase</u></p>
<p>Serious injury IncNot0047849 Open cut coal mine</p>	<p>A worker suffered a serious laceration to his hand in the process of removing a radiator from a dozer.</p> <p>While lifting the radiator out vertically with slings and an overhead crane, a plant mechanic was manipulating the radiator by hand when the radiator moved, causing his left-hand thumb to be crushed between the radiator and a bracket.</p> <p>A tag line or alternative was not used.</p> <p>It was found that the job hazard analysis (JHA) was inadequate for the task and failed to detail high risk steps and suitable controls.</p> <p>A step-up supervisor had signed off on the JHA after review.</p>	<p>Inadequate procedures and poor supervision are precursors to serious injuries.</p> <p>Safe systems of work are designed to prevent the type of injury associated with this incident.</p> <p>A safe system of work for the removal and replacement of dozer radiators should include a risk assessment that addresses the following:</p> <ul style="list-style-type: none"> • Dozer set up with reference to access around the radiator and clearance for lifting. • Worker positioning with reference to line of fire. • Techniques for safely manipulating/moving the radiator. • Working at heights. <p>The risk assessment should be developed by suitably qualified tradespersons,</p>

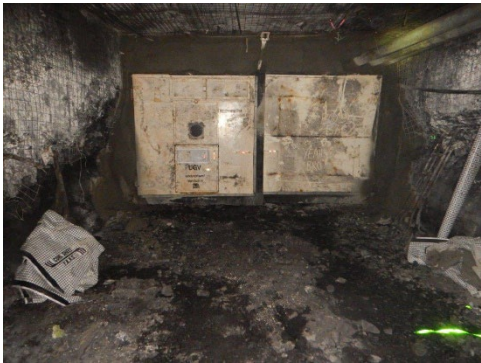
Incident type	Summary	Comments to industry
Serious injury IncNot0047855 Underground coal mine	<p>A worker suffered a fractured eye socket, cheekbone and jaw when his head was caught between a set of ventilation doors.</p> <p>An experienced ventilation crew was finalising the installation of double steel doors at a cut-through. An emergency egress lifeline was disconnected during the process. While the adjacent outbye doors were both in the open position, a worker in the process of reestablishing the escape lifeline temporarily opened one of the closed doors about half-way, without restraining it. As he was reconnecting the lifeline the unrestrained steel door closed and caused the workers head to become trapped, requiring assistance by another worker to be released.</p>	<p>supervisors, and the mines mechanical engineer.</p> <p>Ventilation pressure is a known hazard and mines' procedures for major ventilation changes should identify controls for the associated risks.</p> <p>Workers need to be made aware of the controls and the effects of ventilation pressure when opening self-closing steel doors, while not having the adjacent door set fully closed, and allowing a short circuit of fresh air to return airways.</p>
