Summary of reported incidents

In-Service Failure of Explosion-Protected Diesel Engine Systems (ExDES)

January 2010 - October 2011

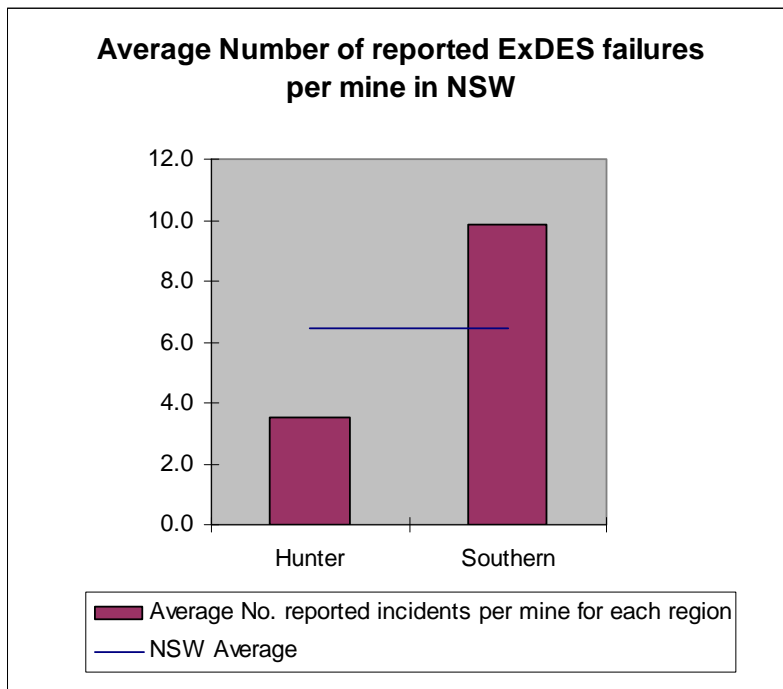
Figure 4 Regional Reporting

Figure 4 below shows the average number of reported ExDES failures per underground coal mine in NSW by region for 2011. This supports anecdotal evidence that Southern mines are more diligent in reporting actual incidents.

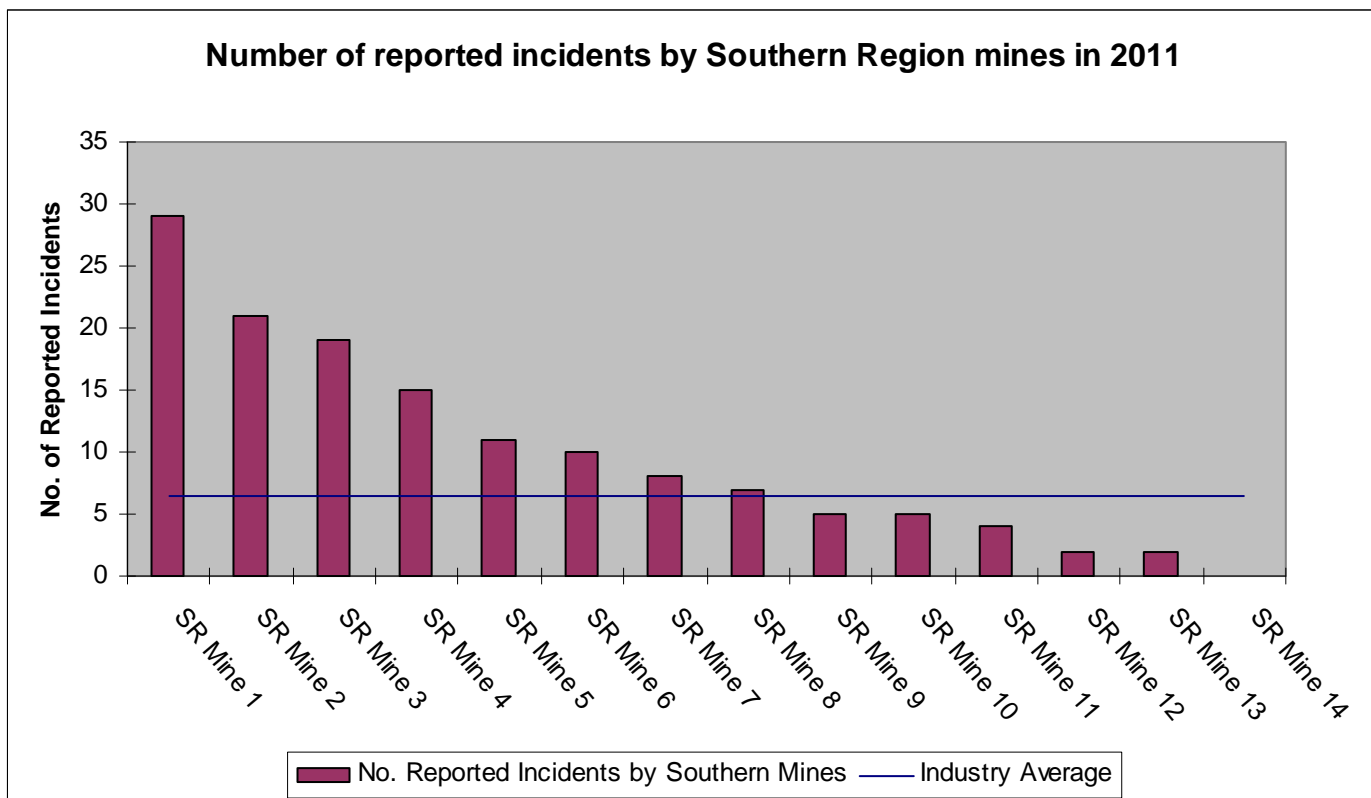
Figure 6 Southern Region Mine Reporting

Figure 6 below shows the number of ExDES failures reported by Southern region mines during 2011.

A majority of Southern region mines have an above average incident reporting rate. The highest reporting mines report over 10 times more incidents than the lowest. Is the high variation due to under-reporting of incidents at the lowest reporting mines?

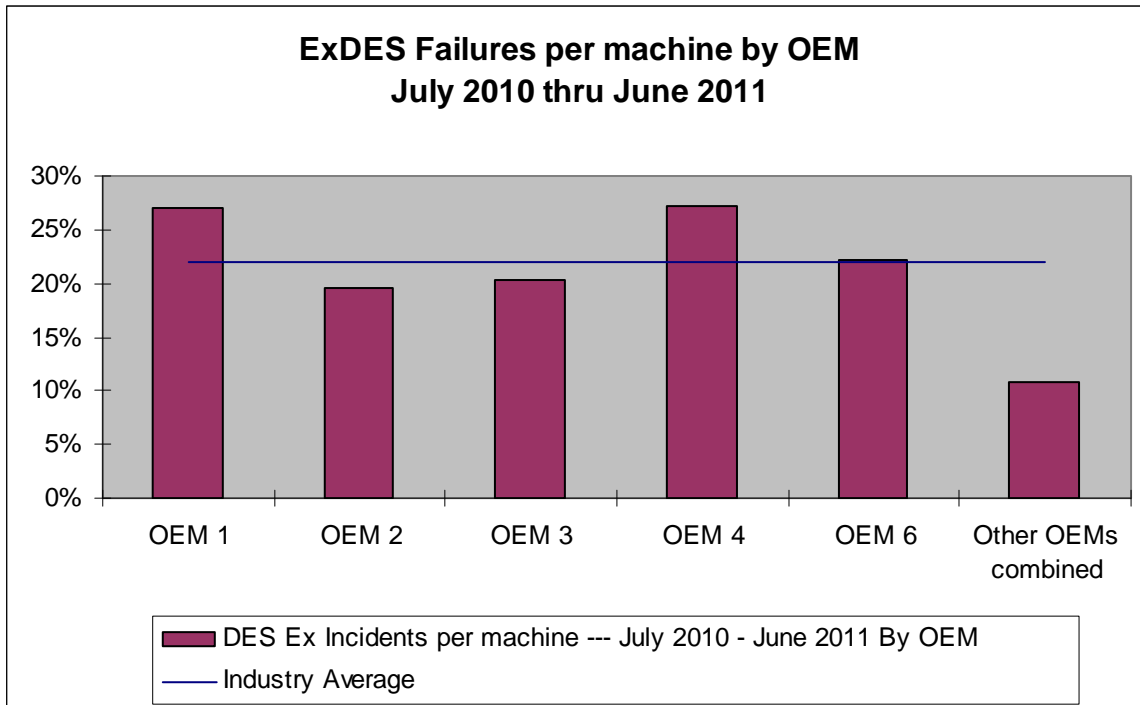
Figure 7 Failure rate by OEM

Figure 7 below shows the likelihood of ExDES failures for the major OEM's for the year July 2010 through June 2011.

The industry average is 22%, or 22 failures per 100 machines in service per year.

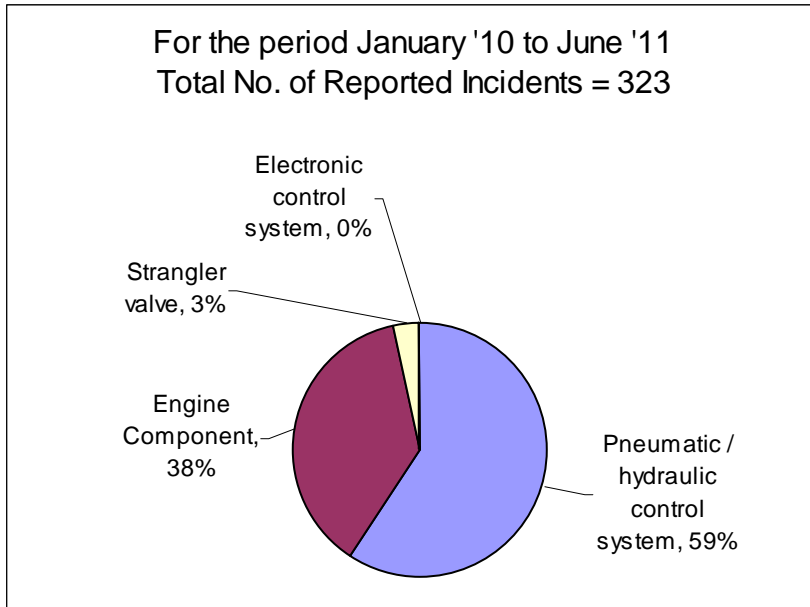
Figure 8 below shows a breakup of the reported failures for the year January 2010 through October 2011⁵.

- 59% were a failure of the control system to keep the DES in an explosion-protected state.
- 38% occurred in a major DES component.

While not strictly reportable, 3% of reported incidents related to a failure of a strangler valve to shut down the engine.

The data contained no reported incidents of the failure of an electronic control system to keep the DES in an explosion protected state. This suggests that if electronic control systems were used in all diesel engine systems, the best part of 59% of failures could be reduced.

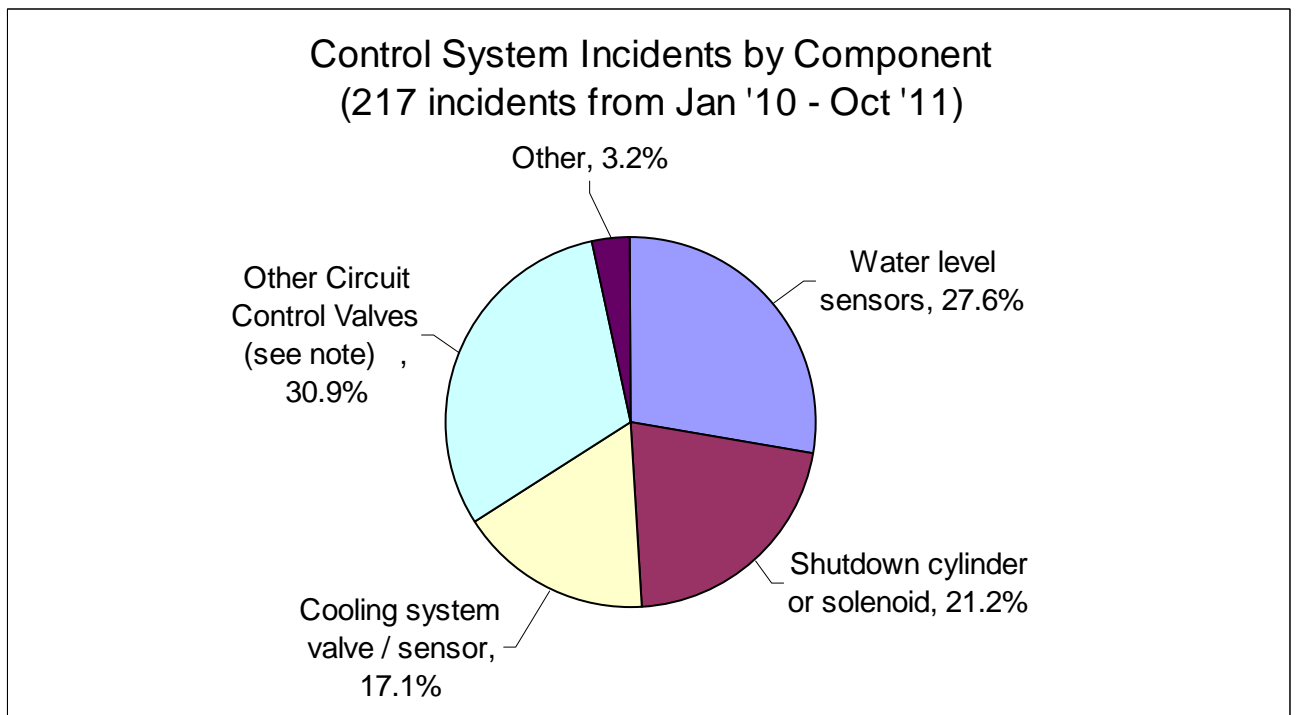
Figure 9 below shows the distribution of failures among control system components⁶:

Water level sensors were the biggest single item among control system components that failed, causing 27.6% of failures. These were mainly Humphrey valve failures. Sometimes this sensor was installed wrong.

The next most frequent location of failure of the DES was at the shutdown cylinder, at 21.2%, mainly by jamming of the cylinder, and sometimes by wrong pressure setting, loose bolts/nuts/studs or bent linkage.

Cooling system valve/sensors contributed 17.1% of failures, mostly by non-operation of the valve/sensor. A couple of failures here were due to wrong installation.

Although contributing 30.9% of failures, "Other circuit control valves" encompassed a number of different functions and types of valves. These included the flow control valve, oil pressure, safety circuit pressure valve, relief valve etc (needle valve, pilot valve etc).

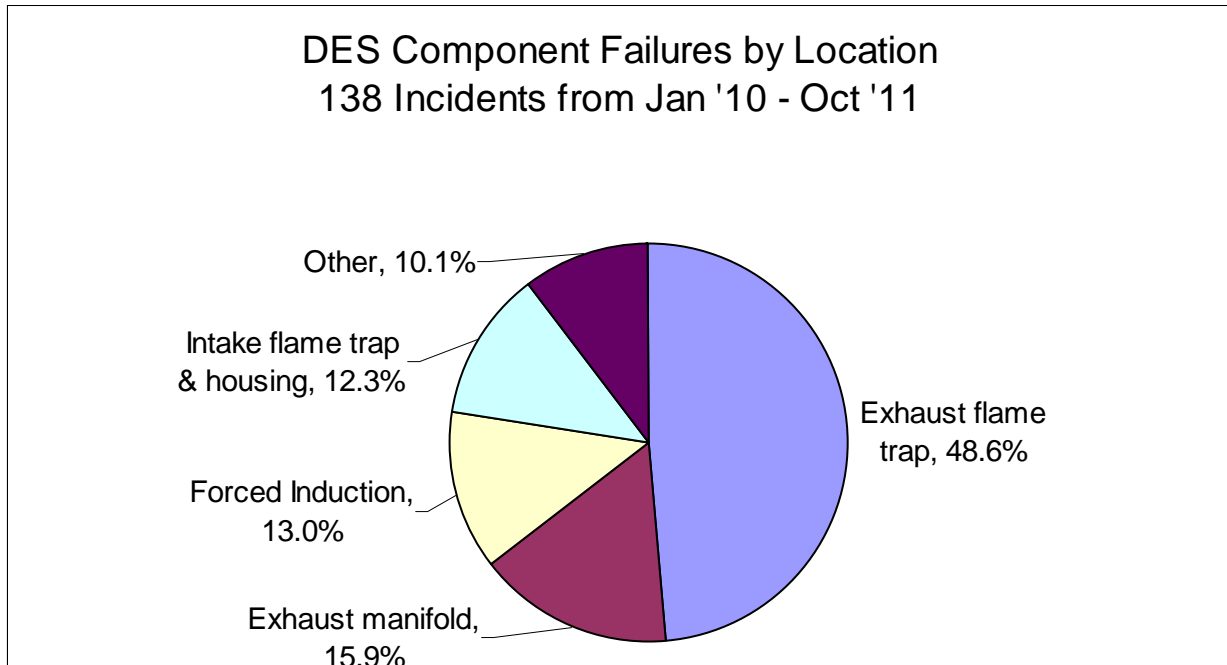
Figure 11 below shows which engine components are more prone to failure.

Second to the control system, the next source of failure of diesel engine systems was the exhaust flame trap, contributing 48.6% of non-control-system failures. Most of these were in the wet scrubber.

Lesser contributions were made by the exhaust manifold (15.9%)

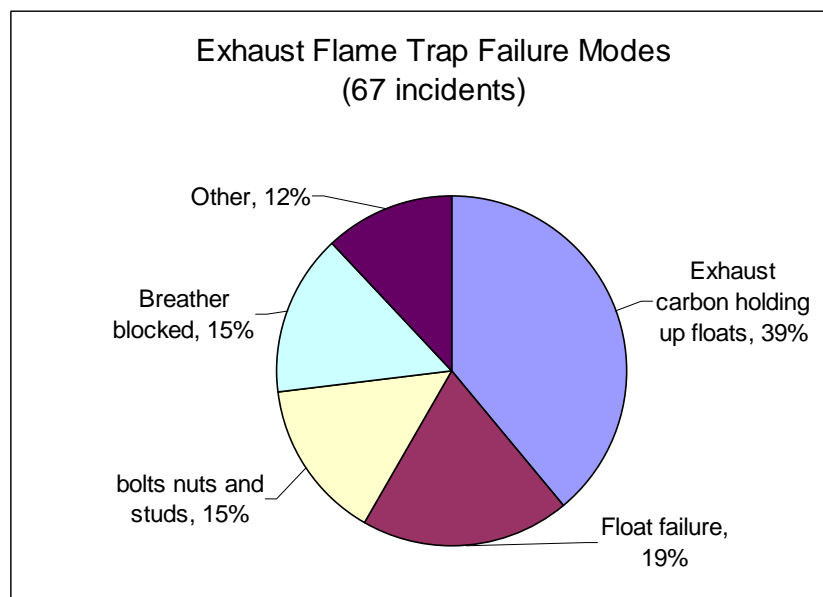
Figure 12 below shows the distribution of failure modes of exhaust flame traps.

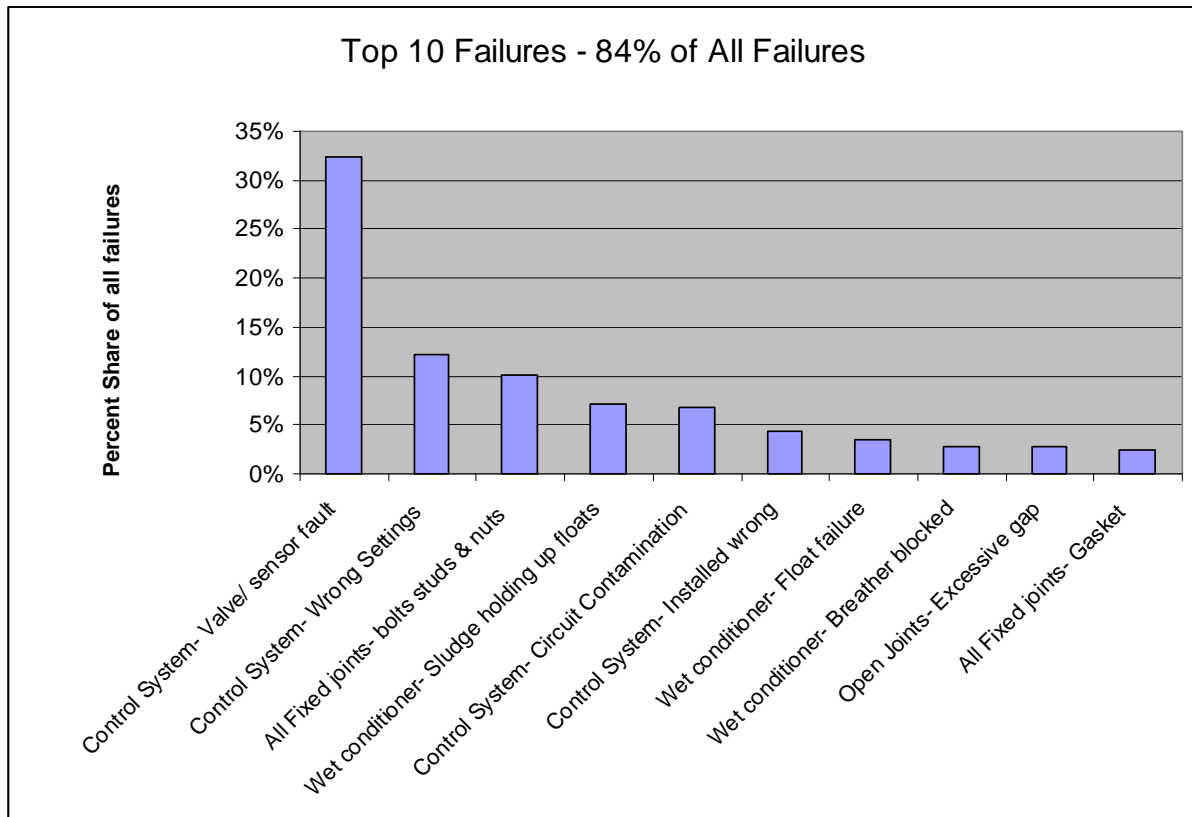
Figure 15 below shows the top 10 ways a DES was reported to have failed. The percentages quoted are a proportion of the total number of failures and 84% of all failures are shown.

Valve/sensor reliability seems to be the greatest opportunity for improvement and could be improved by use of an electronic control system. The failures due to wrong settings in the pneumatic/hydraulic control circuit may have been due to either deliberate misuse, or insufficient security of the settings; there is currently insufficient information available to determine the split between the two.

Similarly for security of bolts, studs and nuts – OEM's and users may share responsibility for improvement.
