MINE SAFETY INVESTIGATION UNIT

INFORMATION RELEASE

Fatality

Incident date	4 November 2016
Event	Fatality in underground opal mine
Location	Mulga Rush Opal Fields (near Lightning Ridge) NSW

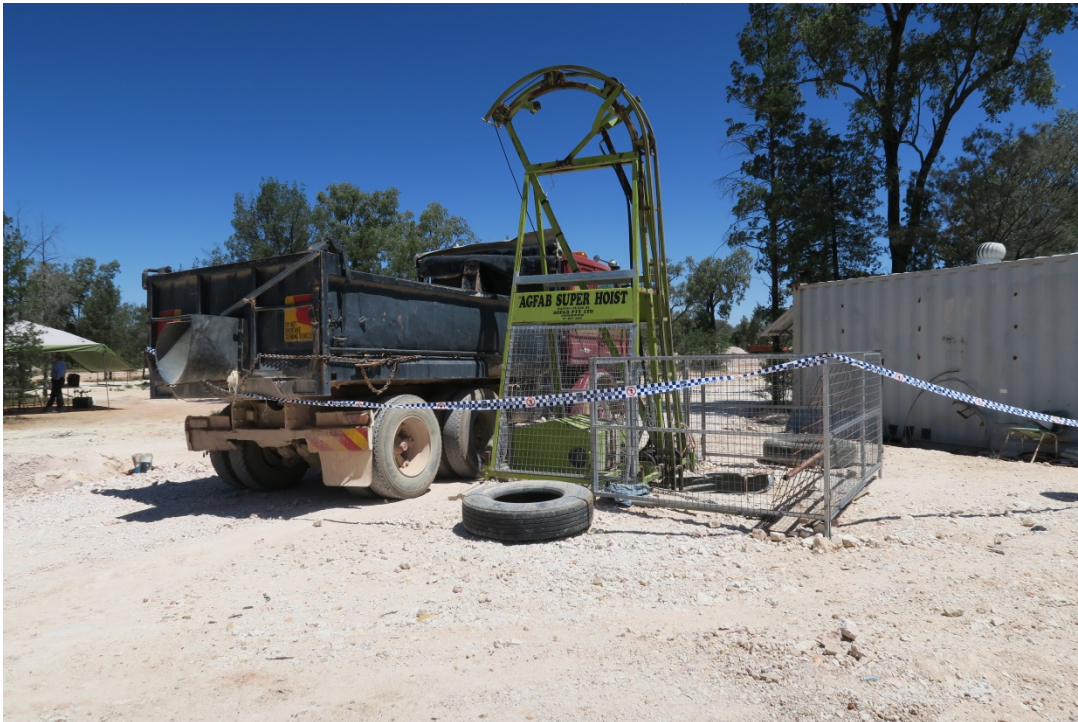
Photograph 2: Headframe and material hoist system at the top of the shaft.

The hoist continued to operate and all the steel cable unspooled from the hoist winder drum. The steel cable then wound onto the hoist's winder drum in the wrong direction and the bucket raised unintentionally to the surface.

When the bucket reached the surface the hoist hydraulic system prevented the bucket from reaching the tipping point, causing it to remain in a static suspended position above the shaft. In this position, the hoist hydraulic and electrical system continued to operate and the hydraulic drive motor prevented the bucket from falling.
