MINE SAFETY INVESTIGATION UNIT

INFORMATION RELEASE

Serious injury

Date	Incident occurred on 7 December 2011
Event	Person crushed between telehandler/forklift and delivery truck
Location	Tasman Underground Coal Mine, Newcastle, NSW

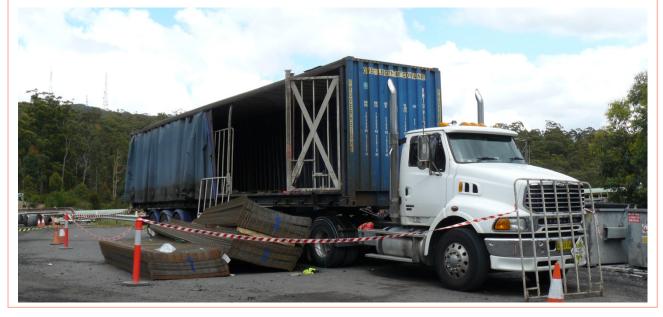
The mine deputy undertook to unload the truck using the mine's telehandler, which is a multipurpose materials handling machine (pictured).

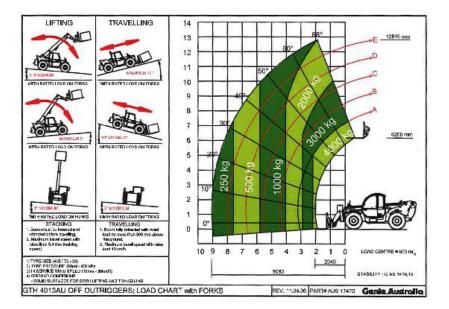
A crucial point to emerge from the investigation is an understanding of where the centre of the load is and the effect this has on the optimum weight that may be lifted.

The overall dimensions of the bundles of mesh meant that the effective centre of the load was 0.125 metres past the centre of the forks.

This reduced the effective lifting capacity of the load from 4 tonne to 3 tonne, meaning that the three bundles of mesh being lifted were at the outer limit or beyond the rated capacity of the machine.

- the need for a level and well-marked truck unloading area.
- the need for demarcation of the area to prevent interaction with pedestrians and other vehicles.
- the need for clear and rigidly enforced procedures for controlling the location and movement of people around operating plant such as telehandlers.
- The need to ensure that the materials handling plant is only operated by people who are trained, competent and appointed to operate the particular machine, and who are authorised to undertake the particular task.
- The need to ensure that training and competency assessment incorporates understanding of machine capacity, load dynamics, and the particular lessons from this incident.
