MINE SAFETY INVESTIGATION UNIT

INFORMATION RELEASE

Fatality

Date	Incident occurred on 30 November 2013
Event	Collision between haul truck and light vehicle
Location	Ravensthorpe Open Cut Mine, Ravensthorpe, NSW

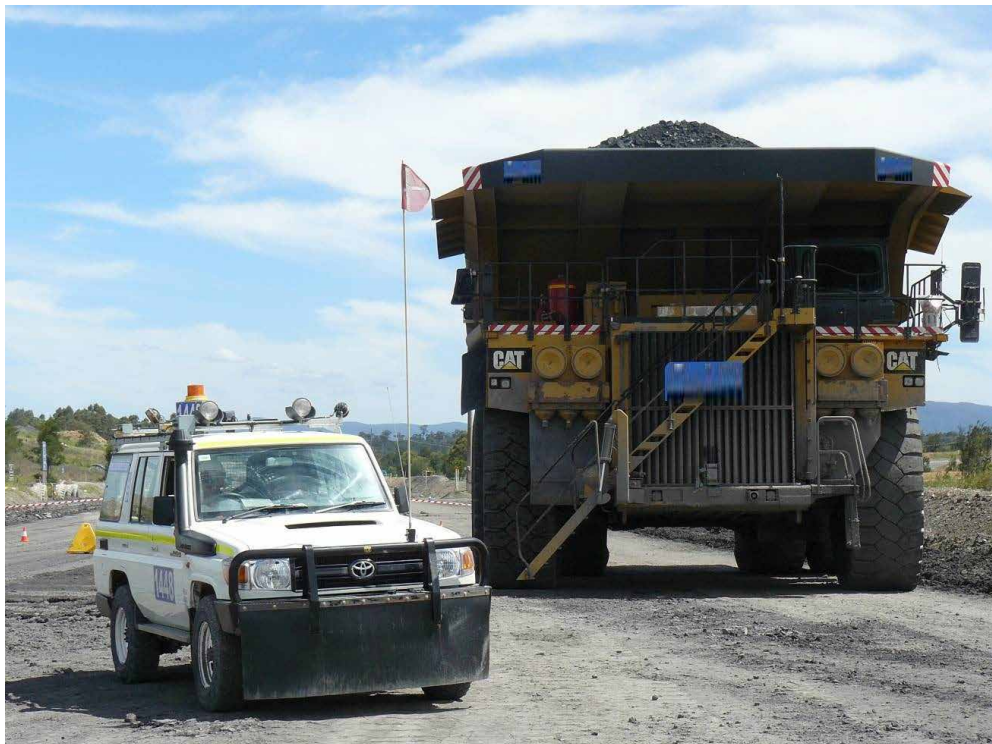
Similar light vehicle and truck at the intersection in daylight

The LV had a pole and flag attached to its bonnet as depicted in the photograph on page 1.

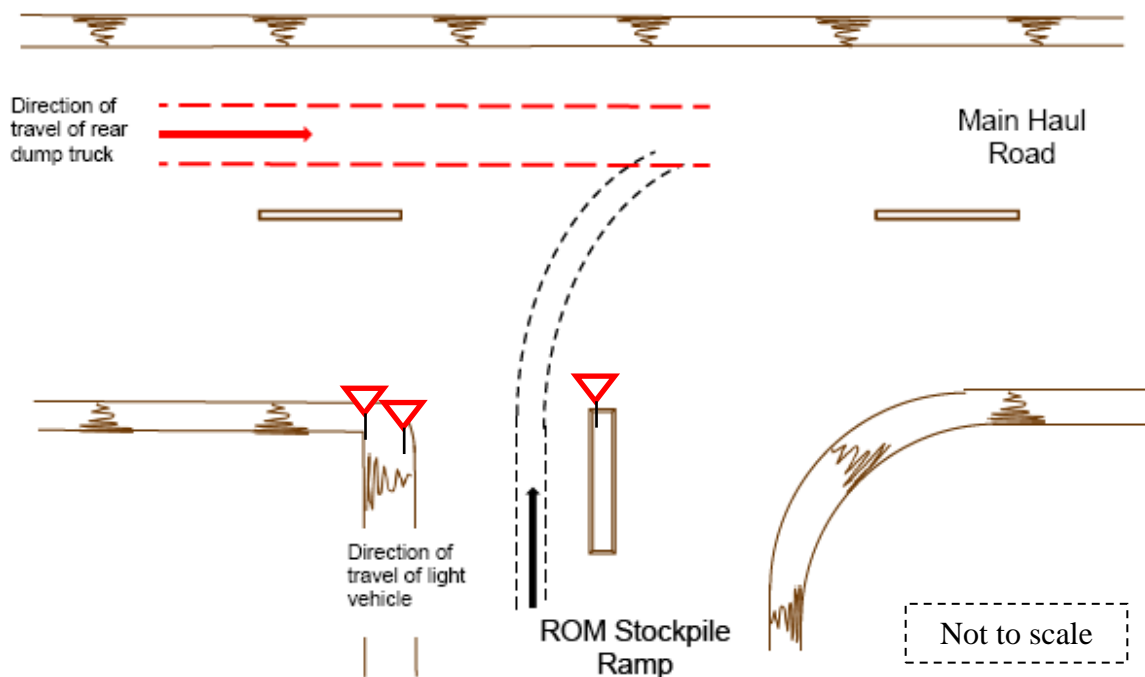
Illustration of intersection – does not depict actual scene *Sketch by Investigation Unit*

The stockpile ramp entered at right-angles to the main haul road. The stockpile ramp had a short dividing centre windrow at the intersection.

'Give Way' signs were posted in the centre windrow and the windrow on the left side of the ramp at the intersection.

The cross-point on the centre of the haul road was marked by a gap between two small windrows in each direction with two white marker posts and 'Keep Left' signs in each windrow.

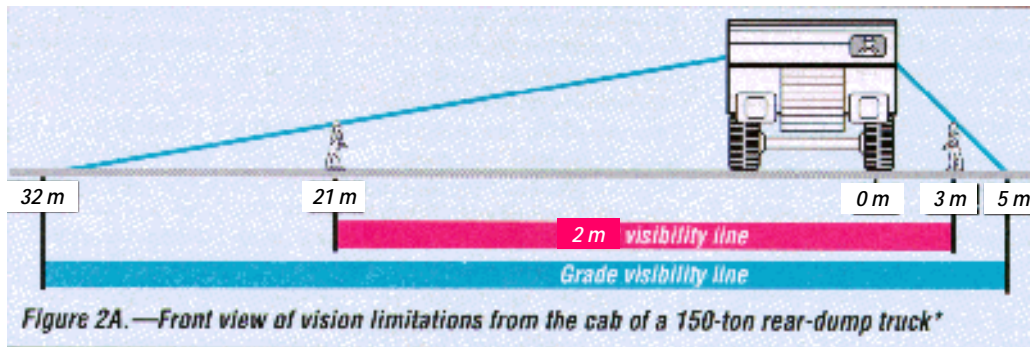
The operator's cab is situated on the left hand side of the truck and is almost 5 metres above the ground. As can be seen in the diagram below, the truck operator has very limited vision for at least 20 metres off to the right side (blind-side) of the truck for anything that is less than 2 metres tall. The truck operator's vision is further restricted by the cab rollover protection structure, mirrors, handrails and other equipment on the truck cab deck.

Illustration of blind spots around a mining truck (from Miller, 1975)²
 Illustration indicative of vision from a large RDT, distances shown are approximate.
