MINE SAFETY INVESTIGATION UNIT

INFORMATION RELEASE

Incident date	11 June 2014
Event	Worker dies in underground sump
Location	CSA Mine, Cobar NSW

IIR14-05

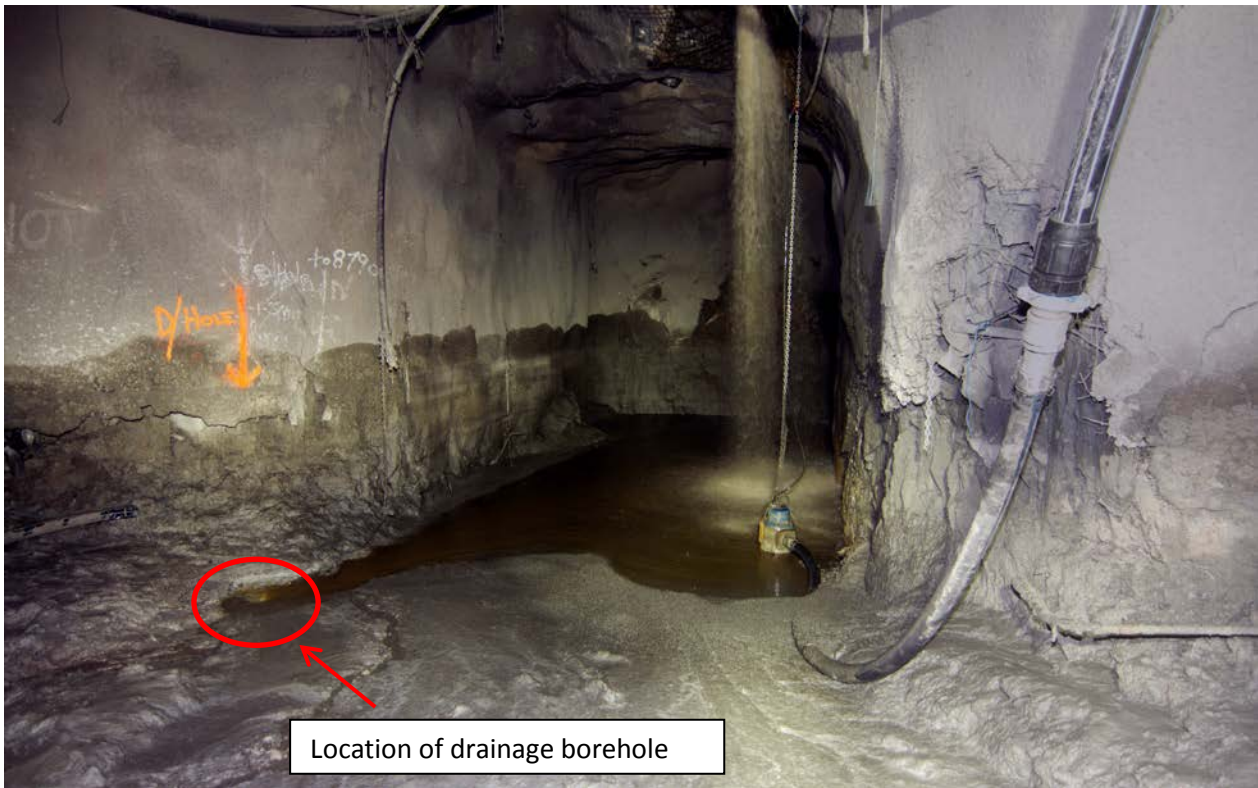
Location of drainage borehole

Underground sump – water level at the time of the incident on side wall - Photograph by Investigation Unit

Two workers were attempting to clear a reported blockage that was preventing the 8820 Nth sump from draining through the borehole to the 8790 Nth level below. The sump contained a considerable volume of water. The depth of water at the time of the incident is indicated by the markings on the side wall around the sump. It is evident from water markings on the backs (mine wall) that the sump was overflowing into the adjacent access roadways.

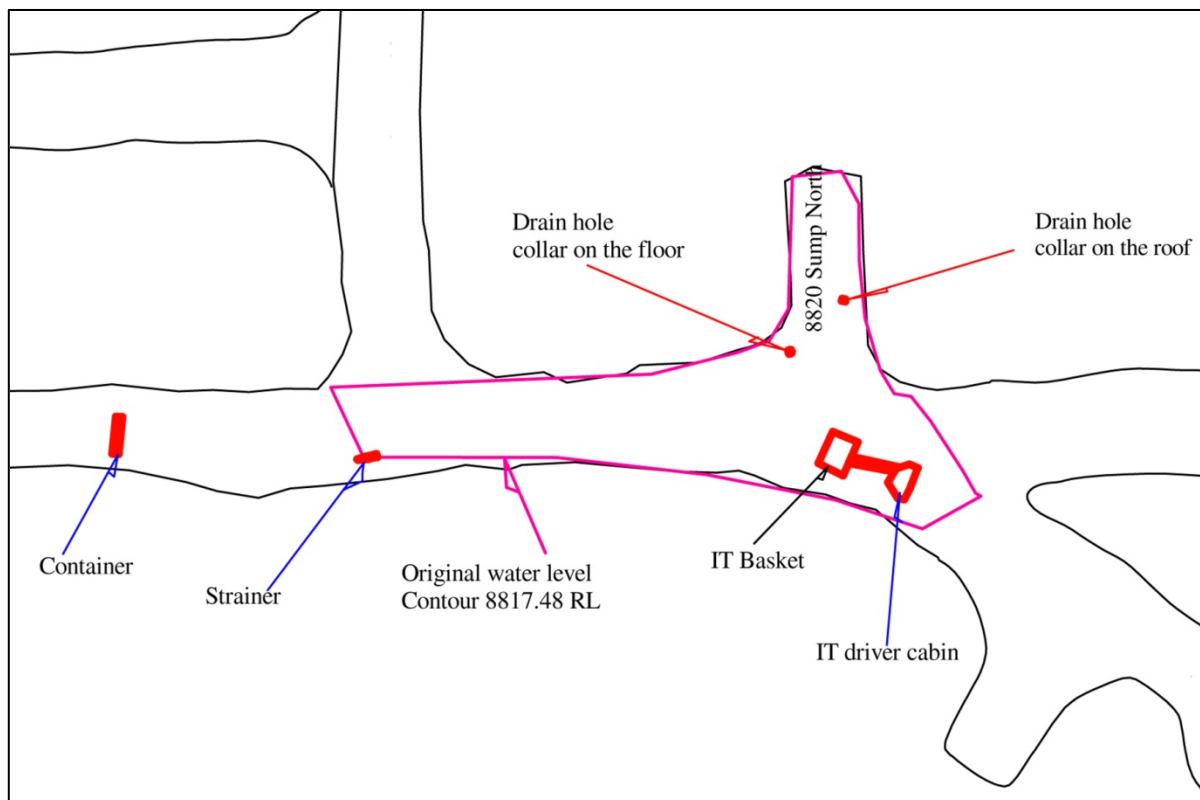
The incident site was at the 8820 level, about 1400 metres underground. The incident site was designated as a sump for collecting ground water from the mine. Water can enter the 8820 Nth sump through a borehole from the sump directly above (8850 Nth) and from the main access decline and roadways.

Water can be pumped from the 8820 Nth sump, or drained by a borehole to the lower 8790 Nth level. At the time of the incident, the borehole was blocked, the cause of which is being investigated. It would appear that the borehole did not have any guarding or cover to prevent a person from being sucked into it. It is unclear what signs were present to indicate the position, or warn of, the open borehole.

Incident site plan – Excerpt of plan supplied by the mine operator

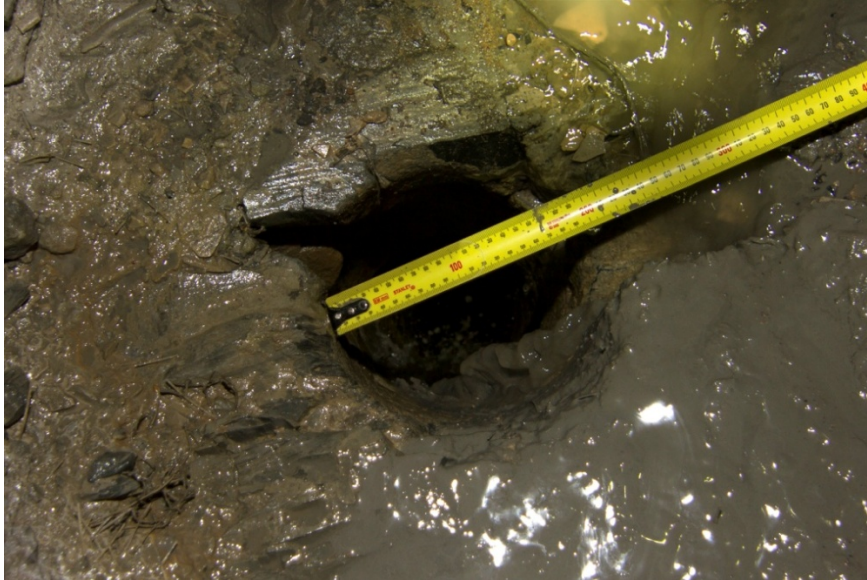
The borehole linking the 8820 Nth sump (incident scene) with the 8790 Nth sump below was about 180 mm in diameter and about 30 m deep.

The borehole was drilled in competent rock and was unlined.

The lower (discharge) end of the borehole at 8790 Nth was accessible and workers checked it before the incident. It is reported that there was no water flowing from the borehole indicating that the borehole was blocked.

Borehole in the bottom of the incident sump - *Photograph by Investigation Unit*

Mine operators should ensure that open holes and boreholes are appropriately guarded and hard barriers are in place to prevent similar incidents from occurring. All open holes should be appropriately signposted. Workers should be prohibited from entering water filled sumps and water bodies without using certified water craft and appropriate flotation protective equipment.

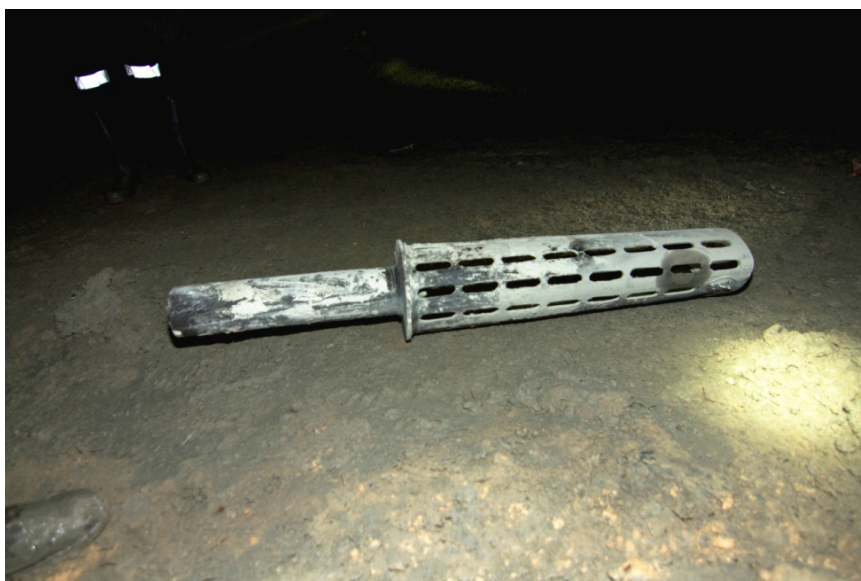
The borehole had been fitted with a strainer at some stage. A search of the area found a strainer nearby, but it is not known whether the strainer was fitted in the borehole or, if so, how it came to be separated from the borehole.

During inspection of the strainer, investigators observed an inflatable bag in the solid tube section of the strainer. Investigators will determine if this blockage contributed to the incident.

Strainer found in the vicinity - *Photograph by Investigation Unit*
