MINE SAFETY INVESTIGATION UNIT

INFORMATION RELEASE

Fatality

Incident date	6 September 2015
Event	Fatality in underground mine
Location	Ridgeway Mine, Cadia (near Orange) NSW

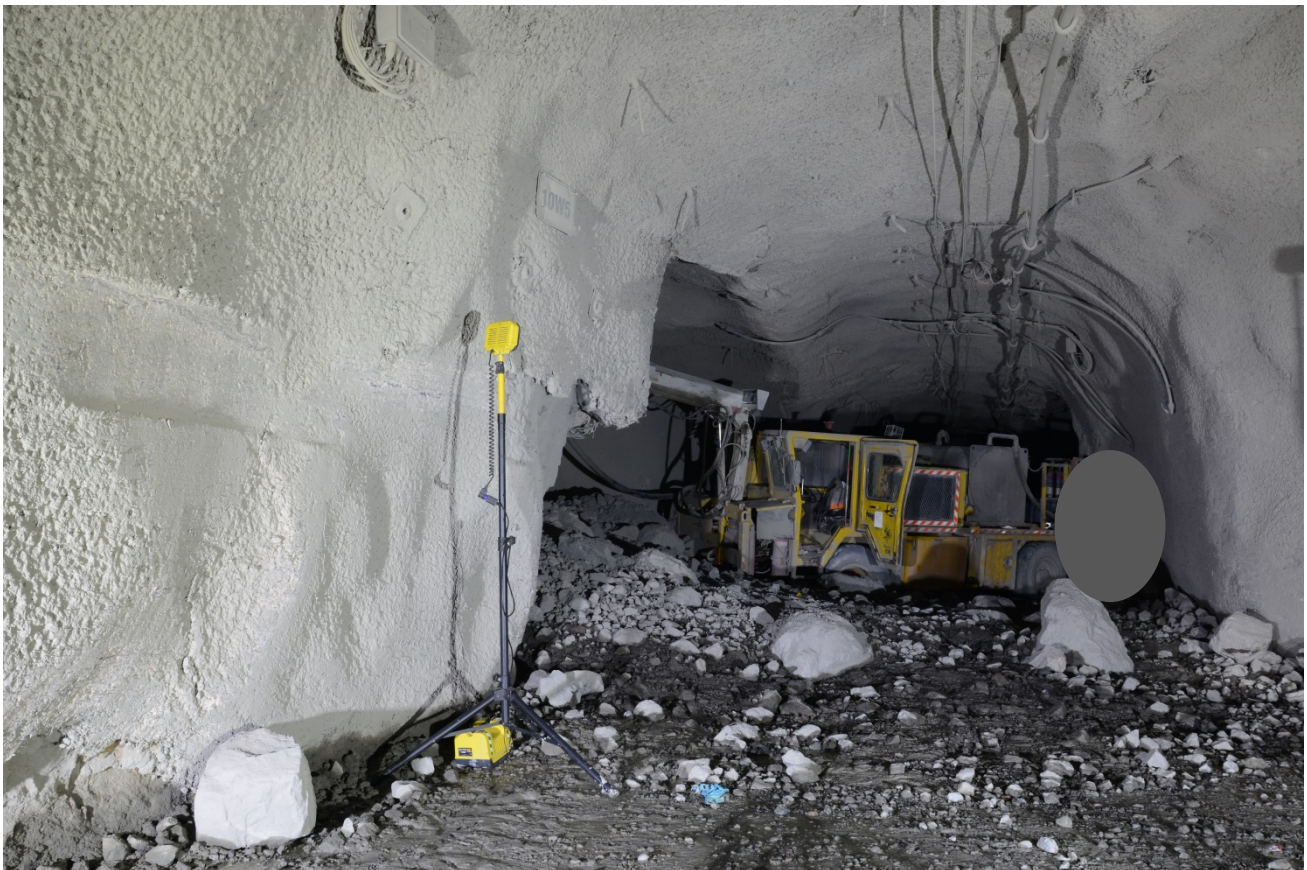
Photograph of the mobile plant and drive taken by an Investigator on 8 September 2015 (after recovery of deceased worker). Photograph taken from north of underground drive looking south.

During the task, it appears that there was a rapid movement of rock and material from the draw point into the extraction drive.

The material impacted the front of the Jacon. For this or other reasons, the Jacon moved backwards trapping the worker between the Jacon and the side wall of the extraction drive.

Where draw points are either choked or hung up, the potential for a sudden movement of material must be considered and an assessment made to ensure appropriate control measures are in place prior to any work being undertaken.

Control measures should include sufficient bunds to prevent movement of material, safe standing and operating zones for mobile machine operators, and safe means of egress.

Systems should also be implemented to ensure that persons working alone are regularly monitored.
