INVESTIGATION INFORMATION RELEASE

Collision between semi-autonomous dozer and manned excavator

Incident date: 27 May 2019

Location: Wilpinjong Coal Mine, Mudgee, NSW

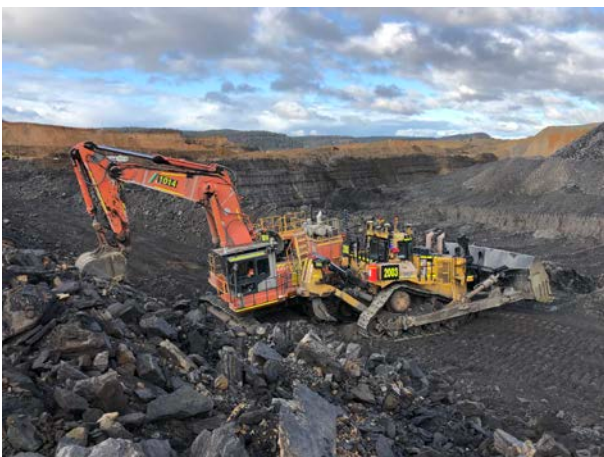
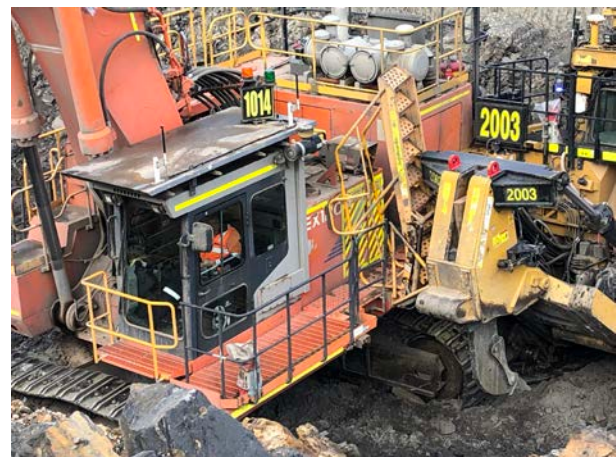
Figure 1 & 2 - Incident scene immediately following the incident

Immediately prior to the incident, the SATS operator was operating dozer 2010 that had paused because it required operator input. As EX1014 proceeded past the end of the windrow and continued scaling the highwall, dozer 2003 had completed a push and commenced reversing. The dozer was travelling in second gear at approximately 7 kilometres/hour. As the ripper box contacted the rear of EX1014, it continued to drive, pushing EX1014 sideways approximately 1.5 metres. At this point, the dozer lost traction. After five seconds of tracks slipping, SATS alarmed and stopped dozer 2003. From initial contact to dozer 2003 stopping took approximately 14 seconds.

As contact was made between the machines, the operator of EX1014 attempted to call the SATS operator on the radio to stop the dozer. This was unsuccessful, due to radio channel selection and radio traffic. The excavator operator had no other means to stop the semi-autonomous dozer. The operator was not injured.

- Reviewing controls in place to prevent workers inadvertently entering an area where automated equipment is operating

- Confirming the hierarchy of controls have been adequately used when developing controls to manage interactions between manned equipment that interacts with semi-autonomous and tele-remote equipment
- Having a suitable physical barrier in place relevant to the equipment being operated, when segregation is required between manned equipment and semi-autonomous and tele-remote equipment
- Scheduling workplace inspections by supervisors of workers operating adjacent to or within semi-autonomous, autonomous and tele-remote operation zones.

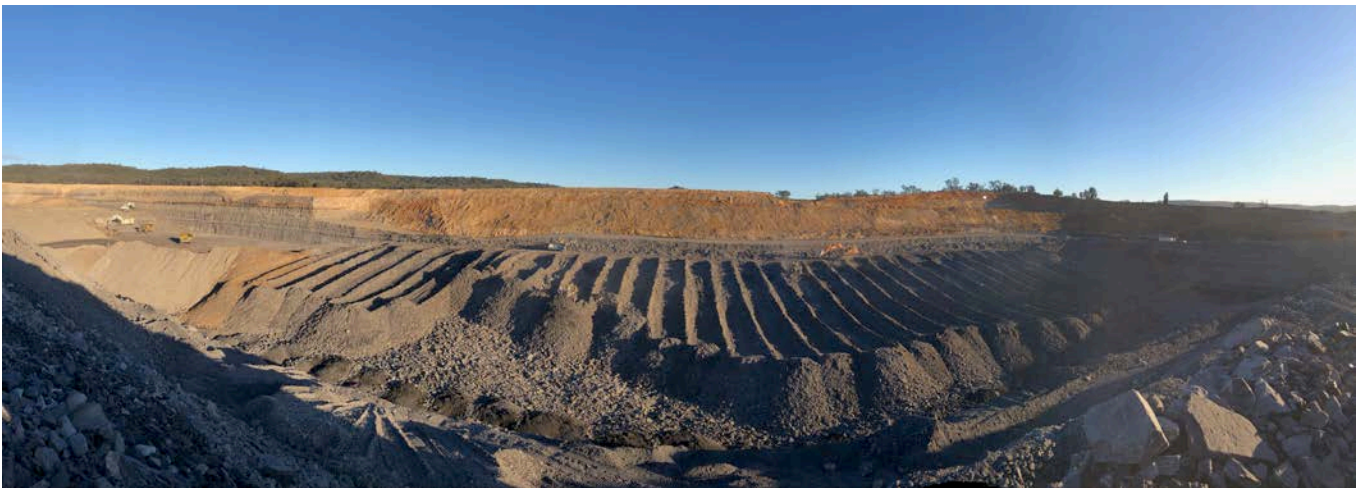
Figure 3- The SATS operating area, taken on the morning of the incident

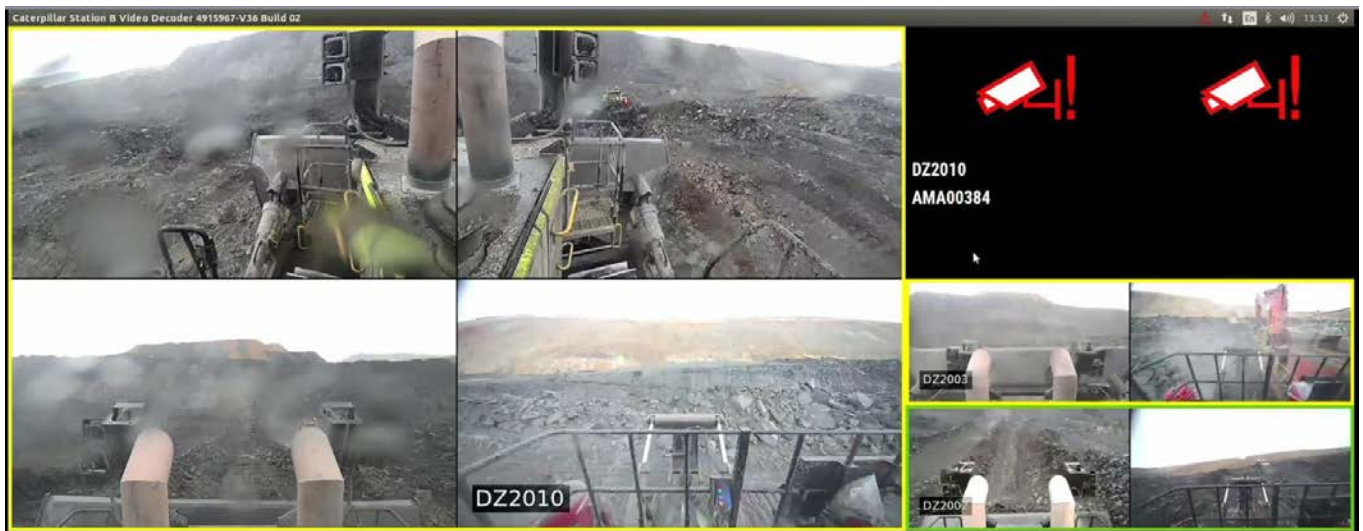
Figure 5 - screenshot of SATS operator monitor prior to incident
