MINE SAFETY

INVESTIGATION UNIT

Fatality of a truck driver
loading from a surface bin
18 February 2009

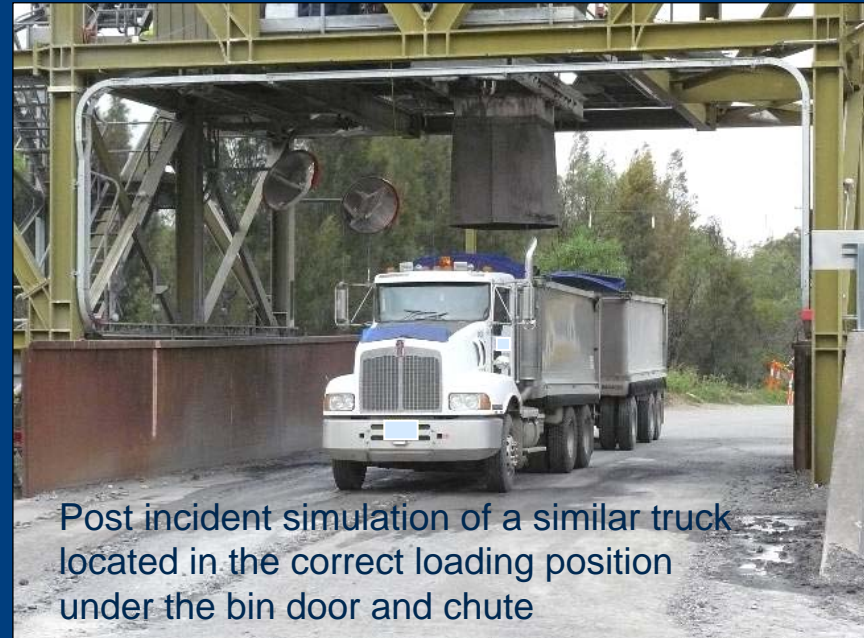
Post incident simulation of a similar truck located in the correct loading position under the bin door and chute

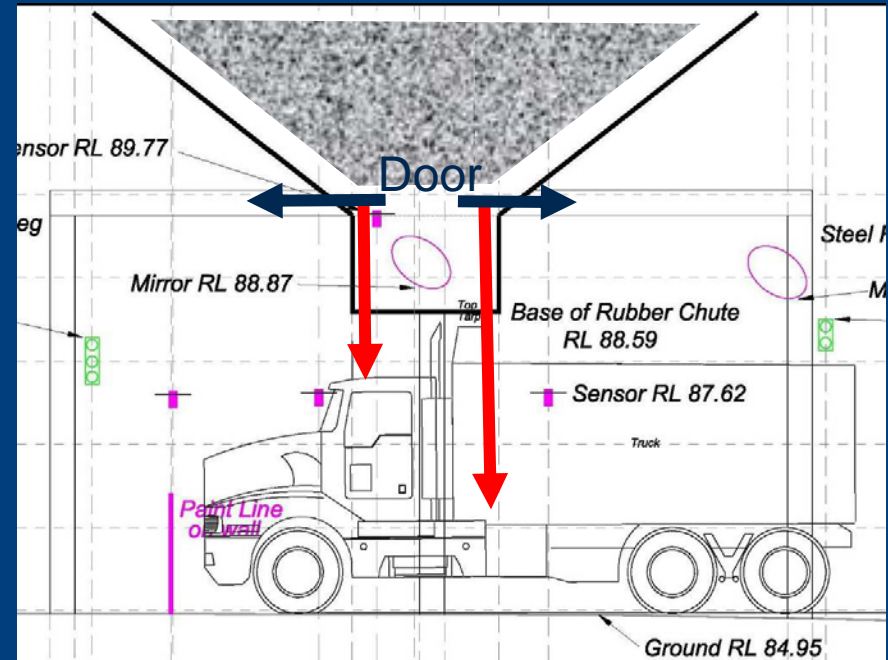
- The fibreglass cabin roof of the truck collapsed onto the truck driver located in the drivers seat as a result of 10 tonnes of rock material being released in 2½ seconds from a bin door located 2m directly above the cabin roof.

- The fibreglass roof of the cabin failed to withstand the dynamic loading of rock material falling onto the roof from height

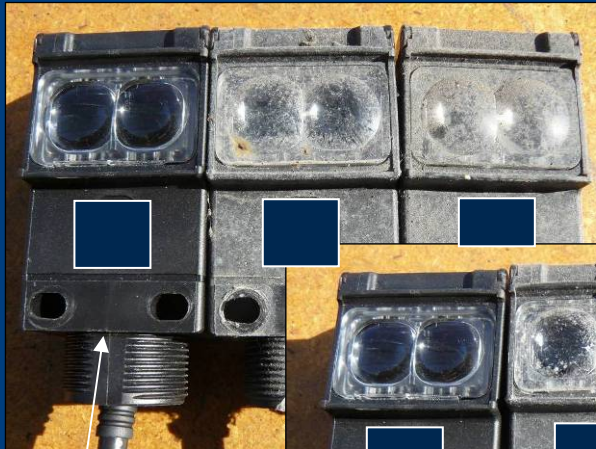
Row One sensors were 17.6% more degraded by dirt build up when compared to new sensors

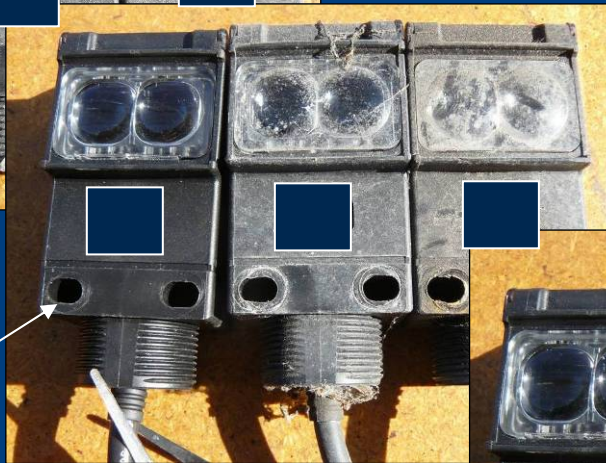
Row Two sensors were identified post incident as being operational but were continually blocked by dirt

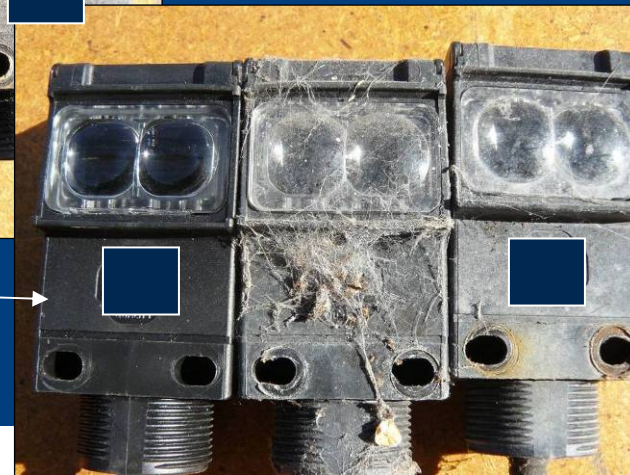
Row Three sensors were only 0.6% more degraded by dirt build up when compared to new

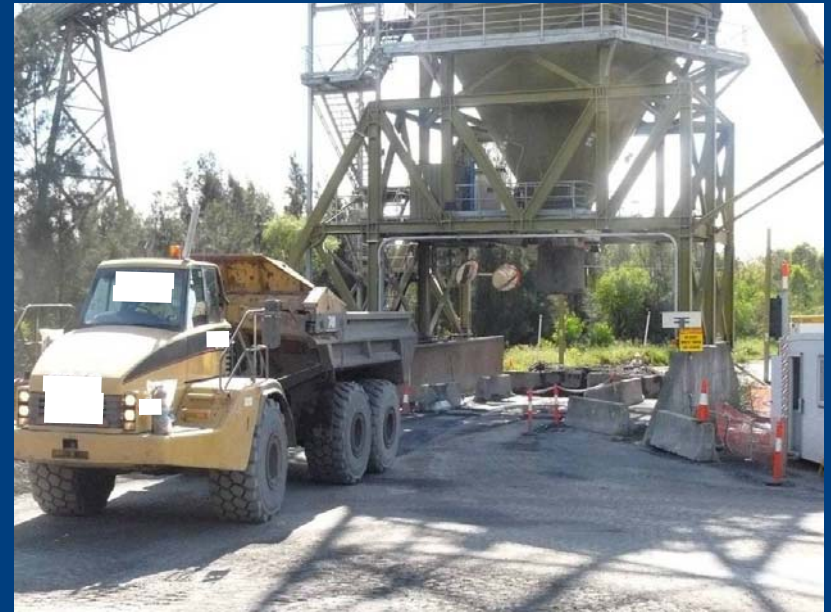
Post incident loading by reversing of FOPS cabin truck under chute

- Functional Safety assessment.
- Truck with FOPS cabin put in use
- Truck reverses under bin
- Cabin never goes under bin door
- PLC time out device installed
- Extra area lighting
- Hydraulic isolation devices added
- Remote control holders in truck cabin.
- New inspection and maintenance procedures
- New shift pre start documents
- Shift inspection and cleaning of safety critical components
