# WEEKLY INCIDENT SUMMARY

Week ending Friday 26 July 2019

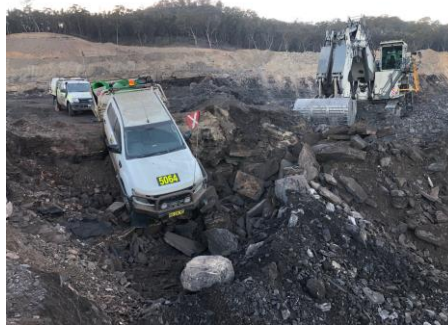
INCIDENT TYPE	SUMMARY	RECOMMENDATIONS TO INDUSTRY
Dangerous Incident IncNot0035137	<p>While a light vehicle was driving back to the assembly point from a drill site, it drove over an open edge. The front of the vehicle dropped over the edge, while the rear wheels remained on the bench.</p> <p>The two occupants of the vehicle were not injured.</p> <p>The vehicle was exiting the drill area at the end of shift. The driver used the same road they had driven on earlier that day. During the shift, an excavator dug through the ramp, leaving an</p>	<p>Mine operators should review the adequacy of their communication arrangements on shift.</p>

open face approximately two metres in height.

The excavator operator was unaware that his work area was intersecting an active light vehicle track. This resulted in the track being excavated without the installation of any delineation markers or communication to the light vehicle operators.

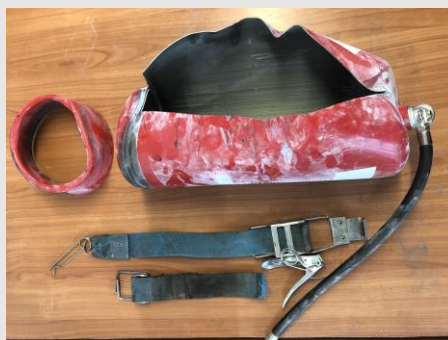
Dangerous Incident  
IncNot0035193

A nine-kilogram dry chemical fire extinguisher, mounted on a CAT D11T Dozer (DOZ817), exploded. This resulted in the metal buckle from the retaining strap releasing and cracking the cabin window. There were no injuries to personnel.

Investigations are underway to try and understand the causal factors contributing to the catastrophic failure of the extinguisher.

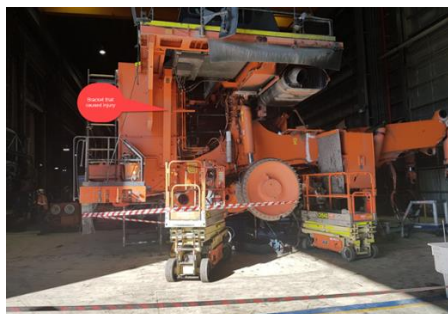
Serious Injury  
IncNot0035168

A contractor technician was raising himself in an EWP self-propelled scissor lift to change a hydraulic hose on a truck. He was looking up at the hydraulic hose location while raising the EWP with his right hand on the controls and left hand on the hand rail. He contacted his left hand with a bracket on the truck when he stopped raising the EWP. The technician was transported to hospital with a suspected broken hand. The technician was later transferred to the John Hunter Hospital to undergo surgery on his hand. He has since been released from hospital.

The EWP used in this incident was not fitted with two-handed controls. The operator was unaware that his hand was in a vulnerable position and there was no secondary handrail fitted that would have provided a higher level of safety.
