WEEKLY INCIDENT SUMMARY

Week ending Friday 11 June 2021

Mine safety reference ISR21-23

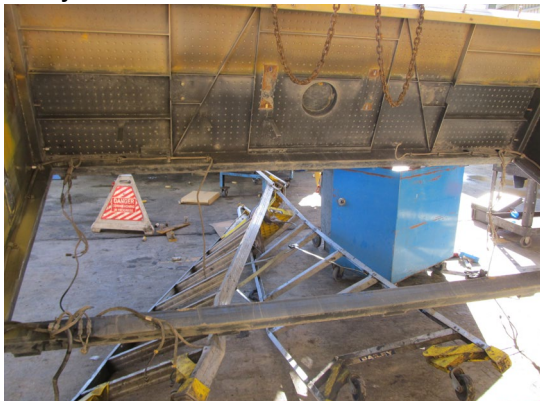
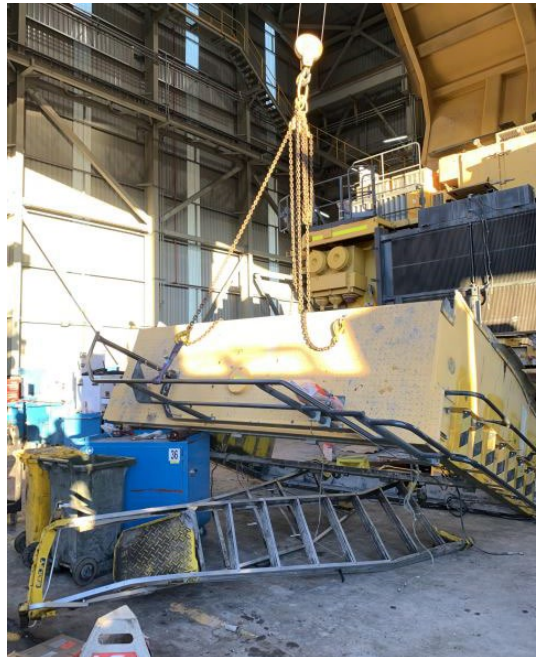
INCIDENT TYPE	SUMMARY	COMMENTS TO INDUSTRY
Dangerous incident IncNot0040052 Open cut coal mine	<p>A fitter was standing on a work platform attaching a lifting sling to a radiator cowling. The cowling was not adequately restrained and fell forward, causing the ladder and fitter to fall. The fitter landed on a nearby tool trolley and was uninjured.</p>

<p>When conducting maintenance activities involving the removal of objects, controls must be put in place to manage the risk of the objects falling. Mine operators should ensure that pre-use inspections are available for workers and are completed for all lifting/lowering equipment tasks. The rating of all lifting components within a system should consider the worst-case scenario where the load becomes unbalanced.</p>
