Week ending 15 February 2019

This incident summary provides information on reportable incidents and safety advice for the NSW mining industry. To report an incident to the NSW Resources Regulator: phone 1300 814 609 24 hours a day, 7 days a week.

CM9 reference	DOC19/141418
Mine safety reference	ISR 19-07
Date published	22 February 2019

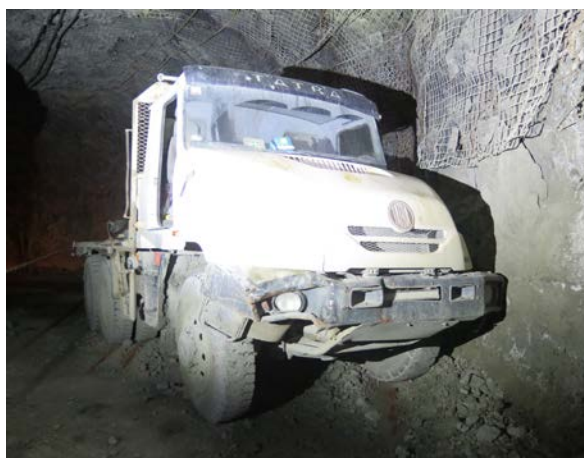
Incident type	Summary	Recommendations to industry
Dangerous incident IncNot0033899	A collision occurred in an underground metalliferous mine. A haul truck was descending the decline when it collided with a rigid body truck travelling up the decline. The rigid truck was pushed two metres as a result of the collision. The driver of the rigid body truck briefly lost consciousness and suffered a head laceration.	Mine operators must conduct an assessment and identify areas where there is a risk of collision. When developing risk control measures, the hierarchy of controls must be considered. Positive communication requirements must be implemented where a risk of collision remains. The mine was issued with a s195 prohibition notice and the incident is the subject of further investigation.

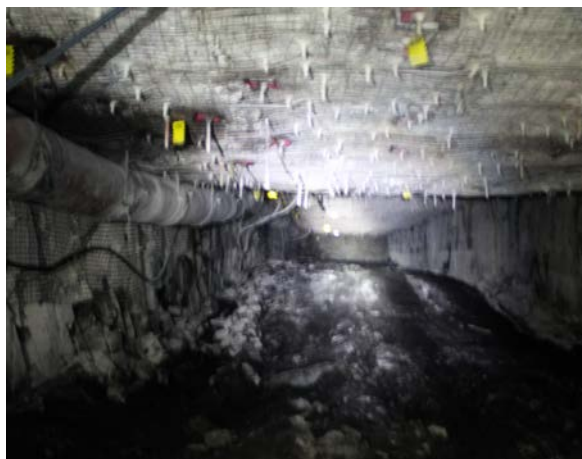
Dangerous incident
IncNot0033897

A roof fall occurred on the longwall installation face at an underground coal mine. The face line had been widened and completed and work had started flitting out the continuous miner. Signs of weighting were first reported on the night shift and the fall occurred during the day shift.

Underground mines should review the adequacy of their strata monitoring arrangements and associated trigger action response plans (TARPs) to ensure that workers are not exposed to unacceptable risks associated with strata failure.

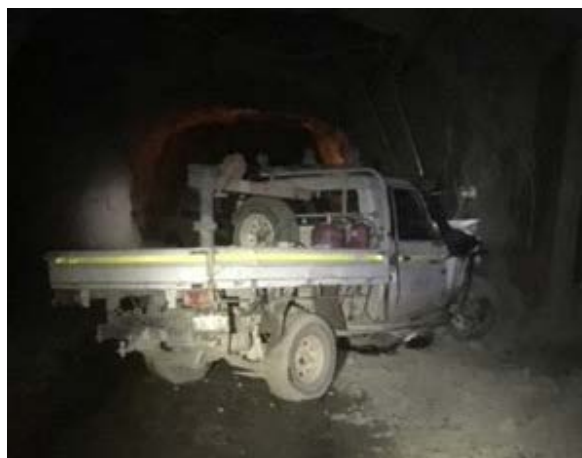
Dangerous incident
IncNot0033889

A light vehicle made heavy contact with the decline wall in an underground metalliferous mine. Maintenance activities had been completed on the vehicle's steering components earlier in the shift. The vehicle was descending in the main access to the mine when the incident occurred. The airbags deployed, and the vehicle was significantly damaged. No-one was injured.

Maintenance processes must include appropriate checks and tests to verify work. When work is carried out on a safety critical system, appropriate work verification procedures must be in place.

The mine was issued with a s191 improvement notice and the incident is the subject of further investigation.

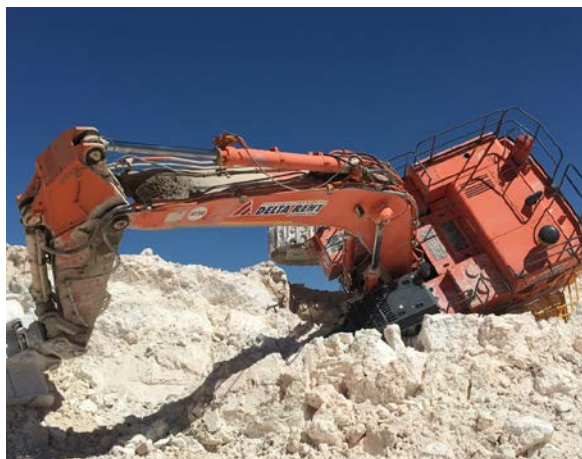
Dangerous incident
IncNot0033855

An excavator rolled in an open cut mine. The excavator was working on a 5-metre high stockpile of loose, wet material when the material under the left-hand track gave way. The operator safely exited the machine and reported soreness to his elbow.

Before starting work, supervisors and equipment operators must inspect and assess the work area to determine hazards, such as material slip. Planning for the work must include identification of hazards, risk assessment and control.

The operating environment should be examined to ensure:

- the ground beneath the working area is stable and free from faults, fractures and soft areas
- there is no moisture or water present in the earth or rock below the equipment
- work is not carried out close to the edge or in a zone of influence of an excavation or any previously disturbed ground.

All excavators should have a means of egressing the cabin if an incident occurs and the main cabin door cannot be opened.

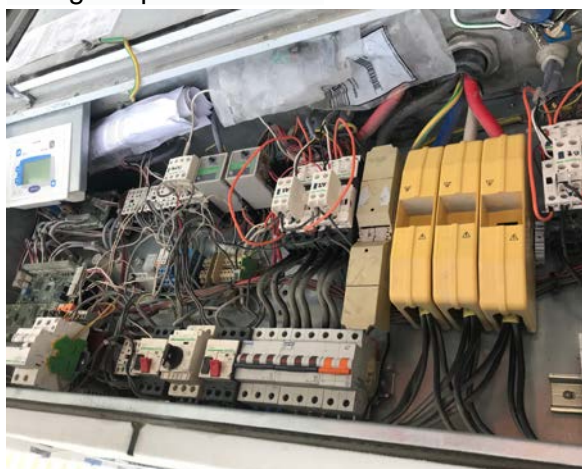
Dangerous incident
IncNot0033837

An electrician suffered an electric shock when he made contact with an 'insulated' wire in the control panel of a chiller unit in a metalliferous mine.

The electrician was resetting a circuit breaker when his finger slipped off the operating toggle and brushed against the sheath of the energised cable. A voltage of 240V was measured on the cable insulation.

The cables were found to have a conductive outer layer (semicon layer) that was in contact with the live terminals of a downstream contactor. As a result, the outer sheath of the cable was energised at voltages up to 240V AC.

Where workers are required to access electrical equipment for isolation or resetting protection devices, the equipment must be designed so that the workers cannot inadvertently make contact with energised cables or components or be exposed to a risk of arcing faults that may occur.

Cable insulation must be suitable for the intended function. Where cables are fitted with semiconductive sheaths, the cables must be installed and terminated in accordance with manufacturer's recommendations.

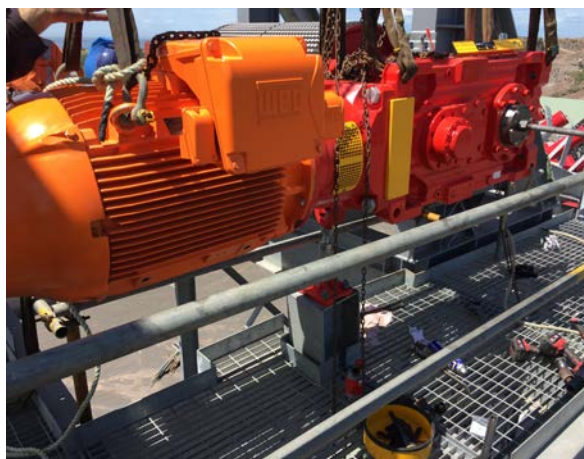
Dangerous incident
IncNot0033833

While installing a conveyor drive module, the supporting structure failed in a quarry processing plant. As the weight was removed from the crane, the support structure buckled. The site investigation revealed discrepancies between suppliers and contractors in the design and supply of steel work.

The mine was issued with a s195 prohibition notice requiring independent structural engineering assessment.

When multiple parties are involved in the procurement of plant and structures, appropriate controls and checks must be in place to ensure all relevant information is communicated between parties, and all parties involved should understand their scope.
