Week ending 19 December 2018

This incident summary provides information on reportable incidents and safety advice for the NSW mining industry. To report an incident to the NSW Resources Regulator: phone 1300 814 609 24 hours a day, 7 days a week.

Summarised incidents

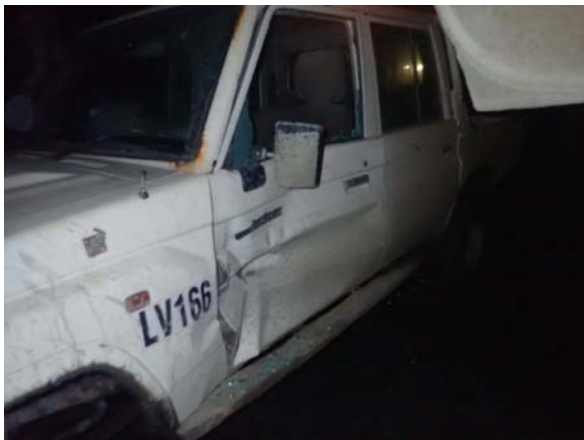
Incident type	Summary	Recommendations to industry
Dangerous incident IncNot0033382	<p>A collision occurred between an underground haul truck and a light vehicle in an underground metalliferous mine. The truck was being loaded when the light vehicle entered the area. Positive communication procedures were not followed. After the truck was loaded, it moved away and hit the light vehicle door. No-one was injured.</p>

<p>Review the verification systems that are in place at your mine. Confirm that workers are meeting the operator's positive communication requirements. Supervisors must continuously monitor workers' compliance.</p>

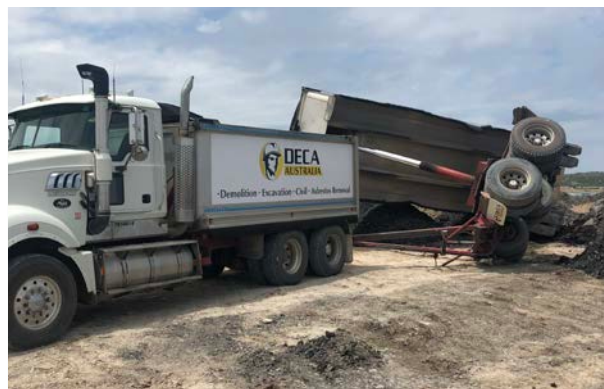
A dog trailer overturned when it was unloading at a sand mine. The driver had emptied the trailer and was reversing to tip the load. The front axle of the trailer rode up a pile, rolling the trailer.

Tip areas should be designed with enough room for trucks to safely perform tipping operations and to account for trailer position and procedure when unloading truck and dog combinations.

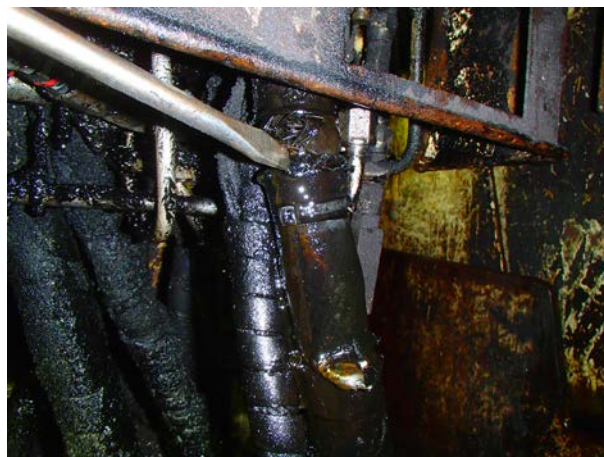
A worker was sprayed with hydraulic fluid when a hose failed on a continuous miner drill rig in an underground coal mine. The worker was transported to hospital where he was cleared of injury.

[MDG41 Fluid power systems](#) section 3.4.4 requires designers to consider fitting guards to prevent fluid release from entering a work area. Mines should review guarding of hoses in work areas and correct any deficiencies. When buying new or overhauling equipment hydraulic hoses in work areas should be eliminated where practicable or appropriately guarded.
