WEEKLY INCIDENT SUMMARY

Week ending Friday 28 August 2020

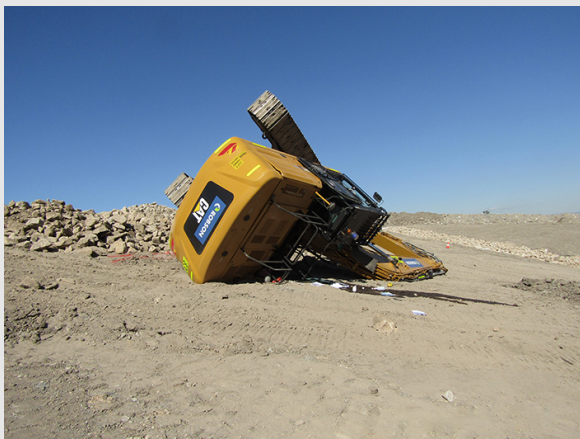
Dangerous incident
IncNot0038085
Open cut coal mine

A 30 tonne excavator conducting rehabilitation work was being walked backwards when one track rode up onto a rock pile, causing the excavator to overturn. The operator suffered a bump on the head.

Equipment operators must maintain situational awareness and remain vigilant to manage the risk of machine rollovers. This includes familiarisation with the work area by visually identifying hazards before starting work.
