# WEEKLY INCIDENT SUMMARY

Week ending Friday 28 February 2020

This incident summary provides information on reportable incidents and safety advice for the NSW mining industry. To report an incident to the NSW Resources Regulator: phone 1300 814 609 24 hours a day, 7 days a week.

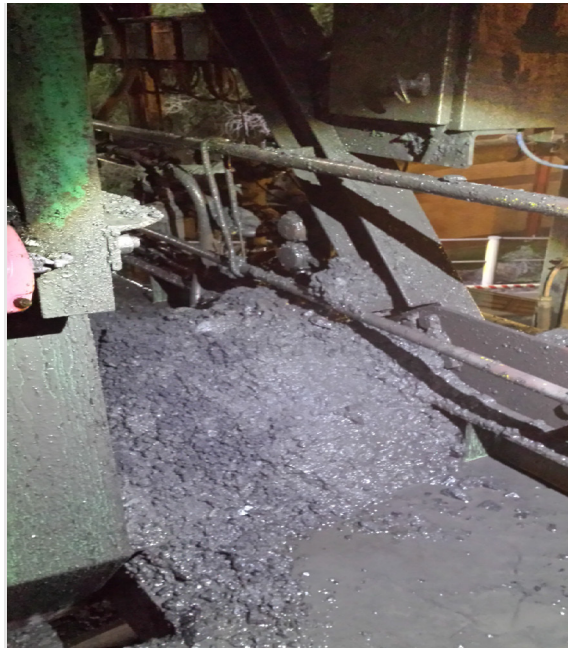
Inundation or inrush of any substance

INCIDENT TYPE	SUMMARY	RECOMMENDATIONS TO INDUSTRY
Dangerous incident IncNot0036795 Coal processing plant	<p>An operator was responding to a blockage in a feeder under a coal loading bin. The operator cleared the blockage and normal feed resumed. Shortly after, wet material flowed out of the feeder chute and hit the operator in the chest, knocking him off his feet. The operator suffered bruising.</p> <p>The plant was processing difficult material that needed the addition of water to keep it moving through the plant. This event was preceded by an upstream blockage in a sizer that was hosed out.</p>	<p>When developing the control measures to manage the risks of inundation or inrush of any substance, mines must consider:</p> <ul style="list-style-type: none"> <li>■ failure or blocking the flow channels</li> <li>■ the potential for the accumulation of water, gas or other substances, or materials that could liquefy or flow into other workings or locations.</li> </ul>

In addition, mine operators should have a written procedure for the task of clearing a blocked chute and they should ensure workers adhere to the procedure.

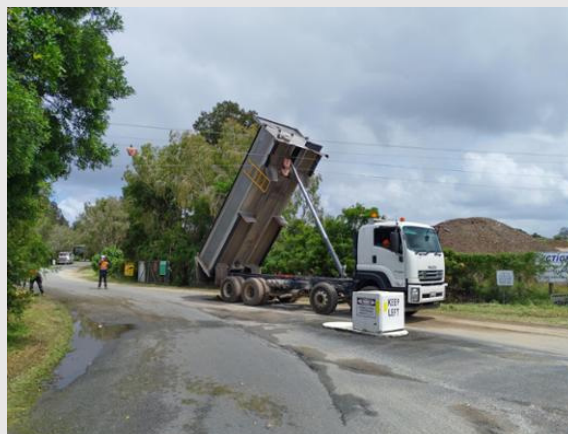
Roads or other vehicle  
operating areas

A tipper truck hit overhead power lines while exiting a sand plant. The driver reported that he had lowered the body and that the body had raised again, by itself. The driver did not suffer an electric shock.

The reason the truck body was in the raised position is to be established.

- [Safety bulletin SB15-05 Plant contacting overhead powerlines and structures](#)

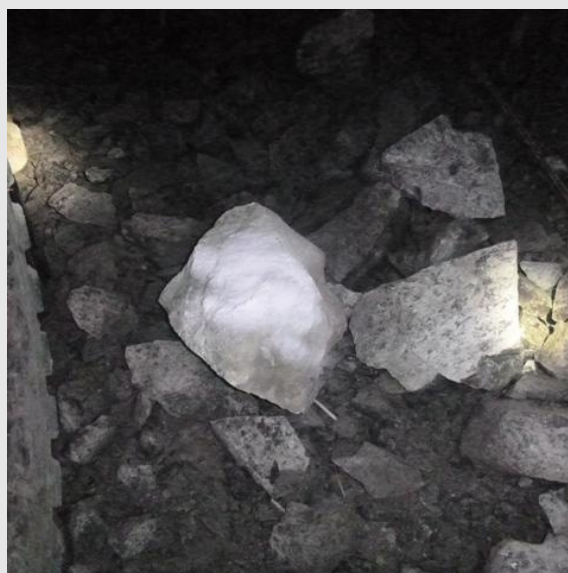
Ground or strata failure

A worker was assisting a Jumbo operator who was bolting a pillar incline. After the worker manually scaled the roof area (removed loose material), he began installing retaining caps resin capsules. He dropped a cap and bent over to pick it up. When he did this, a rock fell from beneath the mesh and hit him on the back of the head. The rock was about 50 centimetres in diameter and weighed about 20 kilograms. The worker lost consciousness briefly.

The worker's hard hat absorbed some of the impact.

Control measures to manage the risks of ground or strata failure include:

- using appropriate equipment and procedures for scaling
- the design, installation and quality of rock support and reinforcement.

Work methods must consider the risk of falling material and locations of people.
