Week ending 7 November 2018

This incident summary provides information on reportable incidents and safety advice for the NSW mining industry. To report an incident to the NSW Resources Regulator: phone 1300 814 609 24 hours a day, 7 days a week.

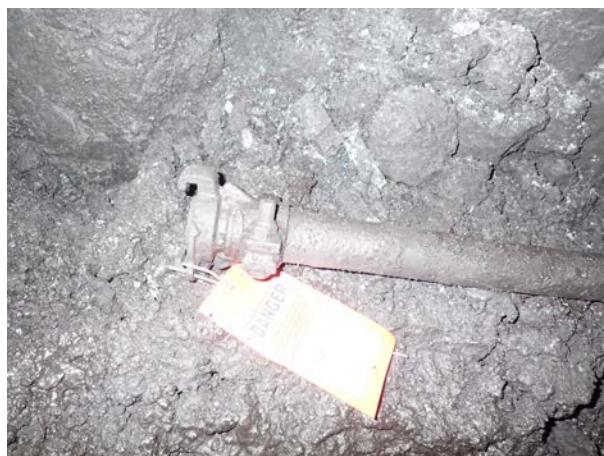
Incident type	Summary	Recommendations to industry
Dangerous incident SinNot-2018/01852	A worker was injured when he was hit by a hose. Two workers were trying to unblock a drain hose from a methane water trap. They broke the line and while one worker was holding the hose, the other worker tried to remove the blockage using compressed air. When the blockage cleared it discharged from the end of the hose with force. The worker holding the hose lost his grip and the hose whipped around hitting him in the jaw and the material hit him in the face.	The risk of a hose whipping when applying compressed air is reasonably foreseeable. Put controls in place to address this hazard before starting work. Risk management tools must be used and should be appropriate for the task.

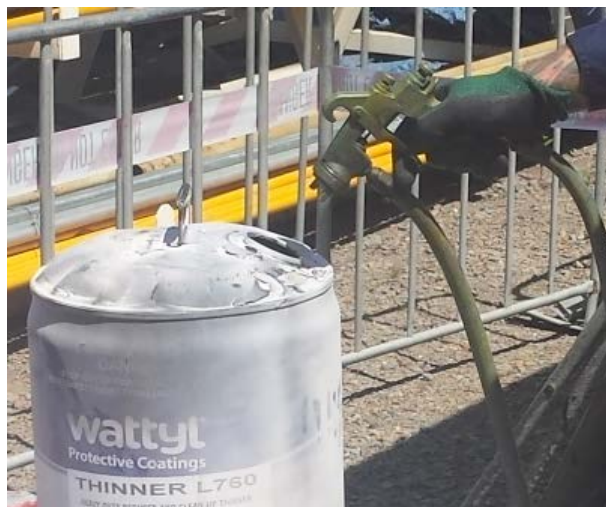
<p>High potential incident SinNot-2018/01821</p>	<p>A painter suffered burns to his hands and face. The painter was cleaning out a pot by running thinners through lines and discharging thinners into an empty thinners tin. The thinners ignited in the tin with flames coming out of tin and causing burns to the painter's hand (through gloves) and the side of his face.</p>	<p>When working with flammable gases and liquids the potential for static energy should be assessed and suitable controls used to address the risk.</p>

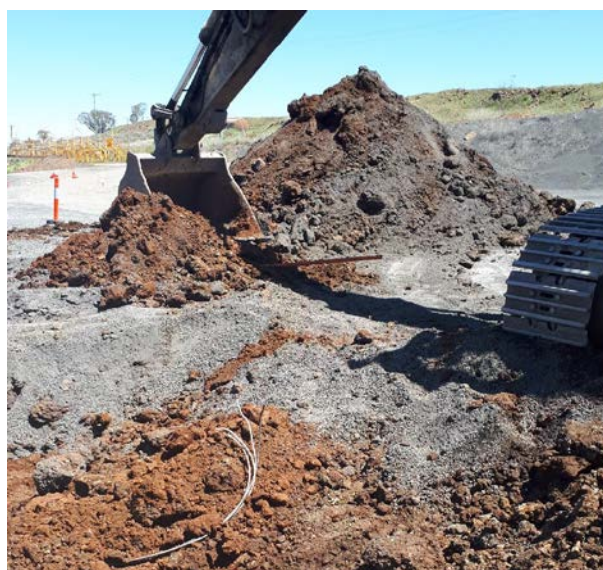
Dangerous incident
SinNot-2018/01818

A buried energised electrical cable was severed while excavating at a quarry.

The cable was known to be buried within the excavation area, however, the depth of cover was much less than expected.

If the depth of cover is questionable, the depth should be confirmed before excavation begins. Any cables in the area should be isolated before starting to dig.

Mines should keep surface infrastructure plans up to date.
