# Weekly incident summary

## Week ending 21 June 2024

This incident summary provides information on reportable incidents and safety advice for the NSW mining industry. To report an incident to the NSW Resources Regulator: phone 1300 814 609 24 hours a day, 7 days a week.

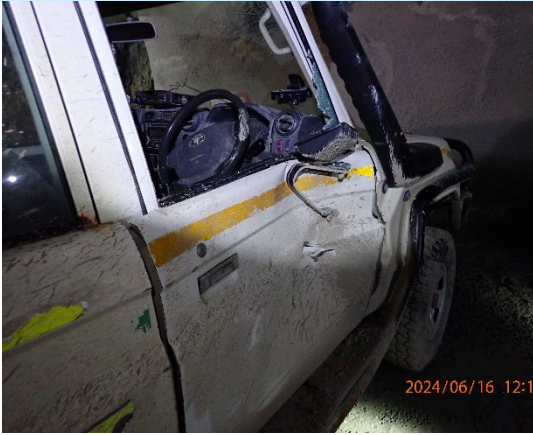
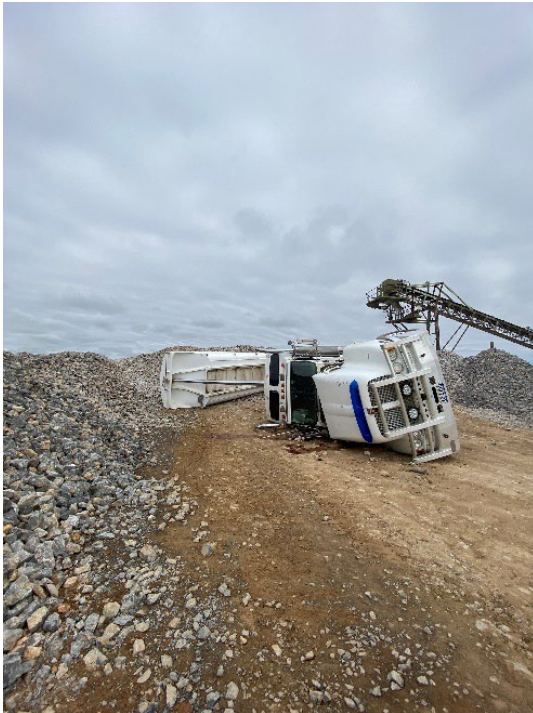
<p>Dangerous incident IncNot0047098 Industrial minerals</p>	<p>An articulated tip truck carrying 24.6 tonnes of rock overturned while tipping its load. The truck was parked fundamentally stable when the incident occurred. The truck driver suffered minor abrasions.</p>

<p>The risks associated with the rollover of mobile plant was the subject of a Regulator compliance priority program in 2018. Refer to the following outcome report for more information:</p> <p><a href="#"><u>Articulated truck rollovers and falls from mobile plant</u></a></p> <p>Refer to: <a href="#"><u>Safety Bulletin SB17-01 Industry reports more truck rollovers</u></a></p>
<p>Dangerous Incident IncNot0047118 Open cut coal Fire or explosion</p>	<p>An operator noticed sparks coming from the grid box of an oncoming truck and notified the driver who immediately called an emergency and hit the E-stop in the truck, then safely positioned positions 1 tyre against the windrow to make the truck fundamentally stable. The operator safely exited the truck via normal egress.</p>	<p>Mine operators should ensure stringent monitoring and quality control of maintenance and repair activities and also ensure risk control measures to prevent the occurrence of fires are implemented and remain effective. Inspection regimes and housekeeping standards should be routinely examined to ensure</p>

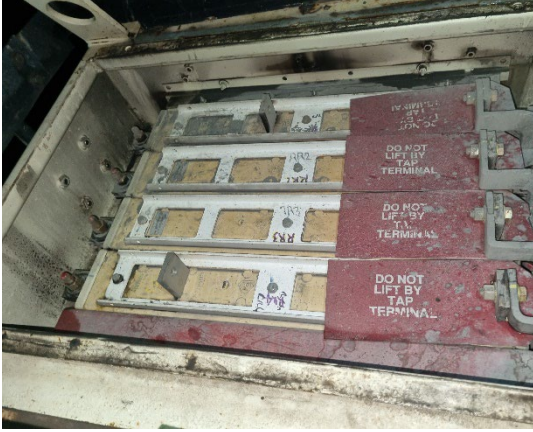
<p>A workshop maintenance worker opened the grid box cabinet and found there was no flame. A water cart sprayed the grid box for about 5 minutes to cool it down.</p> <p>A preliminary investigation shows the grids were aligned in incorrect positions.</p>

<p>minimum standards are met or exceeded.</p> <p>AS 5062 Fire protection for mobile and transportable equipment provides guidance for mines. For more resources, refer to our webpage: <a href="#">Fires on mobile plant safety</a></p>
