Serious injury

Incident date: 2 April 2018

Event: Serious injury at open cut coal mine

Location: Werris Creek No 2 Coal Mine, Werris Creek NSW

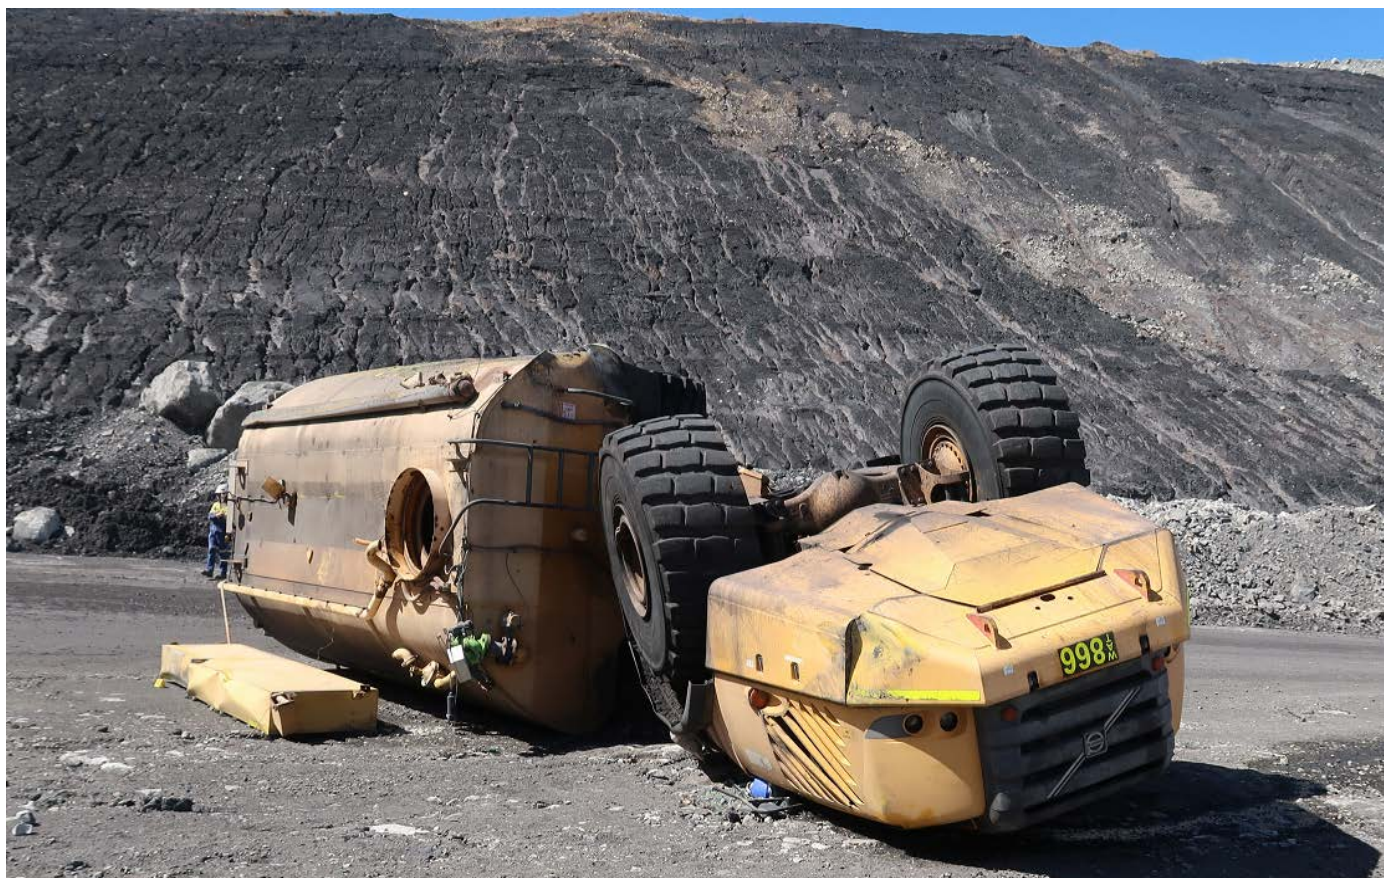
Photograph 1: Final position of articulated water cart.

The fully loaded water cart was then driven down the access ramp toward pit bottom to a right-hand bend. The water cart failed to negotiate the bend and rolled over with the cabin coming to rest on its roof.

Mine operators must have effective safety management systems in place and identify risks associated with the operation of mobile plant. All plant must be fit for purpose and safety critical systems and safety-related components must function as designed.

Safety critical systems include braking, steering, warning systems and interlocks. Safety-related components includes fixed components such as steering arms, and operator protective devices such as ROPS (roll-over protective structure) and FOPS (falling object protective structure).

Mine operators must also ensure that workers are adequately trained and competent in the safe use of mobile plant. All plant should be operated in a safe manner and in accordance with the manufacturer's guidelines.

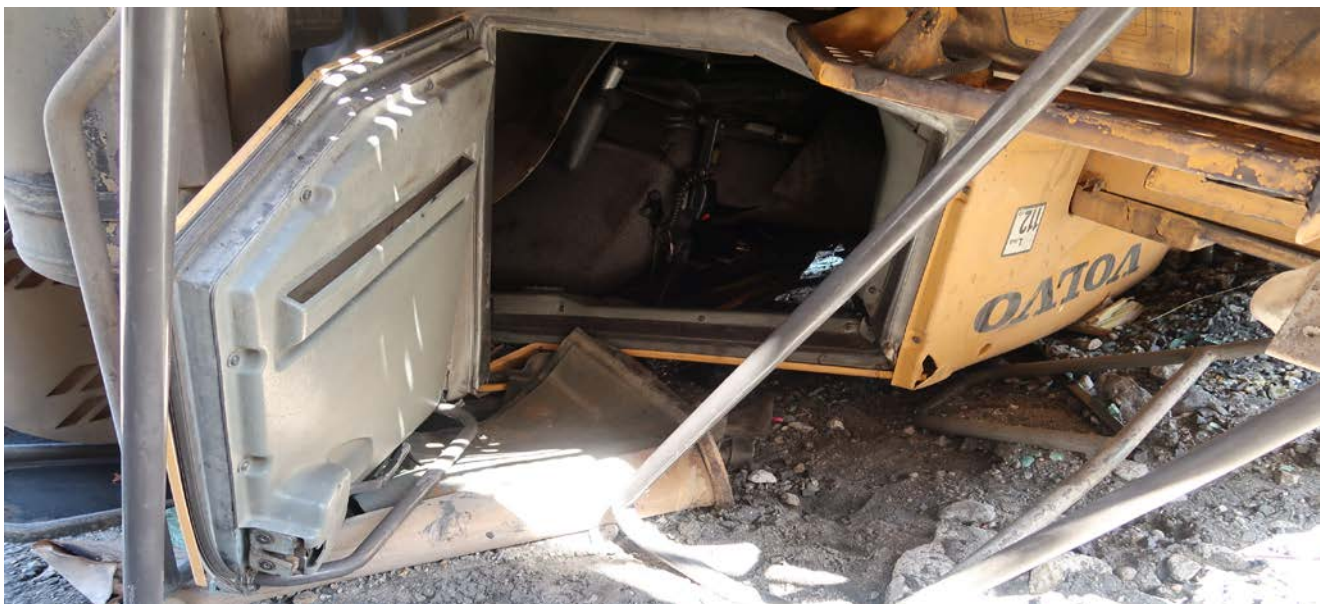
The worker managed to free himself from the damaged cabin of the water cart. The worker walked up the ramp where he located other workers. The worker suffered a large laceration to his lower back. The worker was transported to the workshop where first aid was rendered before he was transported to hospital for further treatment.

Photograph 2: The damaged cabin of the articulated water cart.
