# MINE SAFETY

# INVESTIGATION UNIT

Investigation Case Studies

Proximity Detection and  
Collision Avoidance Systems Workshop  
8-9 February 2011

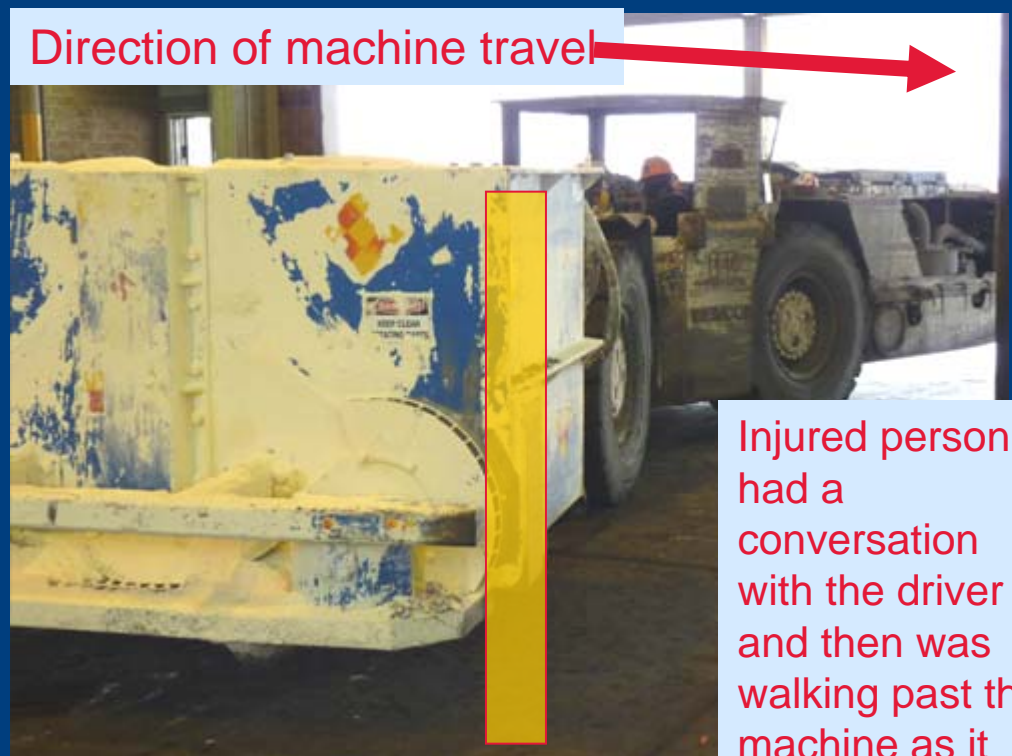
# Case study 1 – Femur fracture Dec 2010

Leg struck by the stone dust pod as the vehicle turned into a cut through.

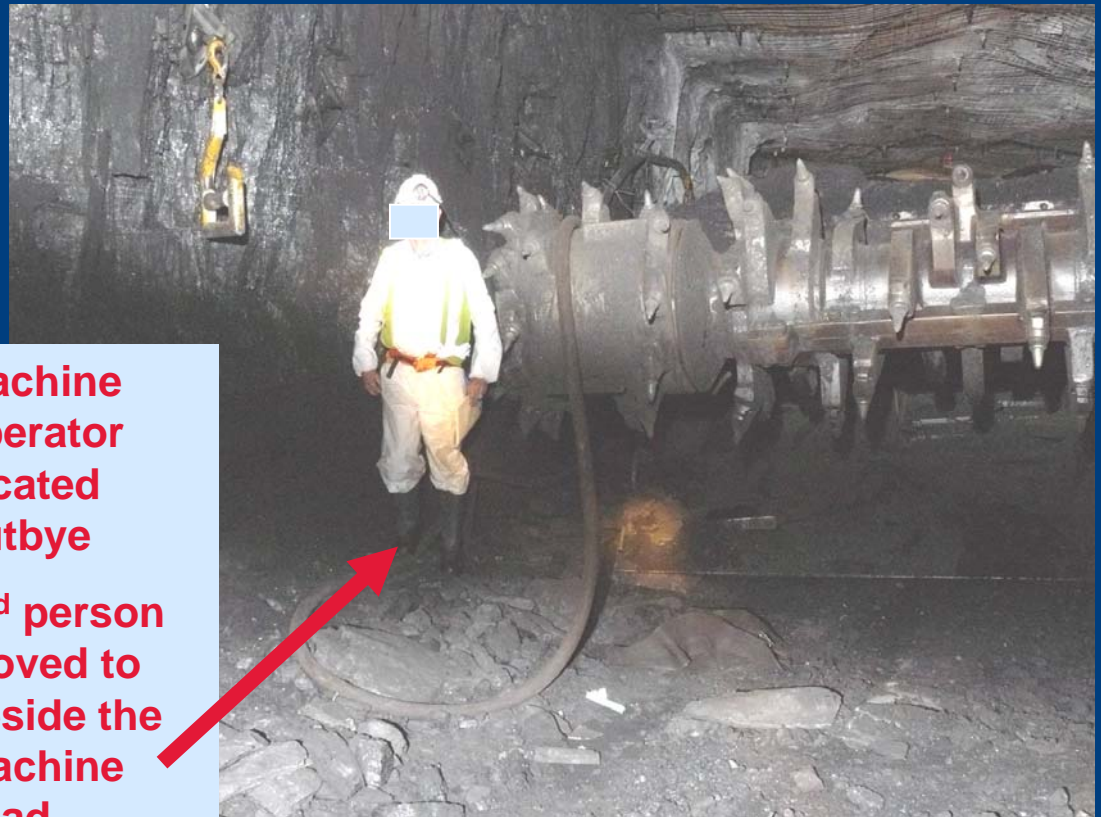
# Case study 2 – Crush injuries Sept 2008

Incident – Remote control machine being reversed, the operator located out-by of machine tripped over as a second person moved beside the machine cutting head

**Machine operator located outbye**

**2<sup>nd</sup> person moved to beside the machine head**

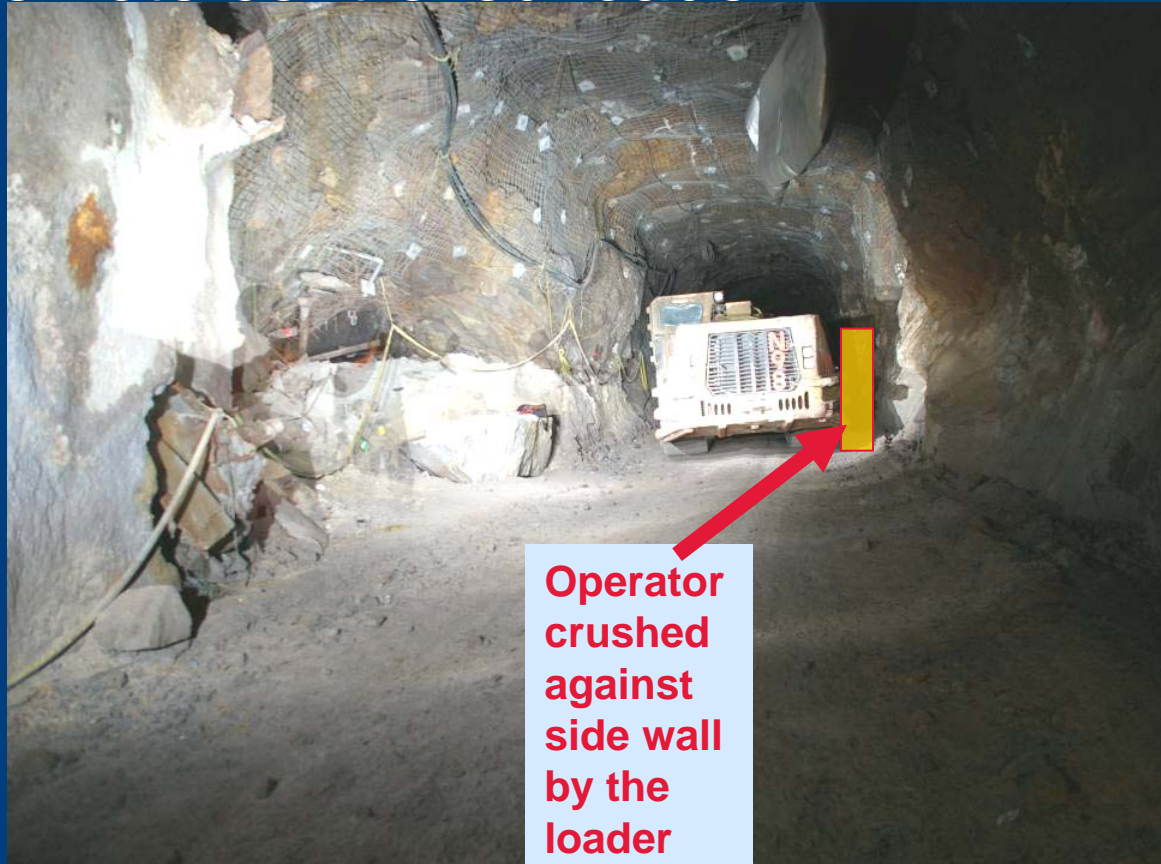
# Case study 3 – Fatal injury Jan 2007

Incident - Operator came within 5m of the loader operation (only soft barrier controls in place)

There were tilt switches on the remote control unit which were presumed to shut down the loader.

**Operator  
crushed  
against  
side wall  
by the  
loader**

Light curtain (electronic barrier) installed post incident ?

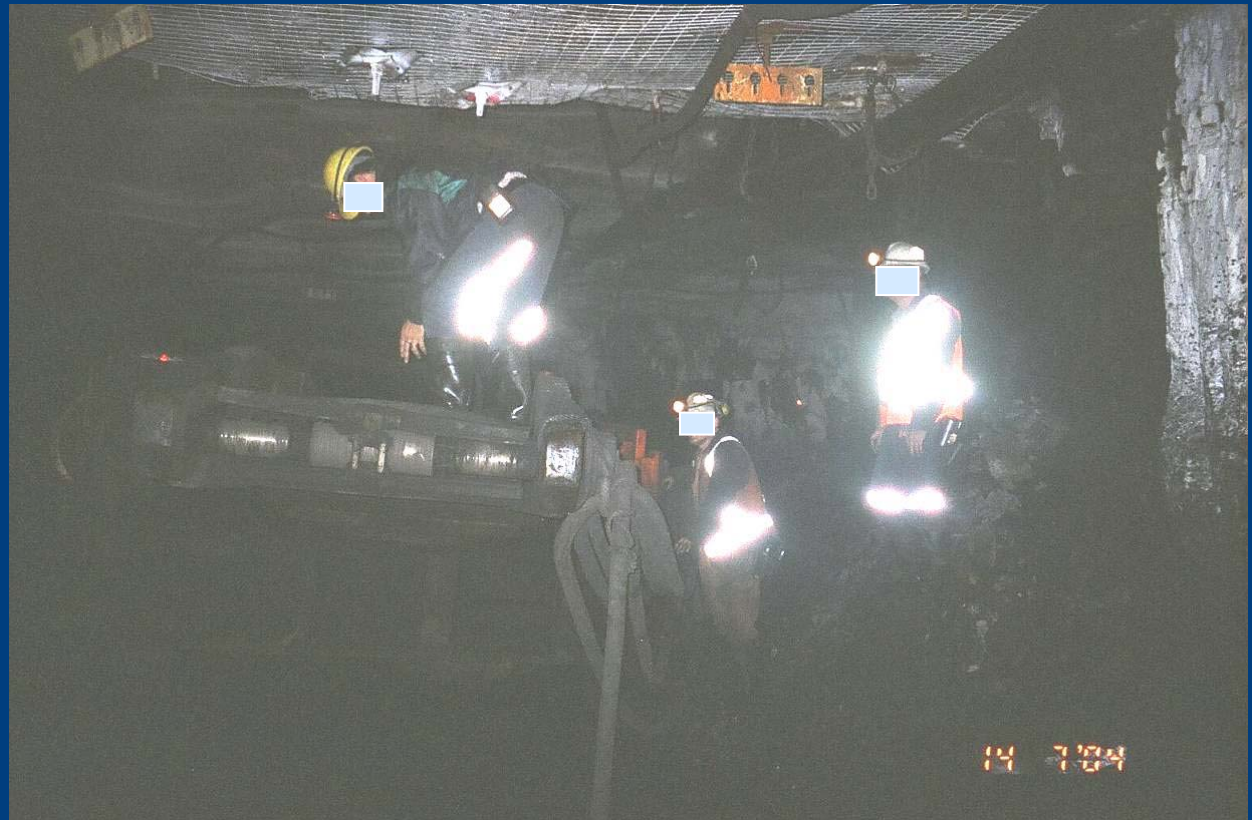
# Case study 4 – Paraplegia July 2004

Incident – Persons riding on continuous miner boom handling power cable during machine relocation

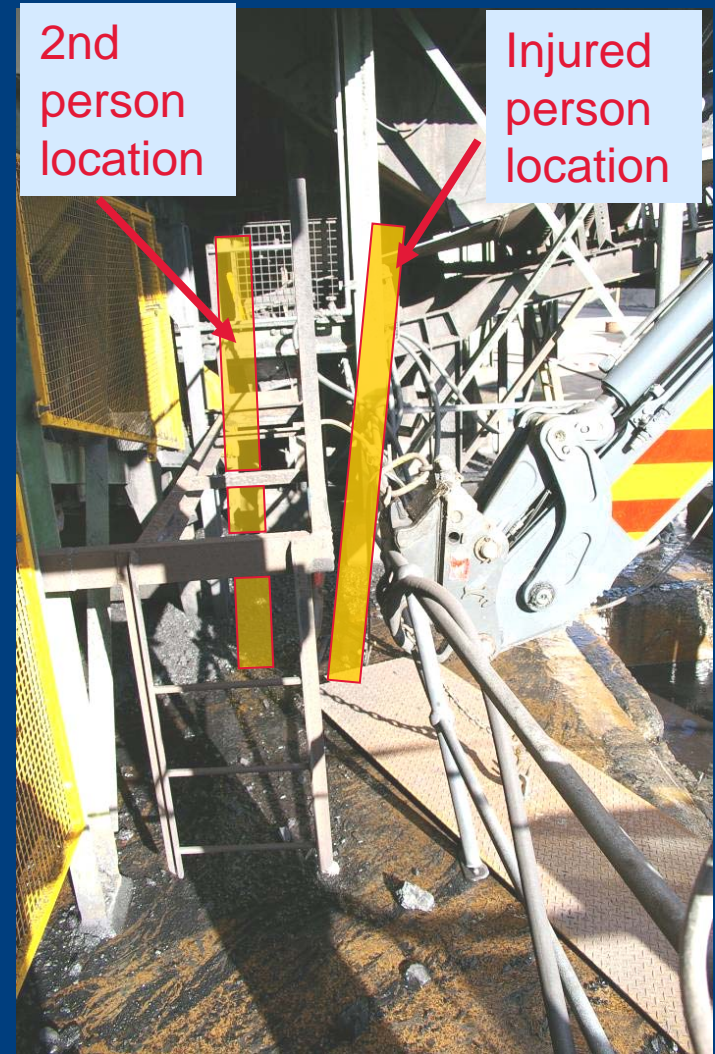
# Case study 5 – crushed pelvis August 2008

- Lifting steel plate into position
- Person moved and relocated in between two steel structures in front of a backhoe arm.
- Backhoe operator not aware the person had entered into backhoe arm work zone
- Unplanned slip and forward movement of the backhoe due to slope of ground

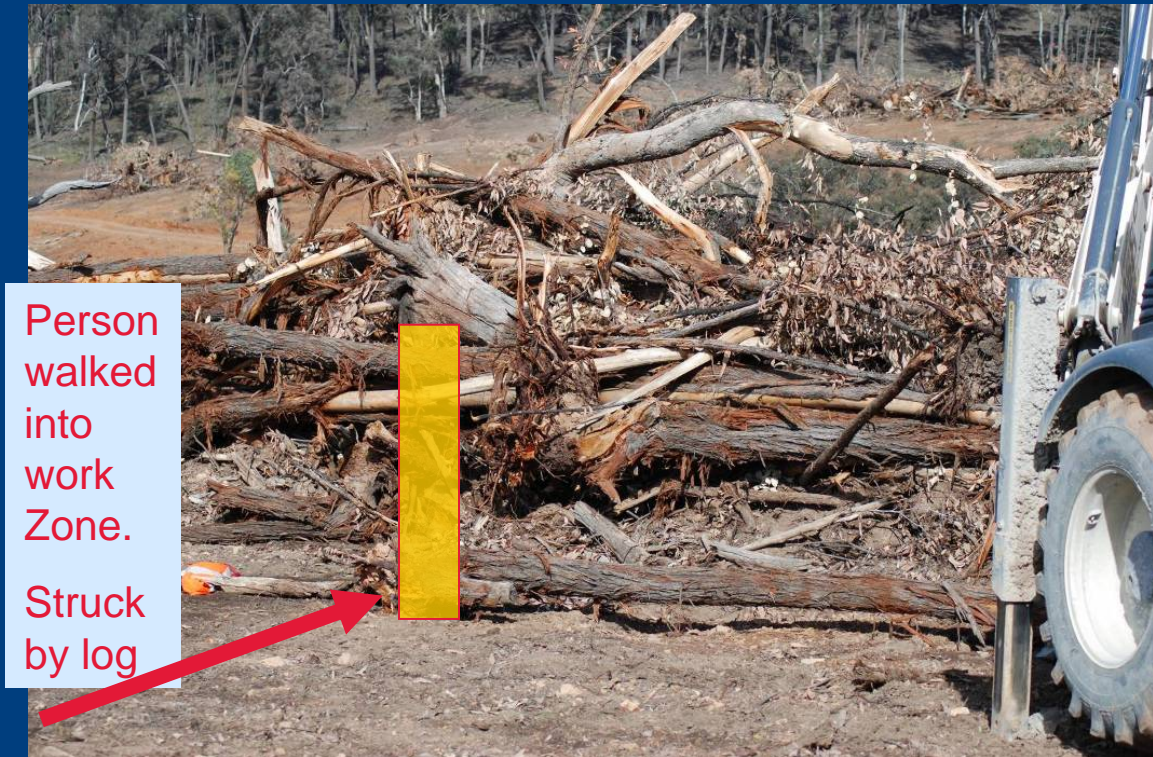
# Case study 6 – fractured skull August 2008

- Person walked into the work area of a backhoe excavator arm whilst levering out a log from a pile of timber logs.

Person  
walked  
into  
work  
Zone.

Struck  
by log

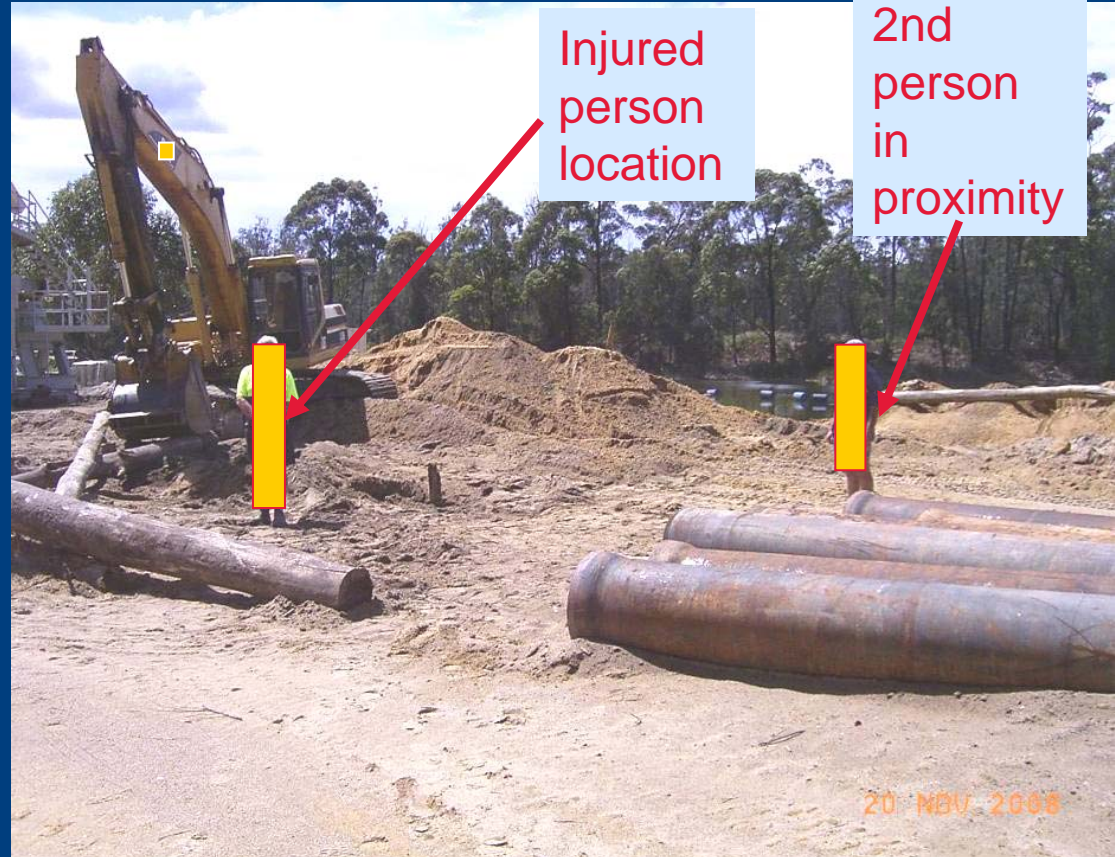
# Case study 7 – fractured pelvis Nov 2008

- Person located in the No Go Zone of an excavator moving logs.

Injured person location

2nd person in proximity
