Trade &
Investment
Mine Safety

NSW underground metalliferous mines **Fires on mechanical plant** Incident analysis

2008 to 2012

November 2013

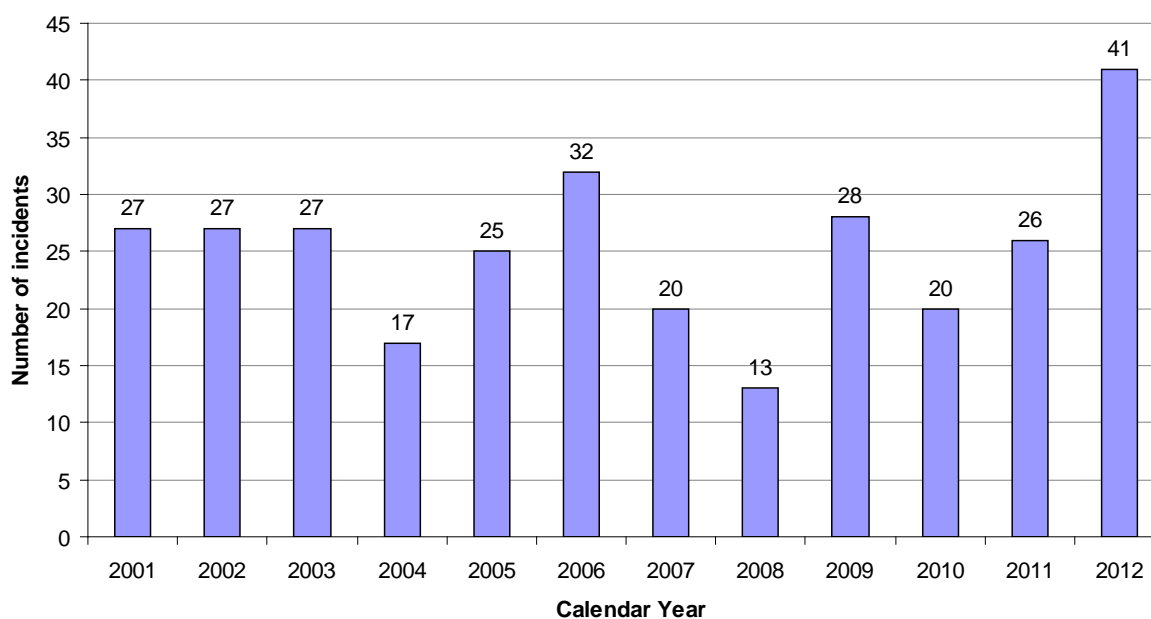
Figure 1 - Fires on mechanical plant at underground metalliferous mines 2001-2012

For the same period there has been a relatively steady increase in the number of fires reported on mechanical plant at underground metalliferous mines (see figure 1).

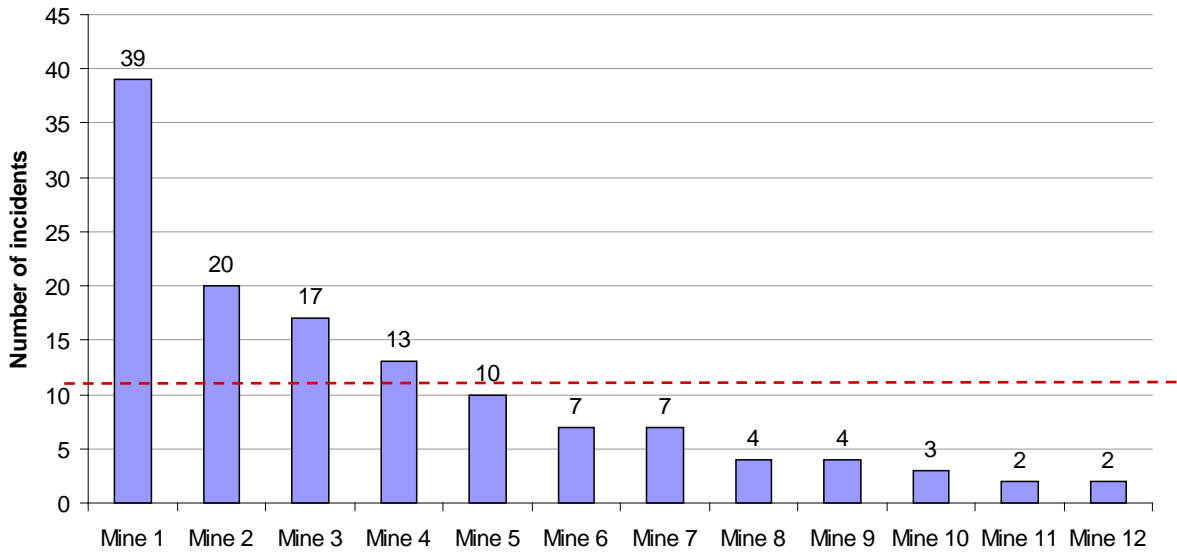
Figure 2 - Fires on mechanical plant at underground metalliferous mines by mine 2008-2012

Figure 2 shows the range of results for some mines.

The greatest number of fires occurred in the Cobar area 70 (55 percent). There have been 45 (35 percent) fires in the Orange area and 13 (10 percent) fires in the Broken Hill area.

The data shows the average number of fire incidents on mechanical plant at underground metalliferous mines for the 2008-2012 period was 10.7 (i.e. average 2.7 fires per mine per year).

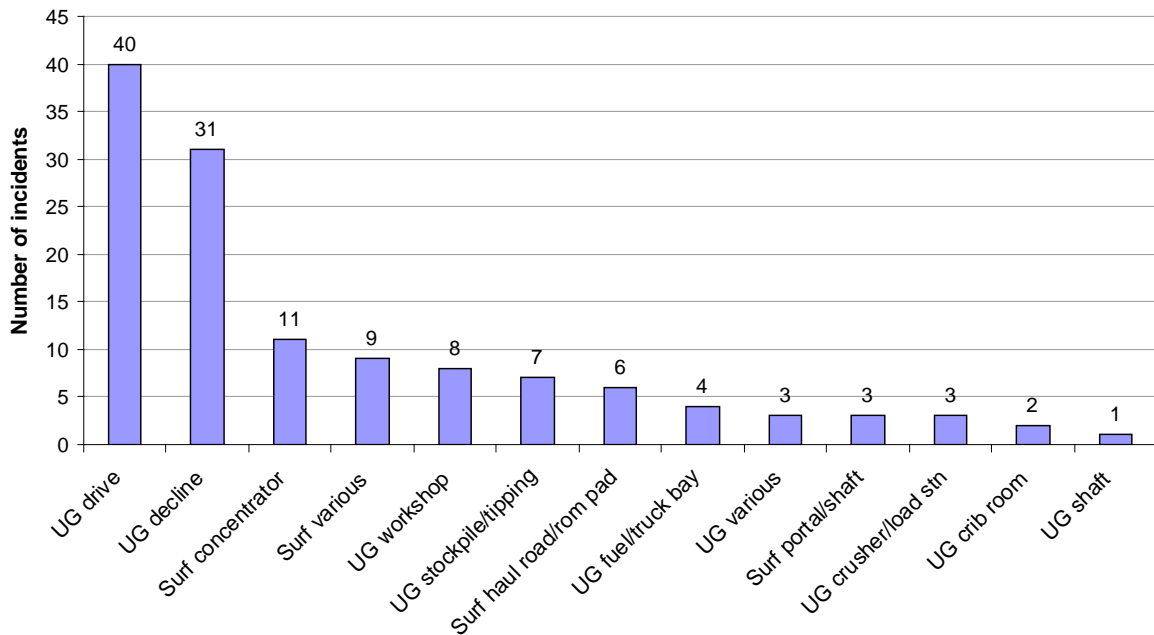
Figure 3 - Fires on mechanical plant at underground metalliferous mines by location of incident 2008-2012

The majority of fires have occurred in underground parts of the mine, 99 (77 percent).

Underground drives and declines were the locations of 71 fires (55 percent), refer figure 3. This is unremarkable given the type of plant being used at these mines and the nature of the work being undertaken.

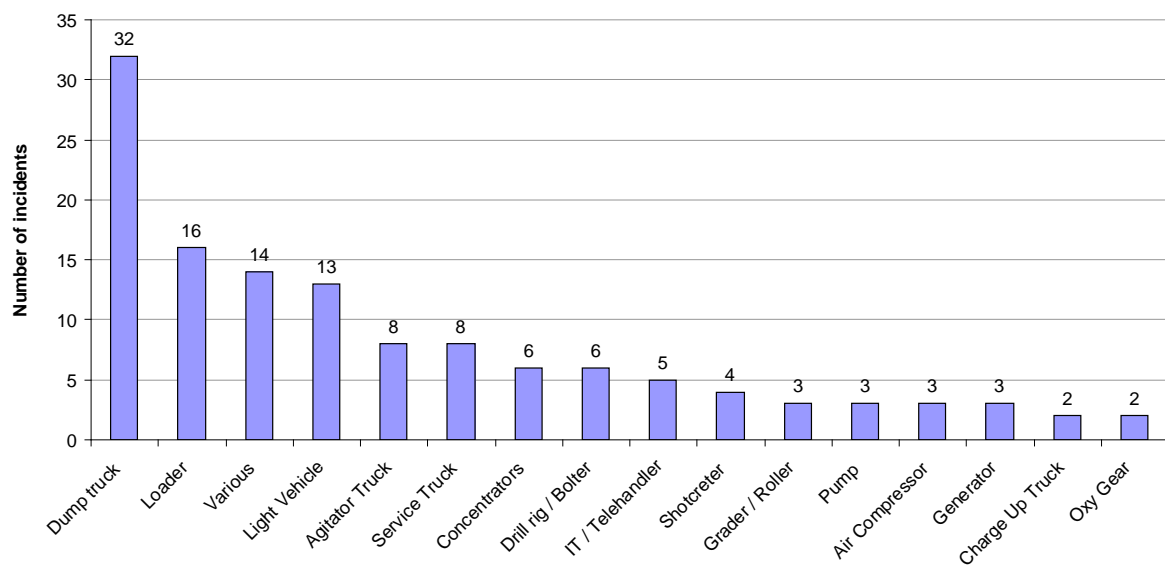
Figure 4 - Fires on mechanical plant at underground metalliferous mines by equipment type 2008-2012

Figure 4 identifies how the number of fires compared for different types of plant.

Dump trucks and loaders sustained 48 fires (38 percent), all other heavy mobile plant combined sustained 36 (28 percent) fires. Light vehicles, which at most mines significantly outnumber heavy plant, sustained only 13 (10 percent) fires.

It appears that the complexity of hydraulic, fuel, electrical and braking systems on heavy mobile plant, and the nature of the work being undertaken, created the greatest potential for damage and for a fire. Data available from COMET was not sufficient to establish if any particular item of plant was particularly prone to fire.

Mobile plant made up 97 (76 percent) of the 128 fires reported on mechanical plant at underground metalliferous mines (see figure 4).

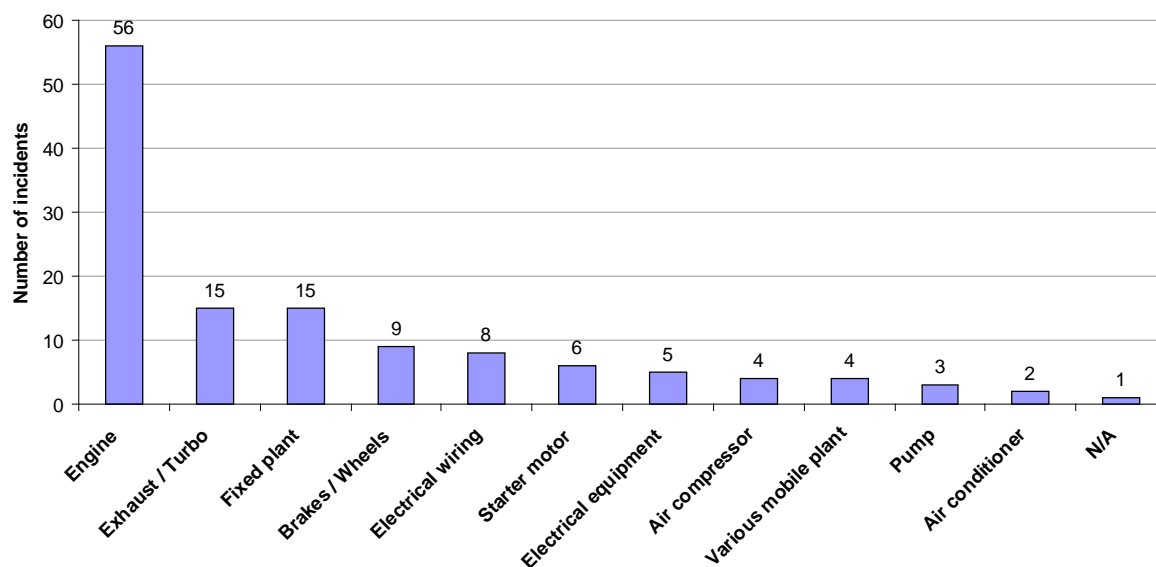
Figure 5 - Fires on mechanical plant at underground metalliferous mines by location of fire 2008-2012

The majority of fires on mechanical plant, 71 (55 percent), have occurred on the engines or exhaust of mobile plant (see figure 5). This result is supported by the data contained in figures 6, 7 and 8.

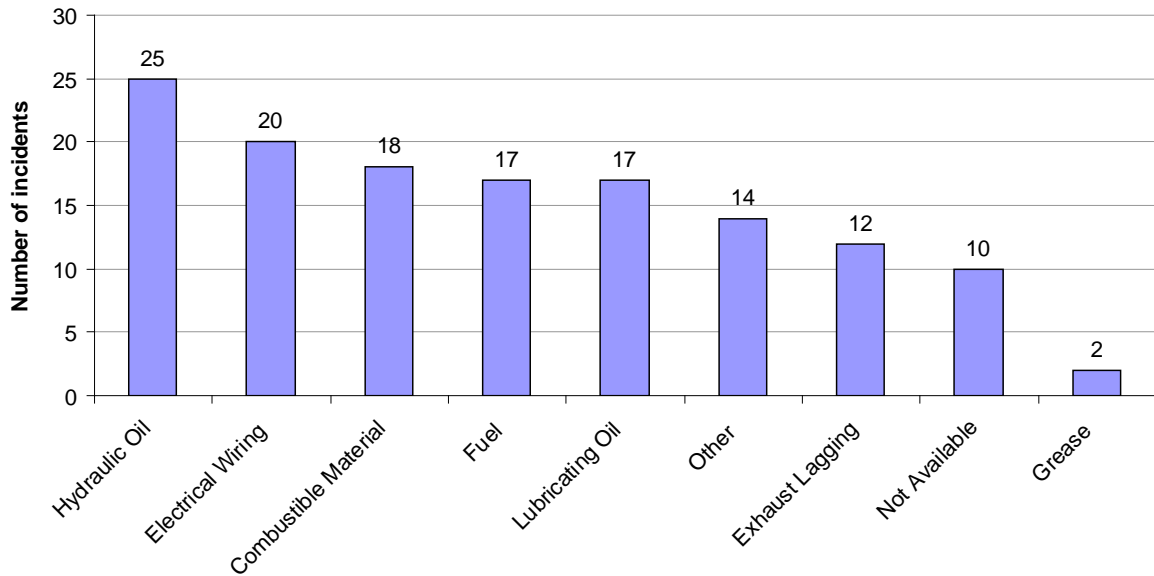
Figure 6 - Fires on mechanical plant at underground metalliferous mines by fuel source 2008-2012

Figures 6, 7 and 8 provide data relating to the fuel source, heat source and contributing factors for fires on mechanical plant at underground metalliferous mines.

Figure 6 shows the principal fuel source for fires is hydraulic oil, lubricating oil, fuel and grease, which made up 45 percent of the total (68 percent for 2001 to 2007). Electrical wiring made up 15 percent of the total, combustible material; e.g. rags, made up 13 percent of the total and exhaust lagging made up 9 percent of the total. All are significant factors.

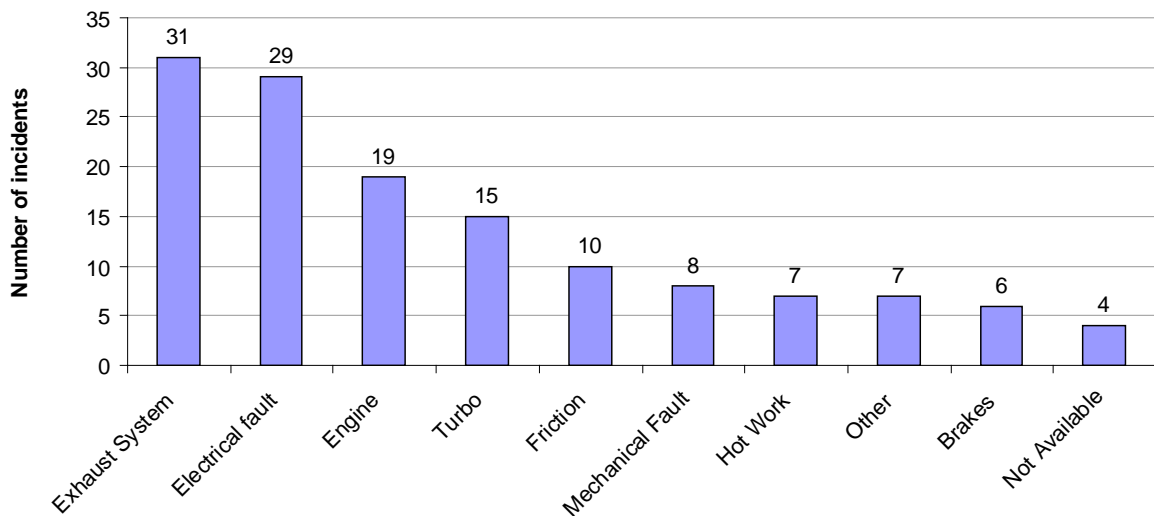
Figure 7 - Fires on mechanical plant at underground metalliferous mines by heat source 2008-2012

Figure 7 identifies the principal heat source for fires is the exhaust system, engine and turbo on mobile plant which made up 48 percent of the total (62 percent for 2001 to 2007). Electrical faults made up 21 percent of the total (14 percent for 2001 to 2007).

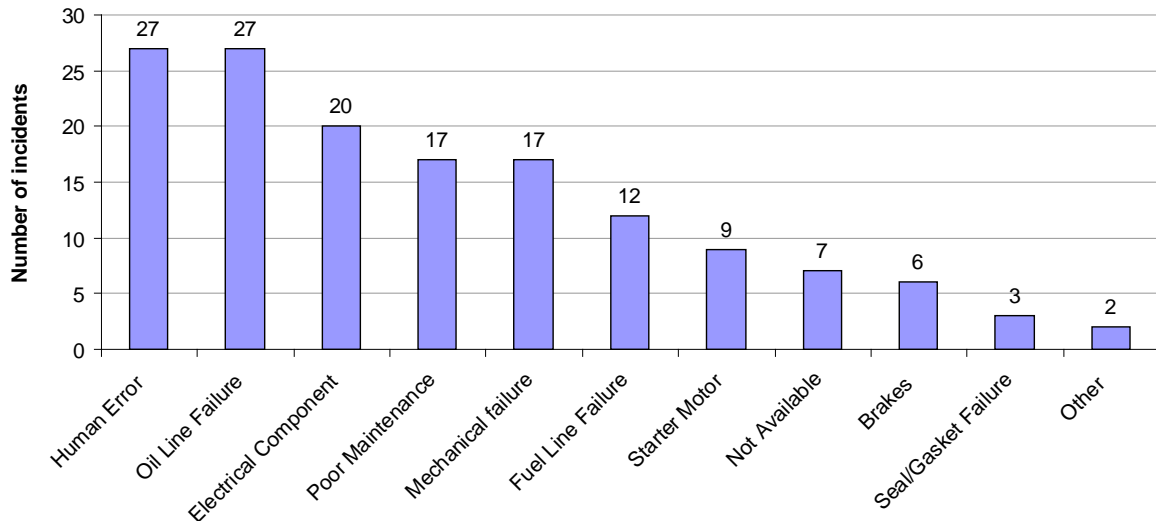
Figure 8 - Fires on mechanical plant at underground metalliferous mines by contributing factors 2008-2012

Figure 8 shows the principal contributing factors for fires are human error and poor maintenance that together made up 30 percent of the total (20 percent for 2001 to 2007). The identification of human error and poor maintenance was made as objectively as COMET data permitted. Oil and fuel line failure made up 27 percent of the total (32 percent for 2001 to 2007) and electrical component failure made up 20 percent of the total (11 percent for 2001 to 2007).

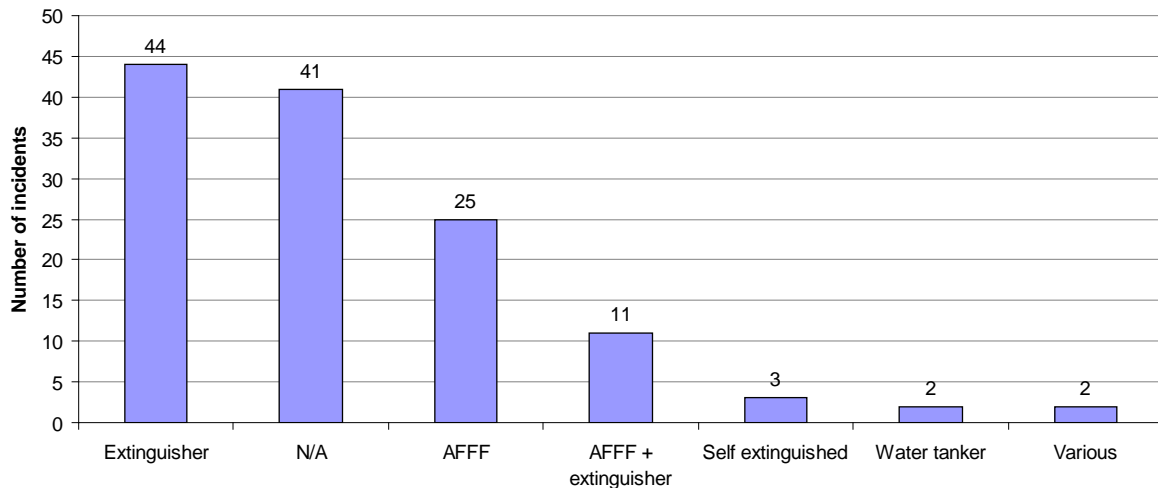
Figure 9 - Fires on mechanical plant at underground metalliferous mines by fire fighting 2008-2012

Figure 9 shows how fires were extinguished. The figure shows most fires were extinguished with hand-held extinguishers 44 (34 percent). AFFF fire suppression systems, generally the safest option for fire fighting on mobile plant, were used in only 25 (20 percent) fires.

Fire suppression systems were used in another 11 (9 percent) fires in combination with a fire extinguisher, which suggests that they did not operate effectively and this conclusion is supported by information contained in some of the corresponding COMET events. However data available from COMET was not sufficient to establish a reliable conclusion regarding fire fighting because 41 (32 percent) COMET events contained no information at all regarding fire fighting.

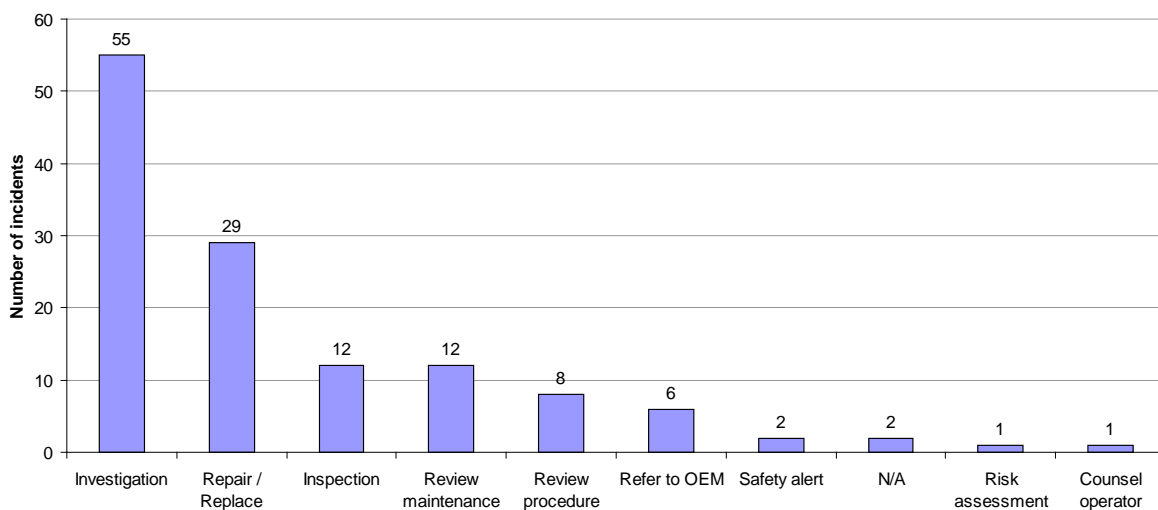
Figure 10 - Fires on mechanical plant at underground metalliferous mines by corrective action 2008-2012

In 67 (52 percent) cases, mines responded to a fire by conducting an investigation or an inspection, refer figure 10.

However in the majority of these cases, data available from COMET was not sufficient to confirm that the cause of the fire was correctly identified and that risk management principles were applied to select and implement appropriate control measures. In 29 (23 percent) cases, mines determined that to repair or replace damaged components was sufficient corrective action and there was no indication that an investigation was completed. In another 29 (23 percent) cases, mines responded by undertaking risk assessments, reviewing operating and maintenance procedures, consulting the OEM and issuing safety alerts.
